# Appendix B: Pump Station Final Condition Assessment Report

This report is an Appendix to HRSD's Rehabilitation Action (Rehab) Plan to satisfy the requirements of the United State's Environmental Protection Agency (EPA) Consent Decree as well as the Virginia Department of Environmental Quality (DEQ) Special Order by Consent (SOC) for reporting on results of the Condition Assessment Program (CAP). This document summarizes condition assessment results related to HRSD's pumping facilities. Appendices A, C, D, and E satisfy the remaining reporting requirements of the CAP. Assets found at material risk of failure, as described further in this report, are addressed in the main document, the Rehab Plan. The primary purpose of the HRSD CAP was to find sanitary sewer assets presenting an actual material risk of failure. For the purposes of this document, "failure" means any condition resulting in a sanitary sewer overflow, pipe leakage, or interruption of service to HRSD's customers, due to a physical condition defect in the system.

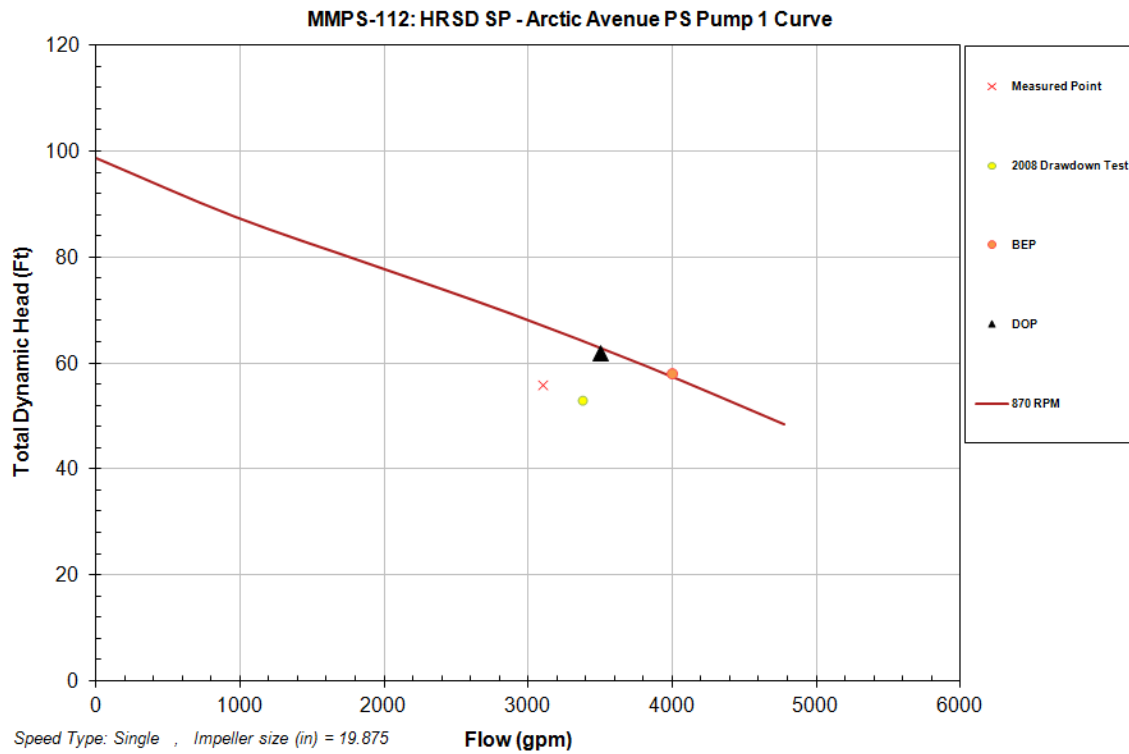
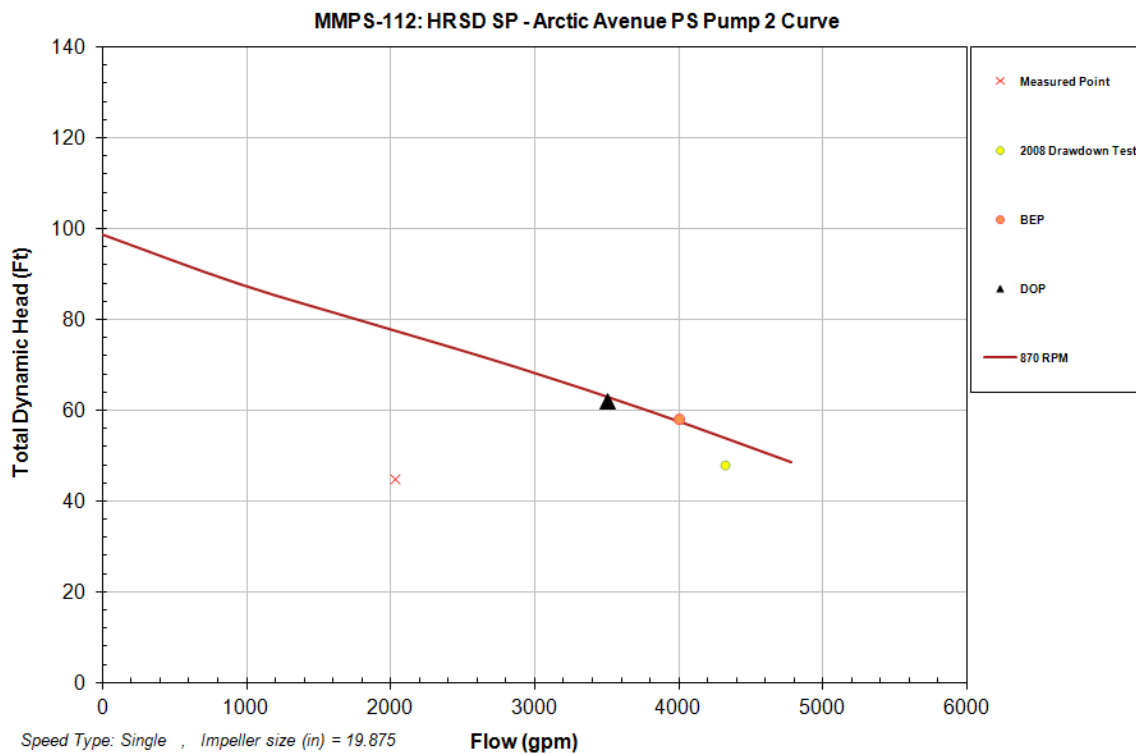
Arctic Ave PS uses variable speed Flomatcher pump controls which do not give a remote indication of pump shaft speed. The plotted curve is for the maximum pump shaft speed and, depending on available data; the measured point gives an indication of the pumps normal operating range rather than pumping capacity.

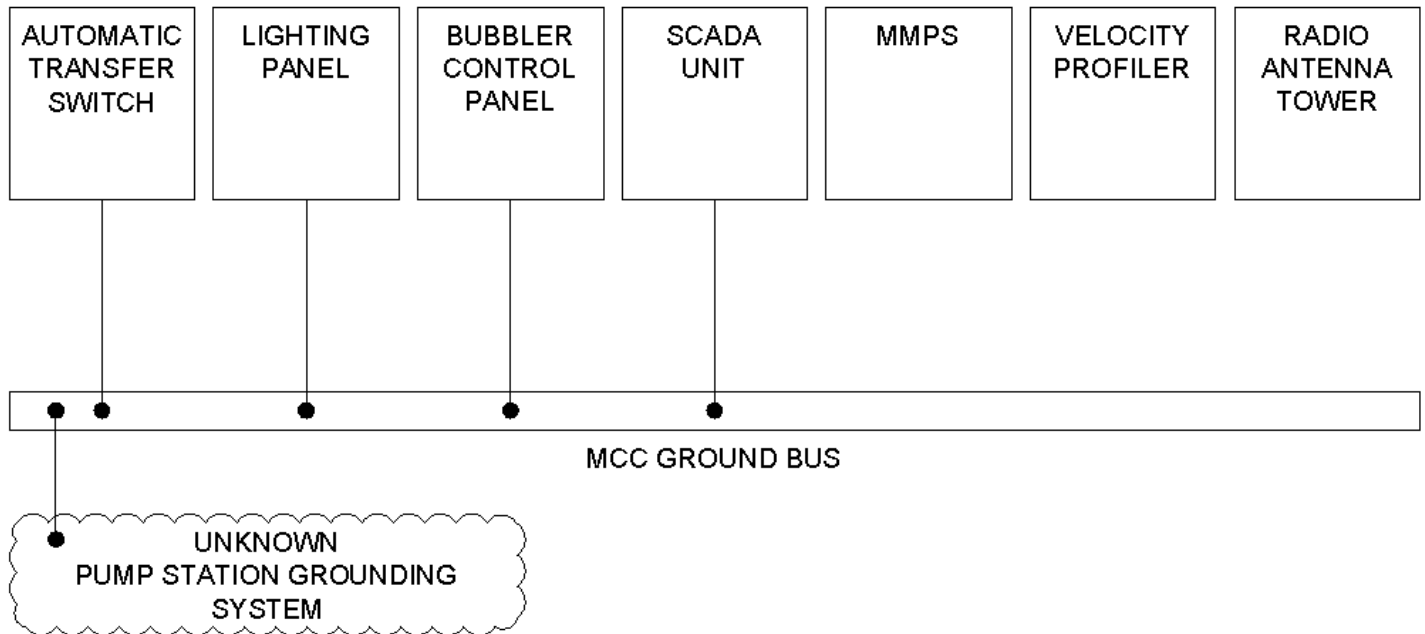
Figure 101-4. Arctic Ave Grounding System

- Service Entrance Surge Protection Device Installed
- Air Terminals Installed and Bonded to Ground System
- Ground Rod Test Wells Noticeable
- Ground Rods Noticeable
  - 0 Rod(s) Noticeable
- Indications of a Building Ground Ring
- No History of Lightning Strikes
- No History of Failures Resulting in SSO in Past 5 Years
- Equipment properly Surge Protected:
  - Velocity Profiler is not protected with surge suppression
  - SCADA Unit has no surge suppression on coax between Antenna & radio
- Equipment Properly Grounded:
  - Velocity Profiler & MMPS are not properly bonded to the station grounding system

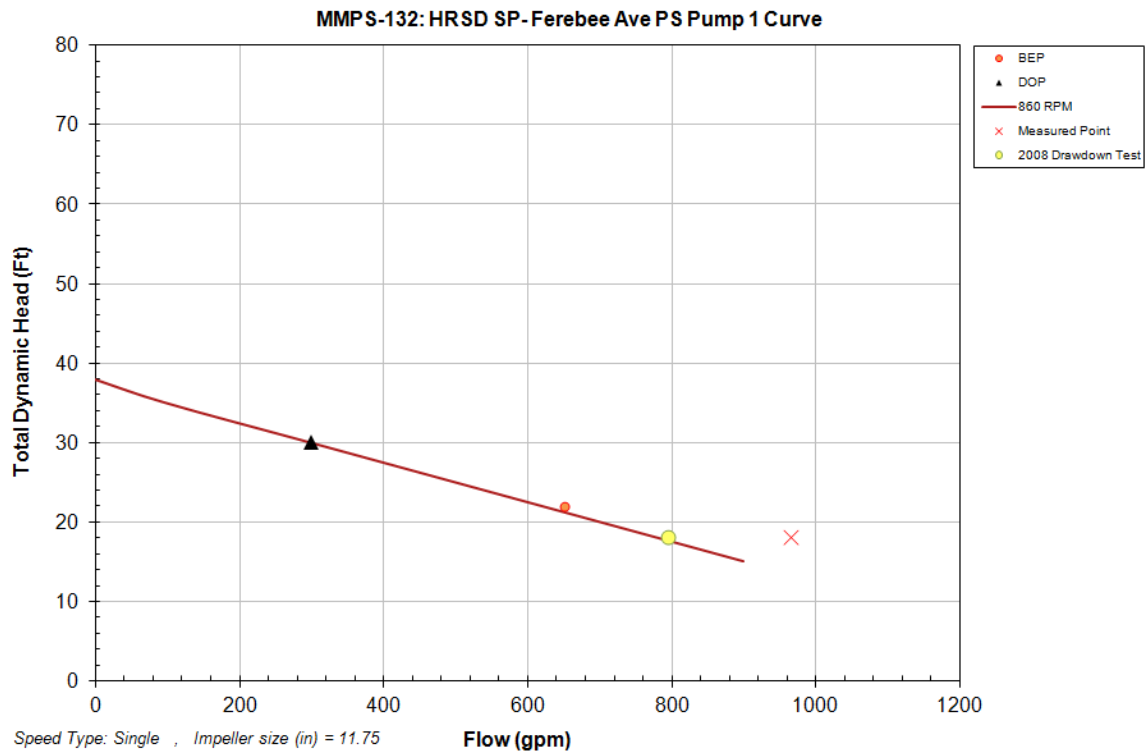
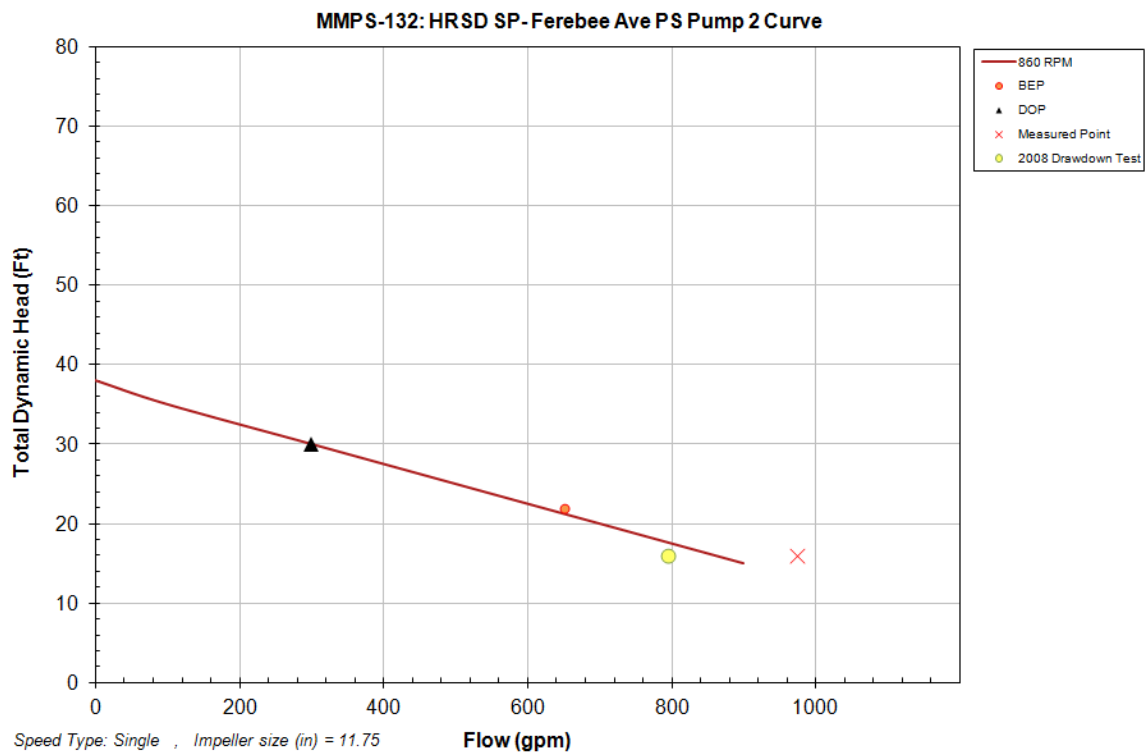
Ferebee PS does not have a discharge pressure sensor with remote indication. The station does not discharge to a manifolded force main so the TDH was assumed based on the results of the 2008 draw down test. The Flow is the average pumping rate. The Pump 3 Measured Point flow was calculated by quantifying changes in wet well stored volume.

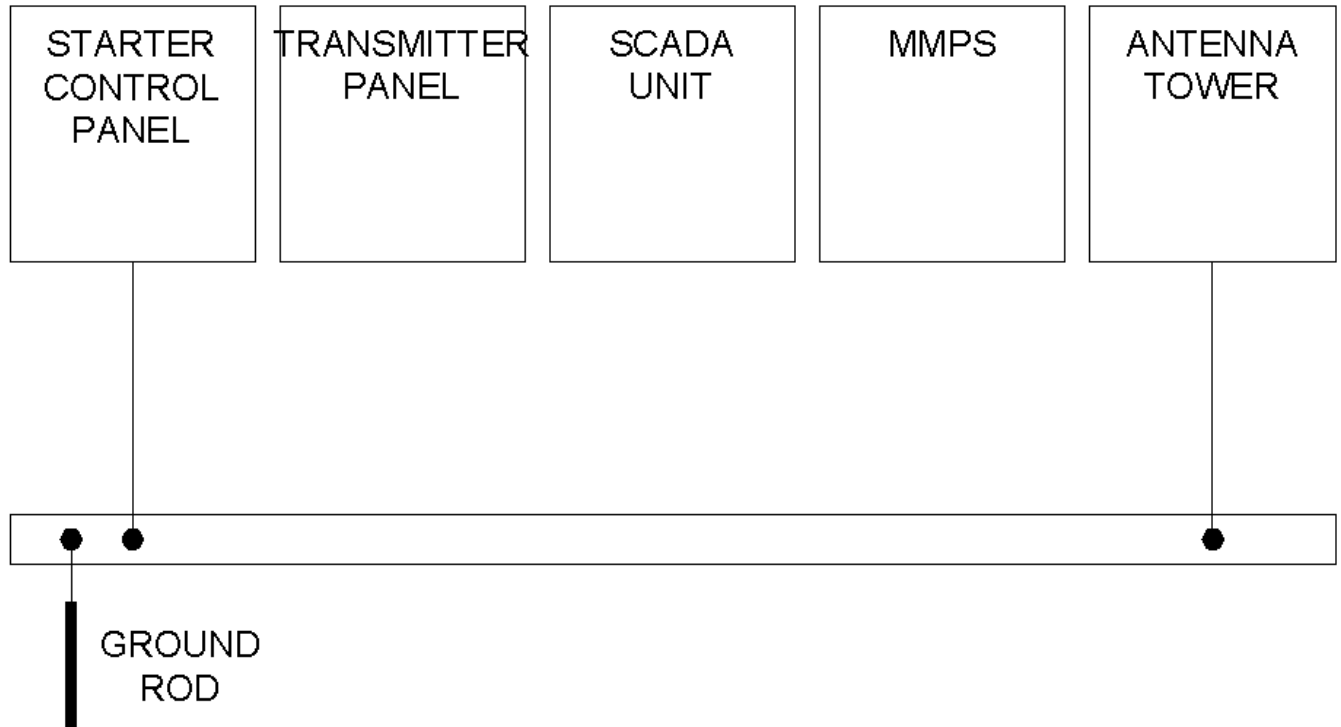
Figure 111-4. Granby Street Grounding System

- Service Entrance Surge Protection Device Installed
- Air Terminals Installed and Bonded to Ground System
- Ground Rod Test Wells Noticeable
- Ground Rods Noticeable
  - 1 Rod(s) Noticeable
- Indications of a Building Ground Ring
- No History of Lightning Strikes
- No History of Failures Resulting in SSO in Past 5 Years
- Equipment properly Surge Protected:
  - SCADA Unit has no surge suppression on coax between Antenna & radio.
  - Starter panel is not protected by a surge suppressor.
- Equipment Properly Grounded:
  - Transmitter panel, SCADA Unit, & MMPS are not bonded to the station grounding system.

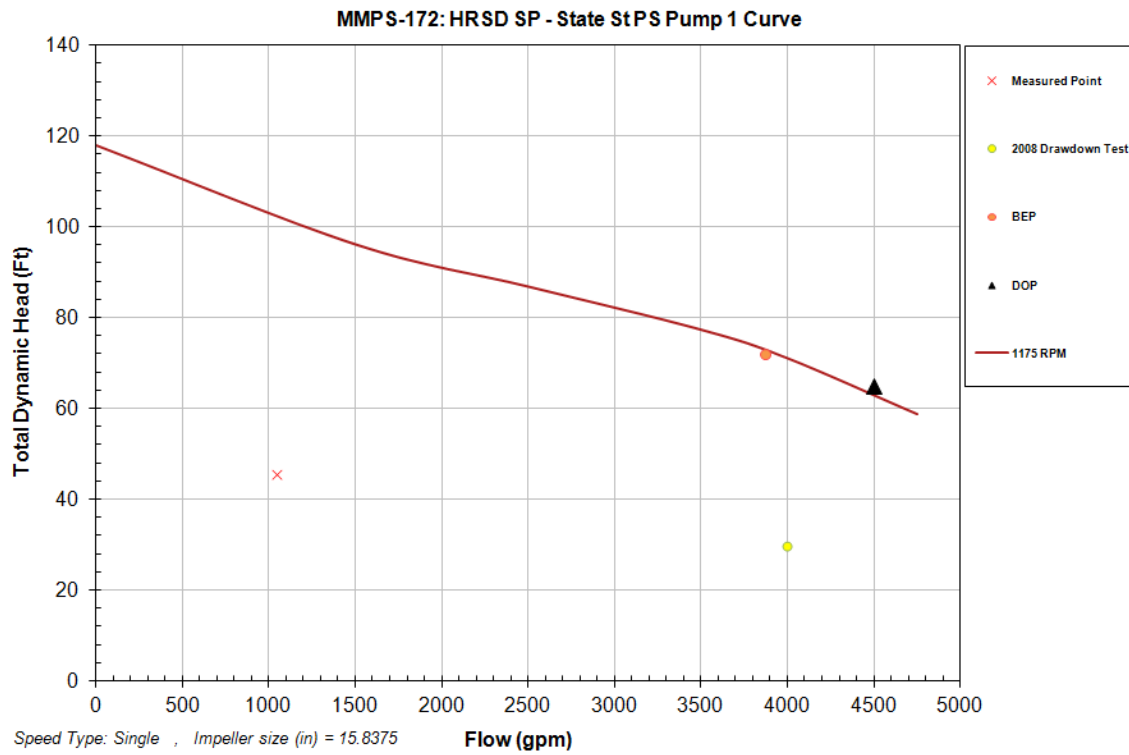
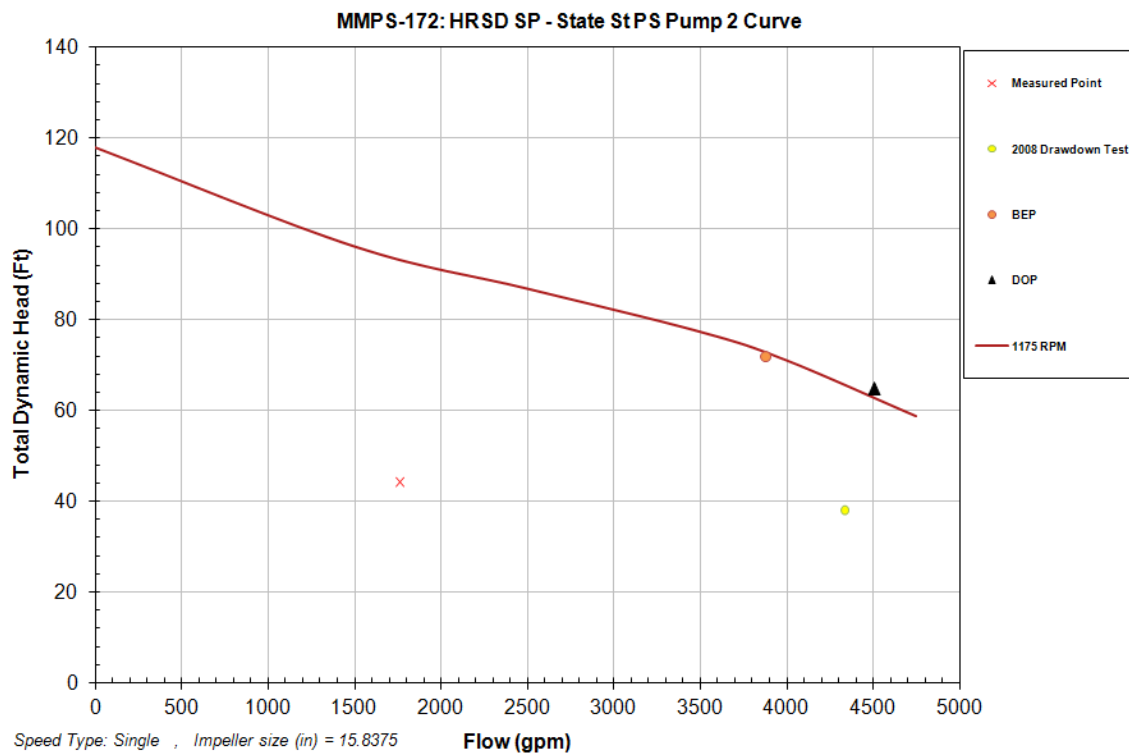
State Street PS uses variable speed Flomatcher pump controls which do not give a remote indication of pump shaft speed. The plotted curve is for the maximum pump shaft speed and the measured point gives an indication of the pumps normal operating range rather than pumping capacity.

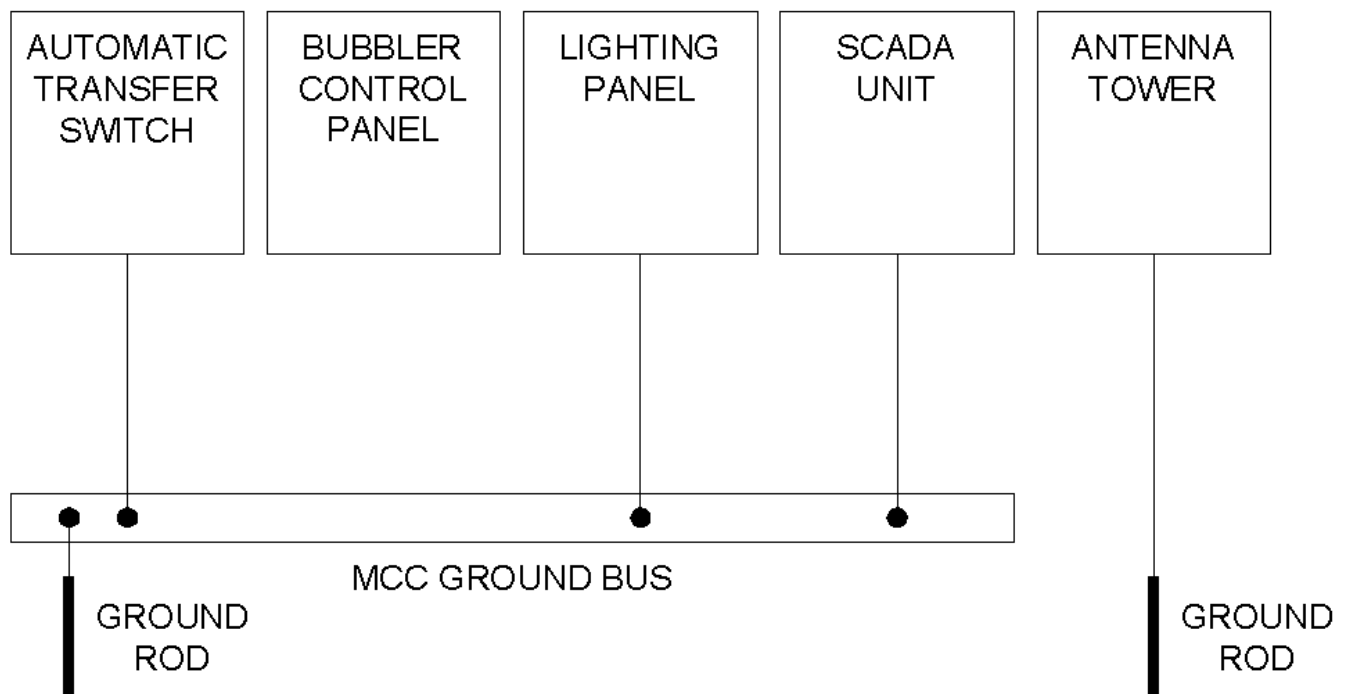
Figure 128-3. Steamboat Creek Grounding System

- Service Entrance Surge Protection Device Installed
- Air Terminals Installed and Bonded to Ground System
- Ground Rod Test Wells Noticeable
- Ground Rods Noticeable
  - 2 Rod(s) Noticeable
- Indications of a Building Ground Ring
- No History of Lightning Strikes
- No History of Failures Resulting in SSO in Past 5 Years
- Equipment properly Surge Protected:
  - SCADA Unit has no surge suppression on coax between Antenna & radio
  - Bubbler control panel is not protected by a surge suppressor
- Equipment Properly Grounded:
  - Bubbler control panel is not bonded to the station grounding system

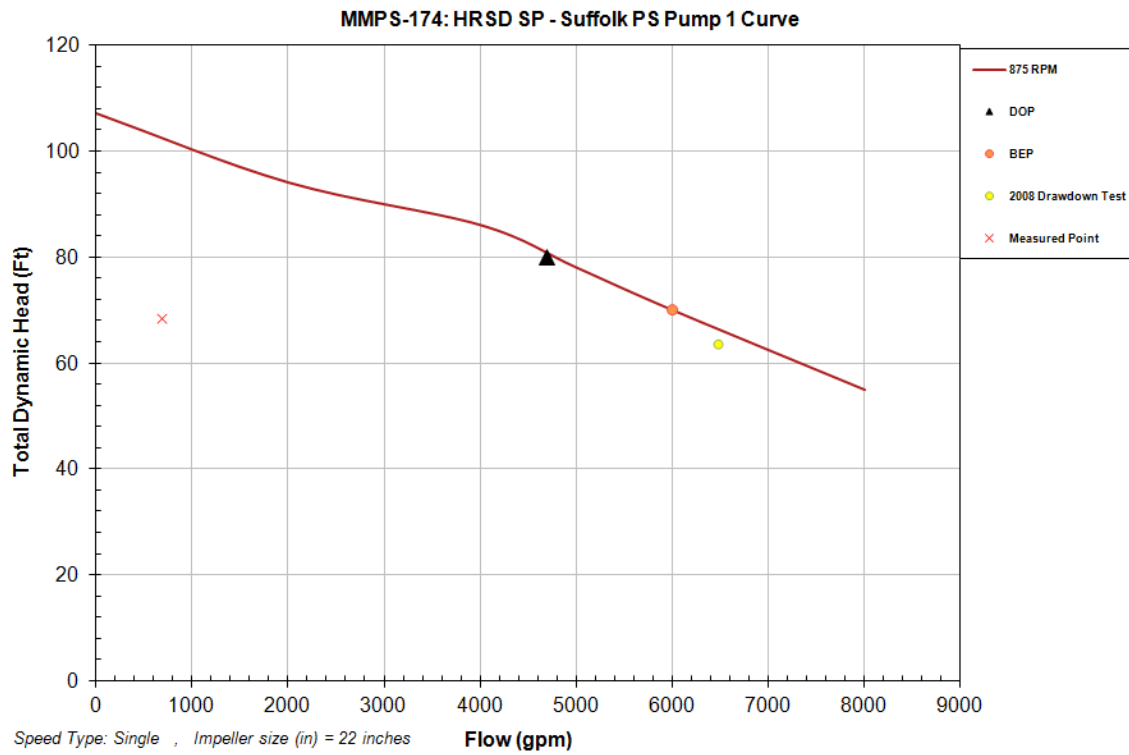
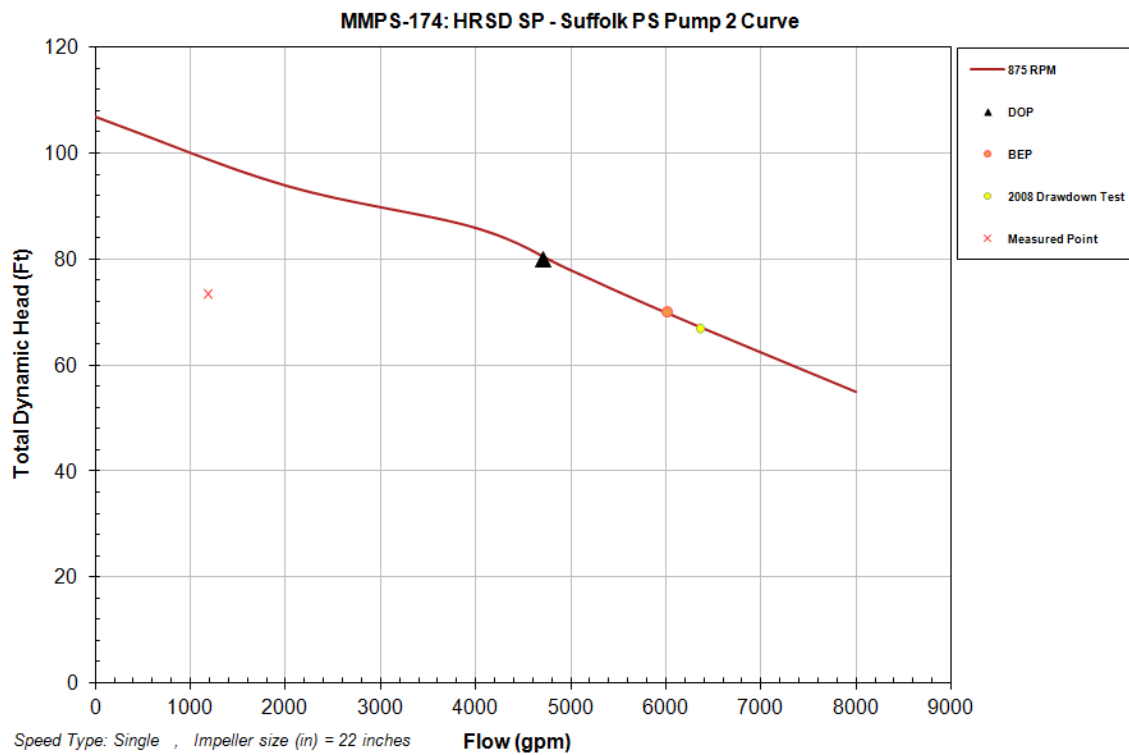
Suffolk PS uses variable speed Flomatcher pump controls which do not give a remote indication of pump shaft speed. The plotted curve is for the maximum pump shaft speed and the measured point gives an indication of the pumps normal operating range rather than pumping capacity.
