**Pre-Construction Survey Report,  
South Trunk Sewer Section G Force  
Main Replacement Project, Norfolk,  
Virginia,**

January 29, 2016

Subject: **Pre-Construction Survey Report, South Trunk  
Sewer Section G Force Main Replacement  
Project, Norfolk, Virginia (SSI Job No. 15-1168)**

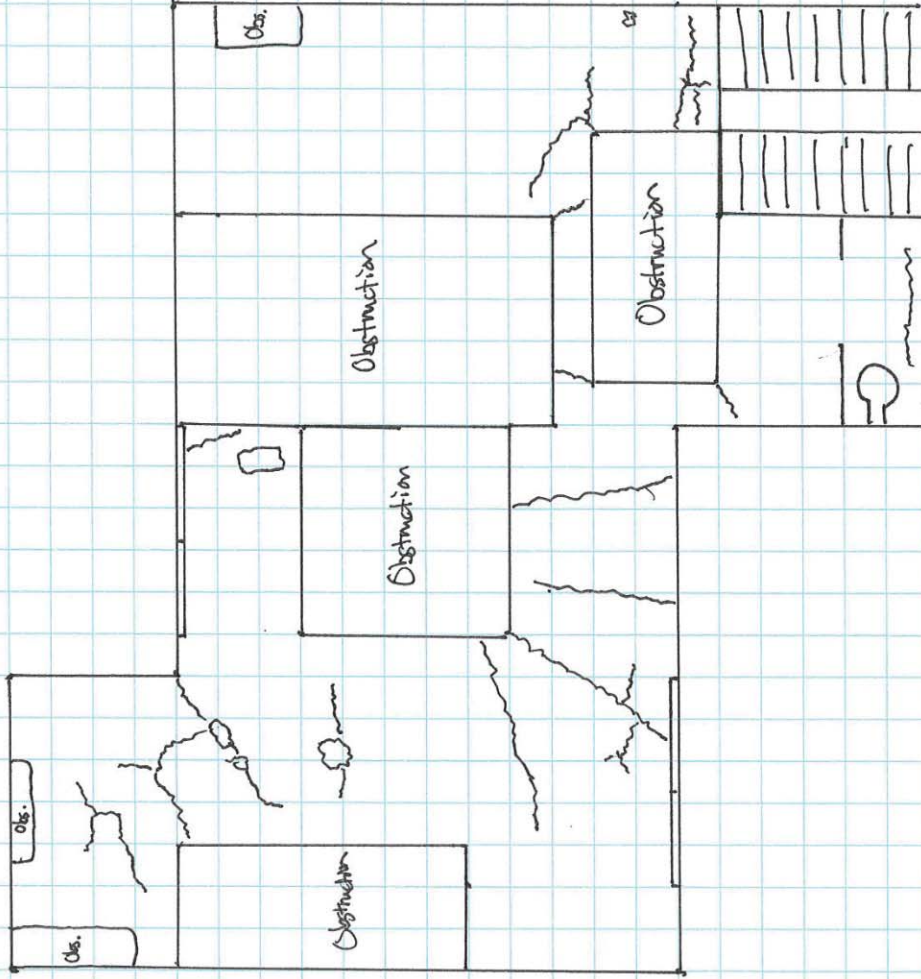
# Ground Level Utility Room

Project: South Trunk Sewer Section G  
Area: Interior – Ground Level Utility Room
