QUARTERLY REPORT
JANUARY 1 – MARCH 31, 2023

Hampton Roads Sanitation District
1434 Air Rail Avenue
Virginia Beach, VA 23455

Post-Storm Report

1/25/2023 – 1/26/2023

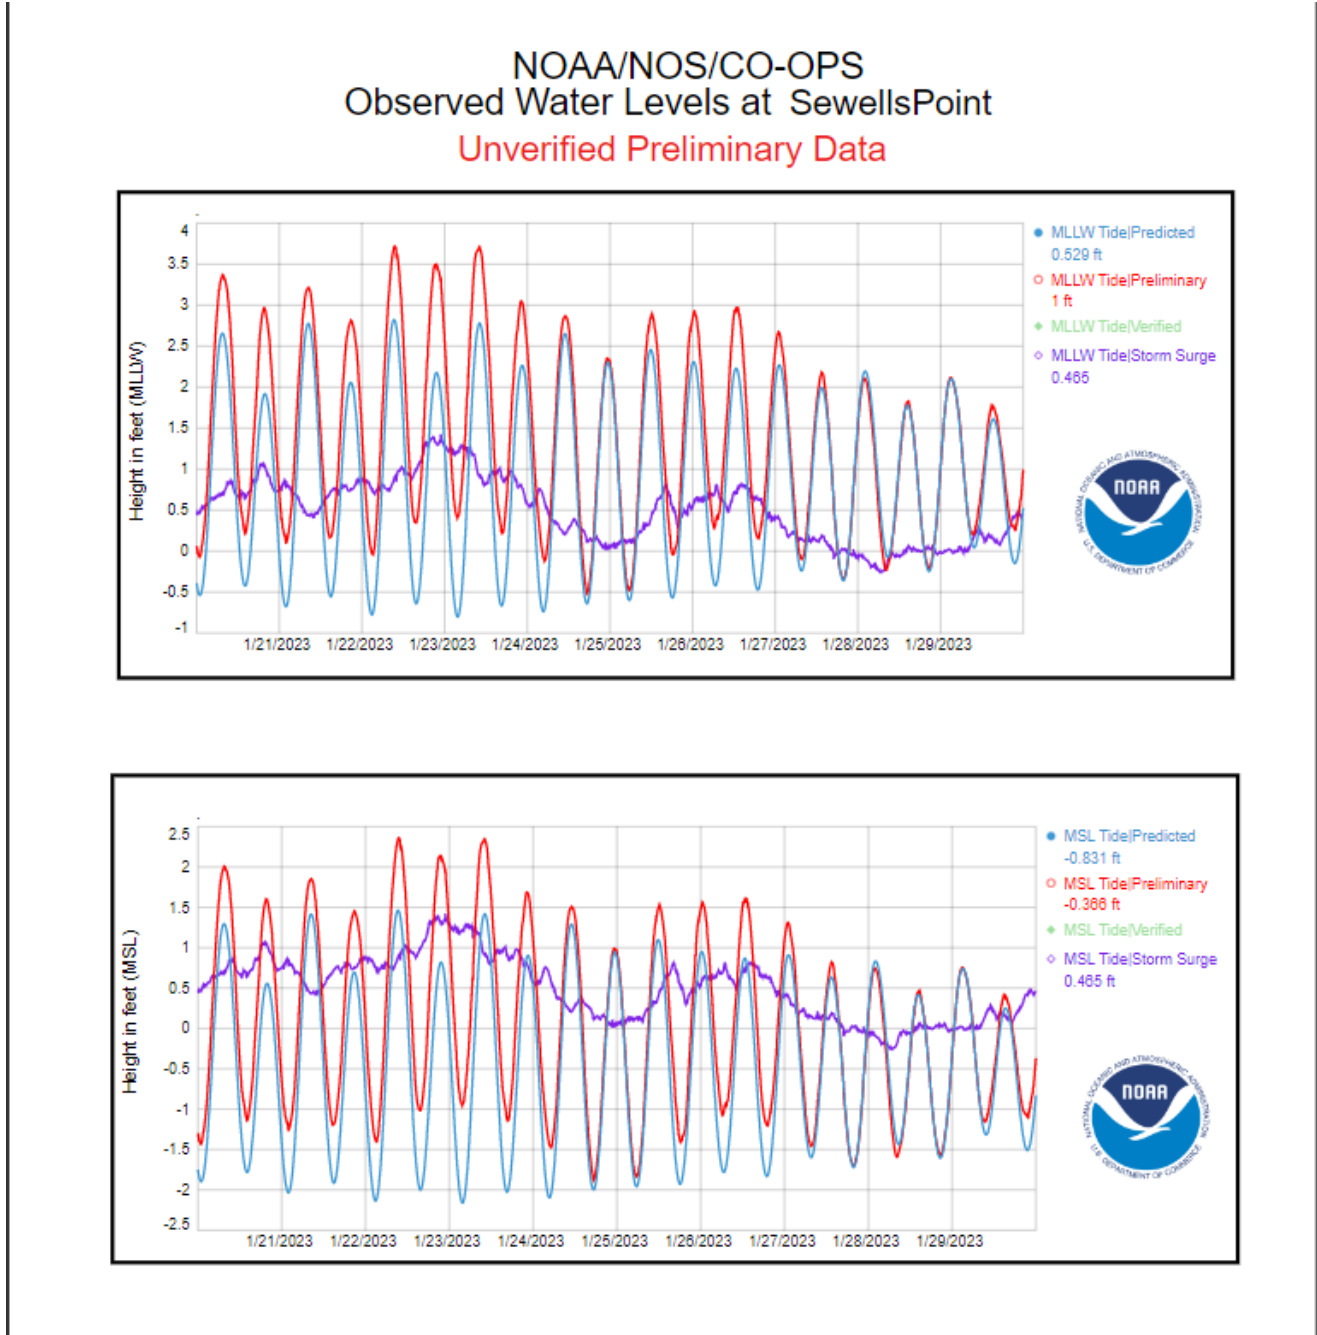
Figure 3. Preliminary data obtained from NOAA and a connection with Open Weather

- Sewells Point Tide Station:
 - Storm Surge: An approximate .78 foot storm surge was observed.

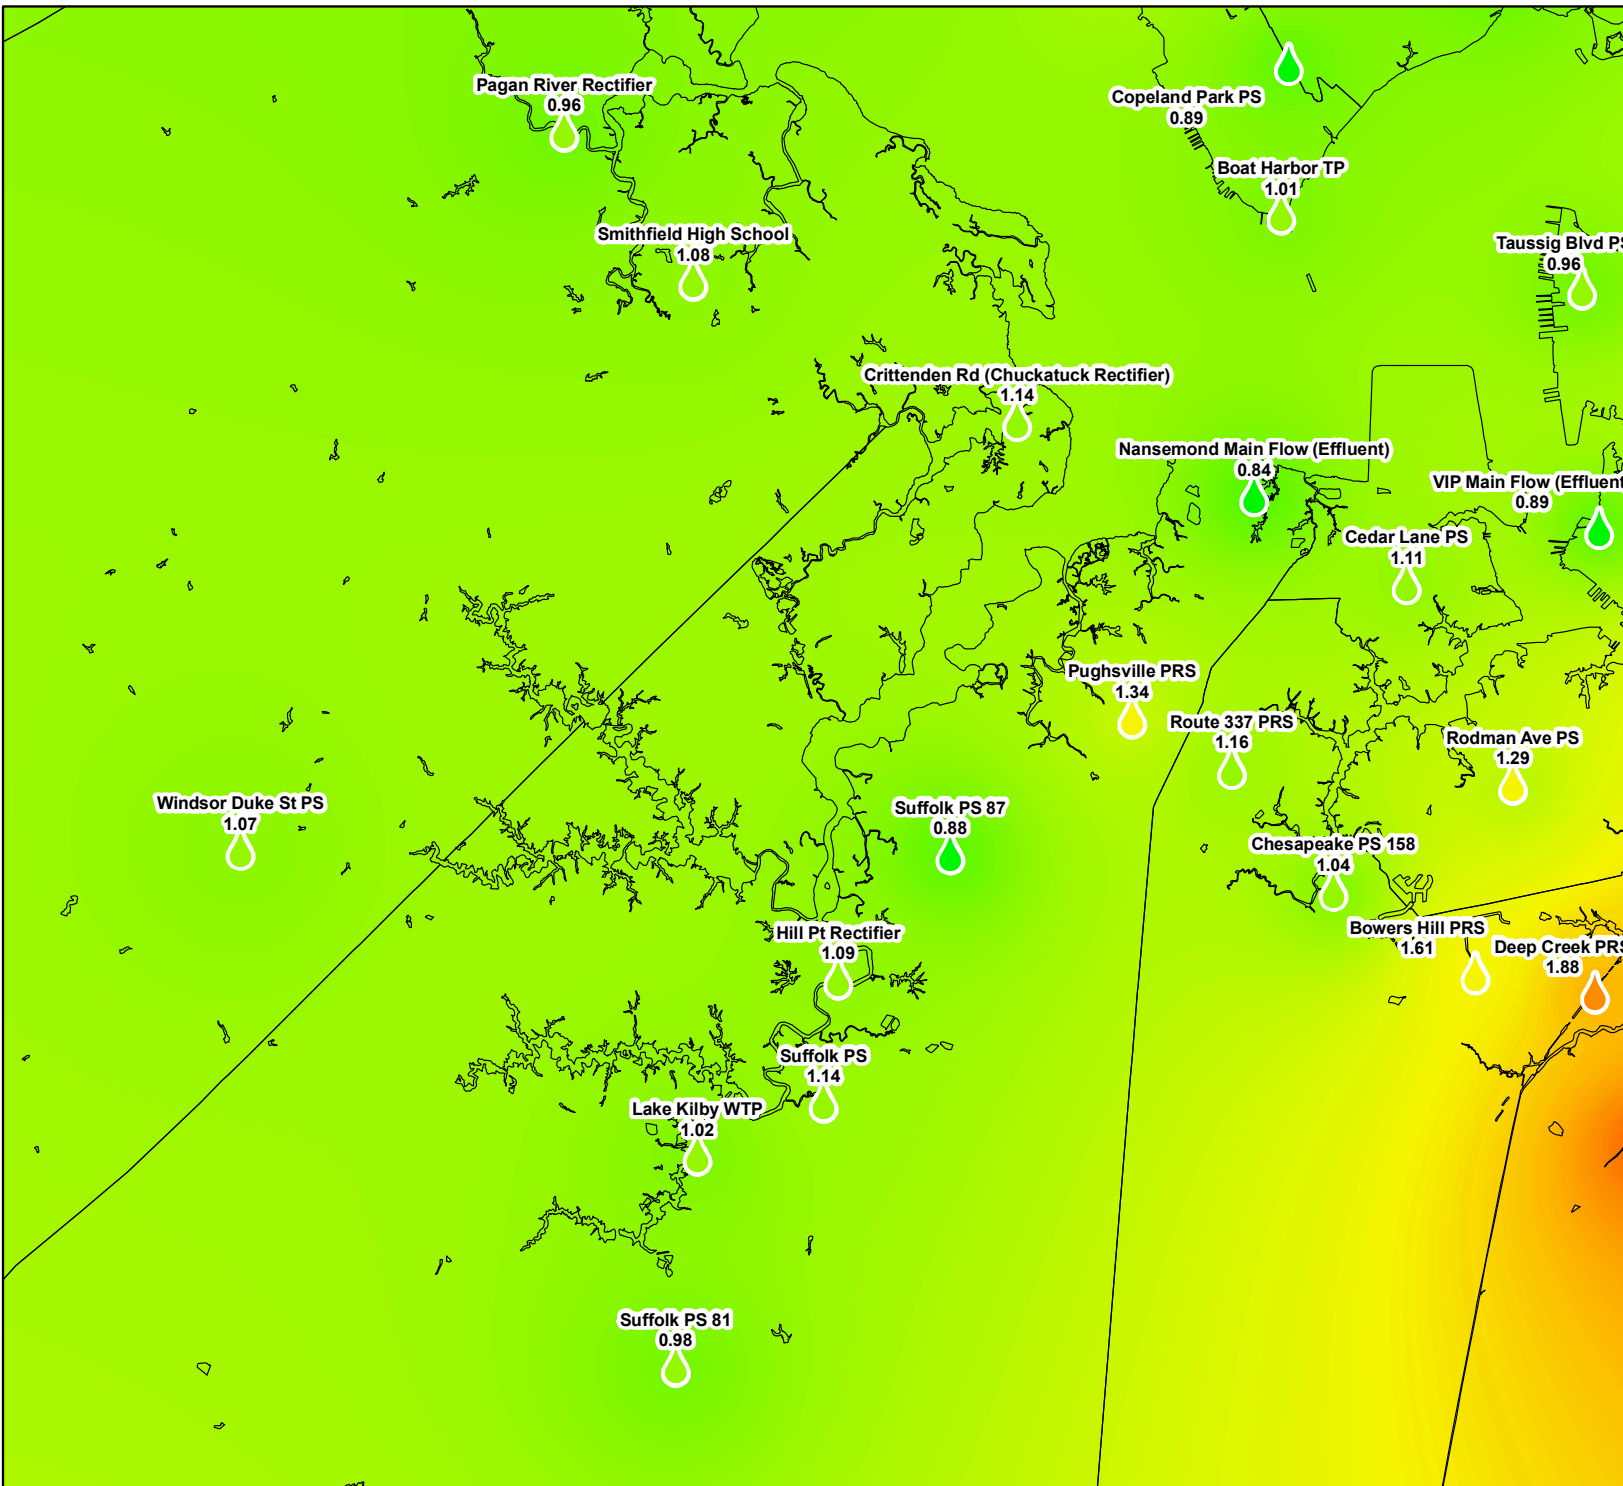
South Shore - West

January 25-26, 2023 Rainfall Analysis Total Rainfall

*Note: Rain Gauge was invalid for event and an average of surrounding sites was used.

Currently, rainfall recurrence intervals are only analyzed for a maximum of 96-hours. Rainfall analysis begins after 0.1 inches of rain has occurred. A 72-hour dry period of less than 0.1 inches of rain is typically used to signify two separate events. However, if a site returns to “dry weather” conditions prior to the next rainfall that occurs within 72 hours of the previous event, it is also considered for separate analysis. See Appendix A for the Rainfall Total System Maps.

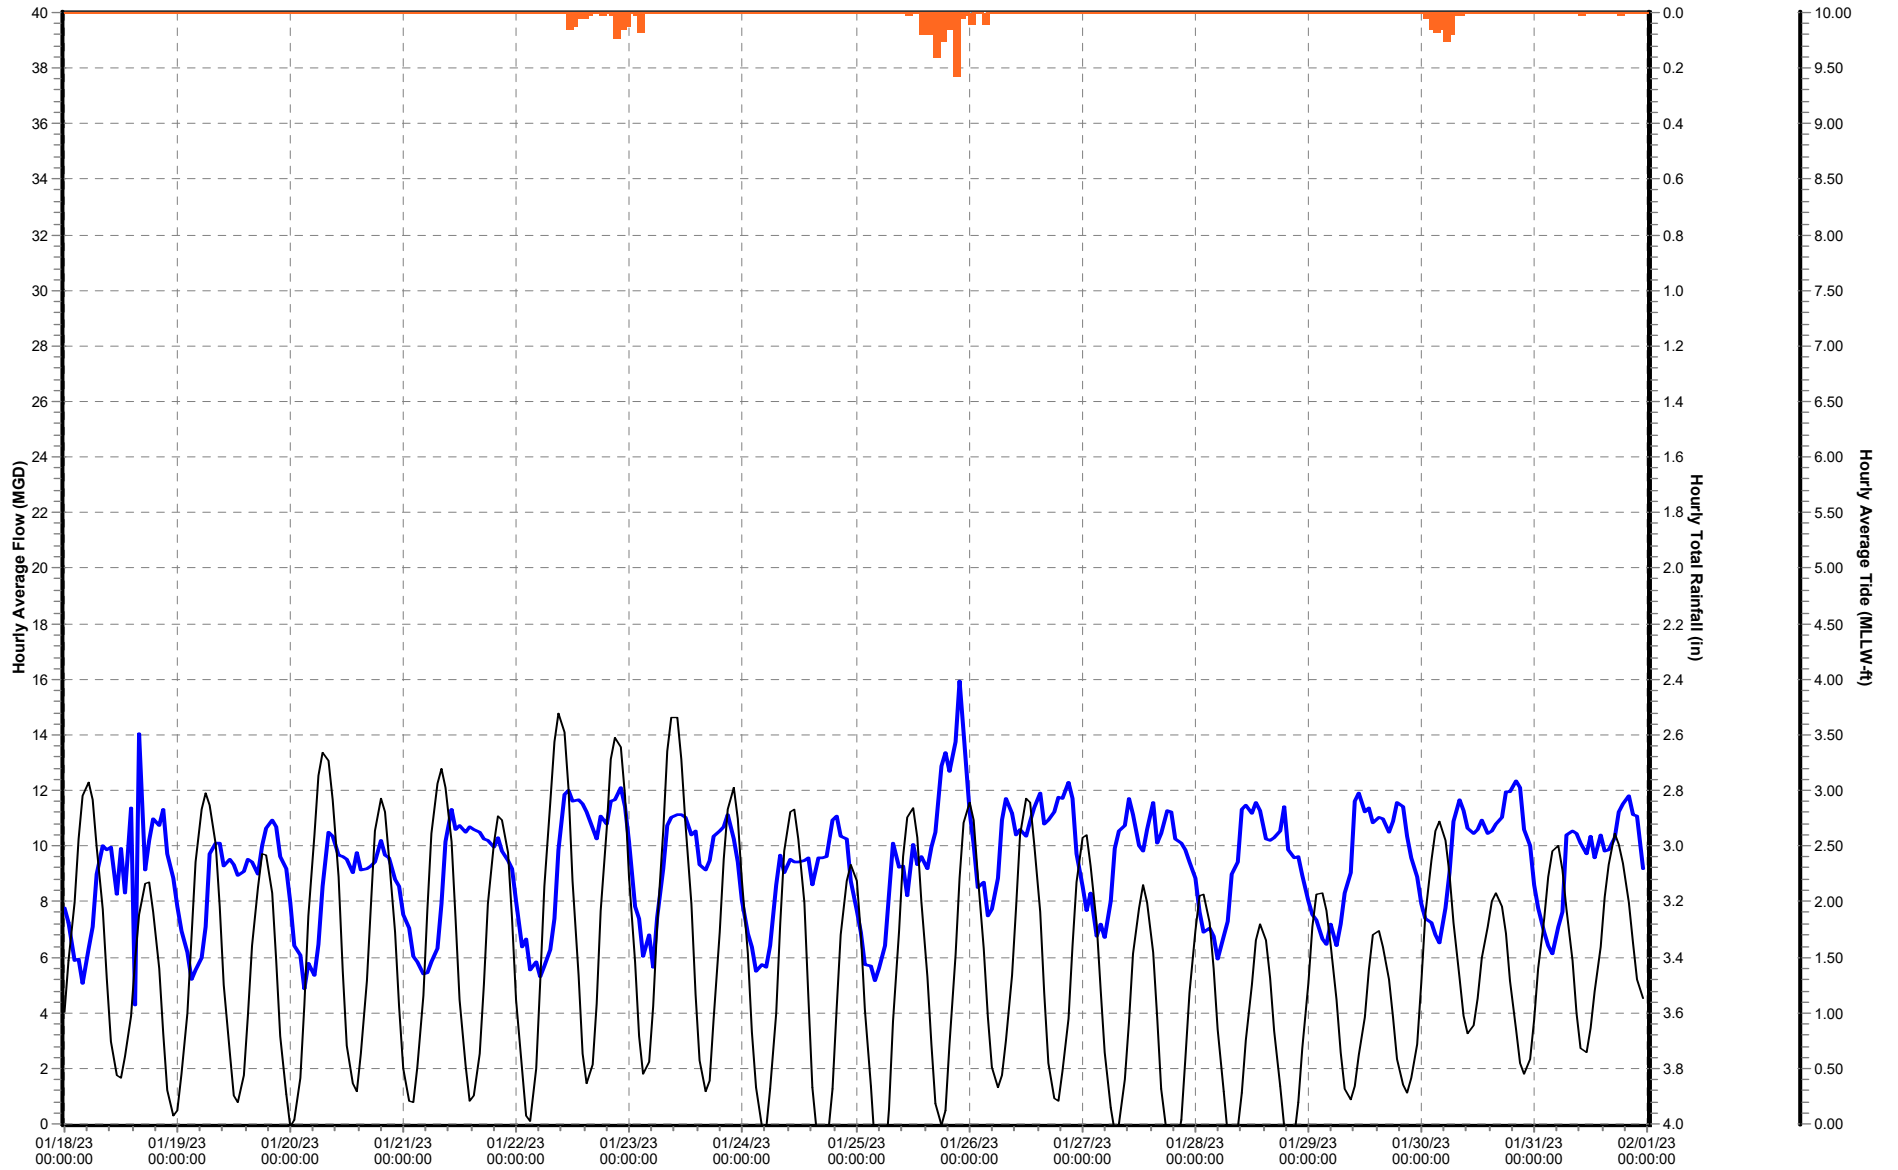
Army Base Treatment Plant

MMPS-035.Flow_Effluent (MGD) MMPS-175: Taussig Blvd PS Rain Gauge SewellsPt Tide - MLLW Preliminary (ft)

Treatment Plant Data: *(Data obtained from Telog Database)*
 See Appendix B for HRSD Treatment Plant Flows

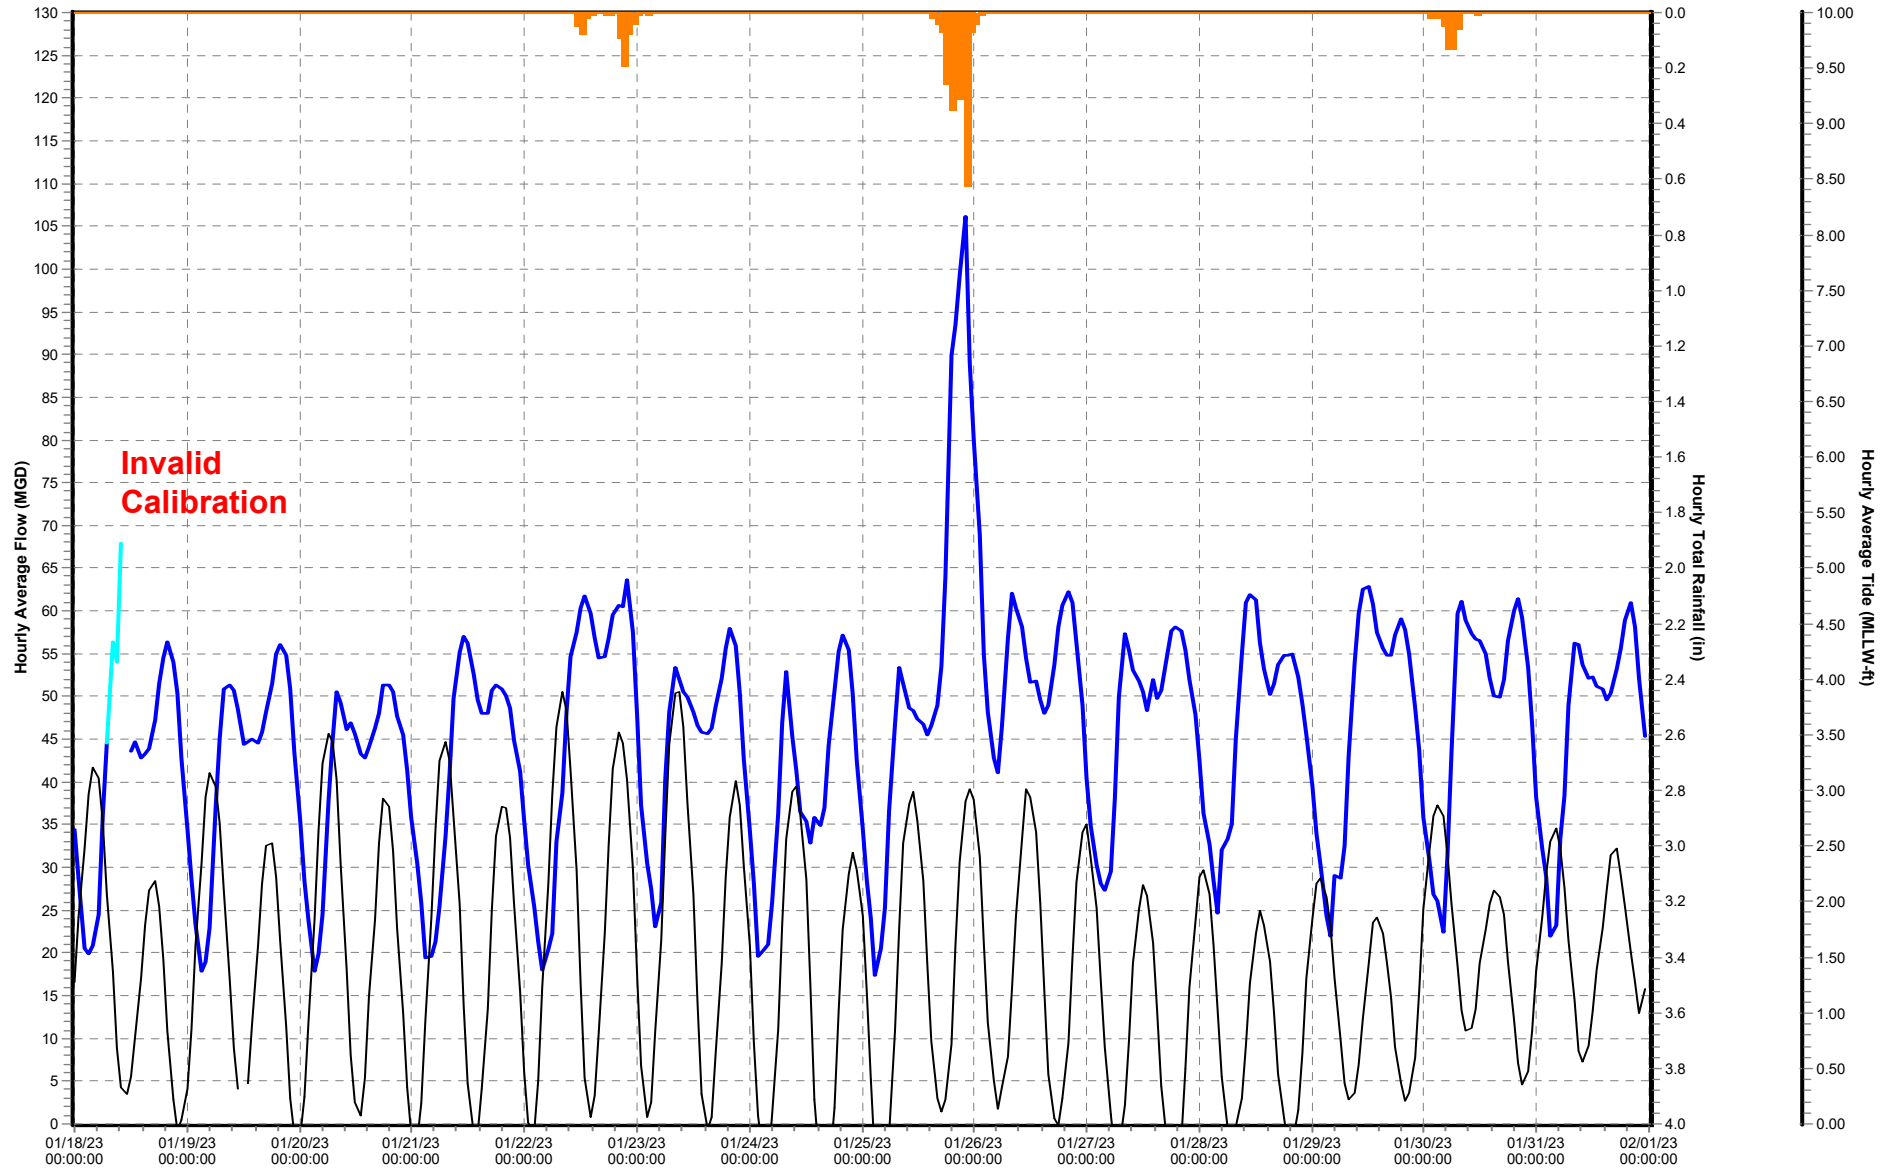
Atlantic Treatment Plant
MMPS-071 (01/18/23 to 02/01/23)

Flow_Effluent (MGD) MMPS-185: Lagomar IFM at Atlantic TP Rain Gauge CBBT Tide - MLLW Preliminary (ft)

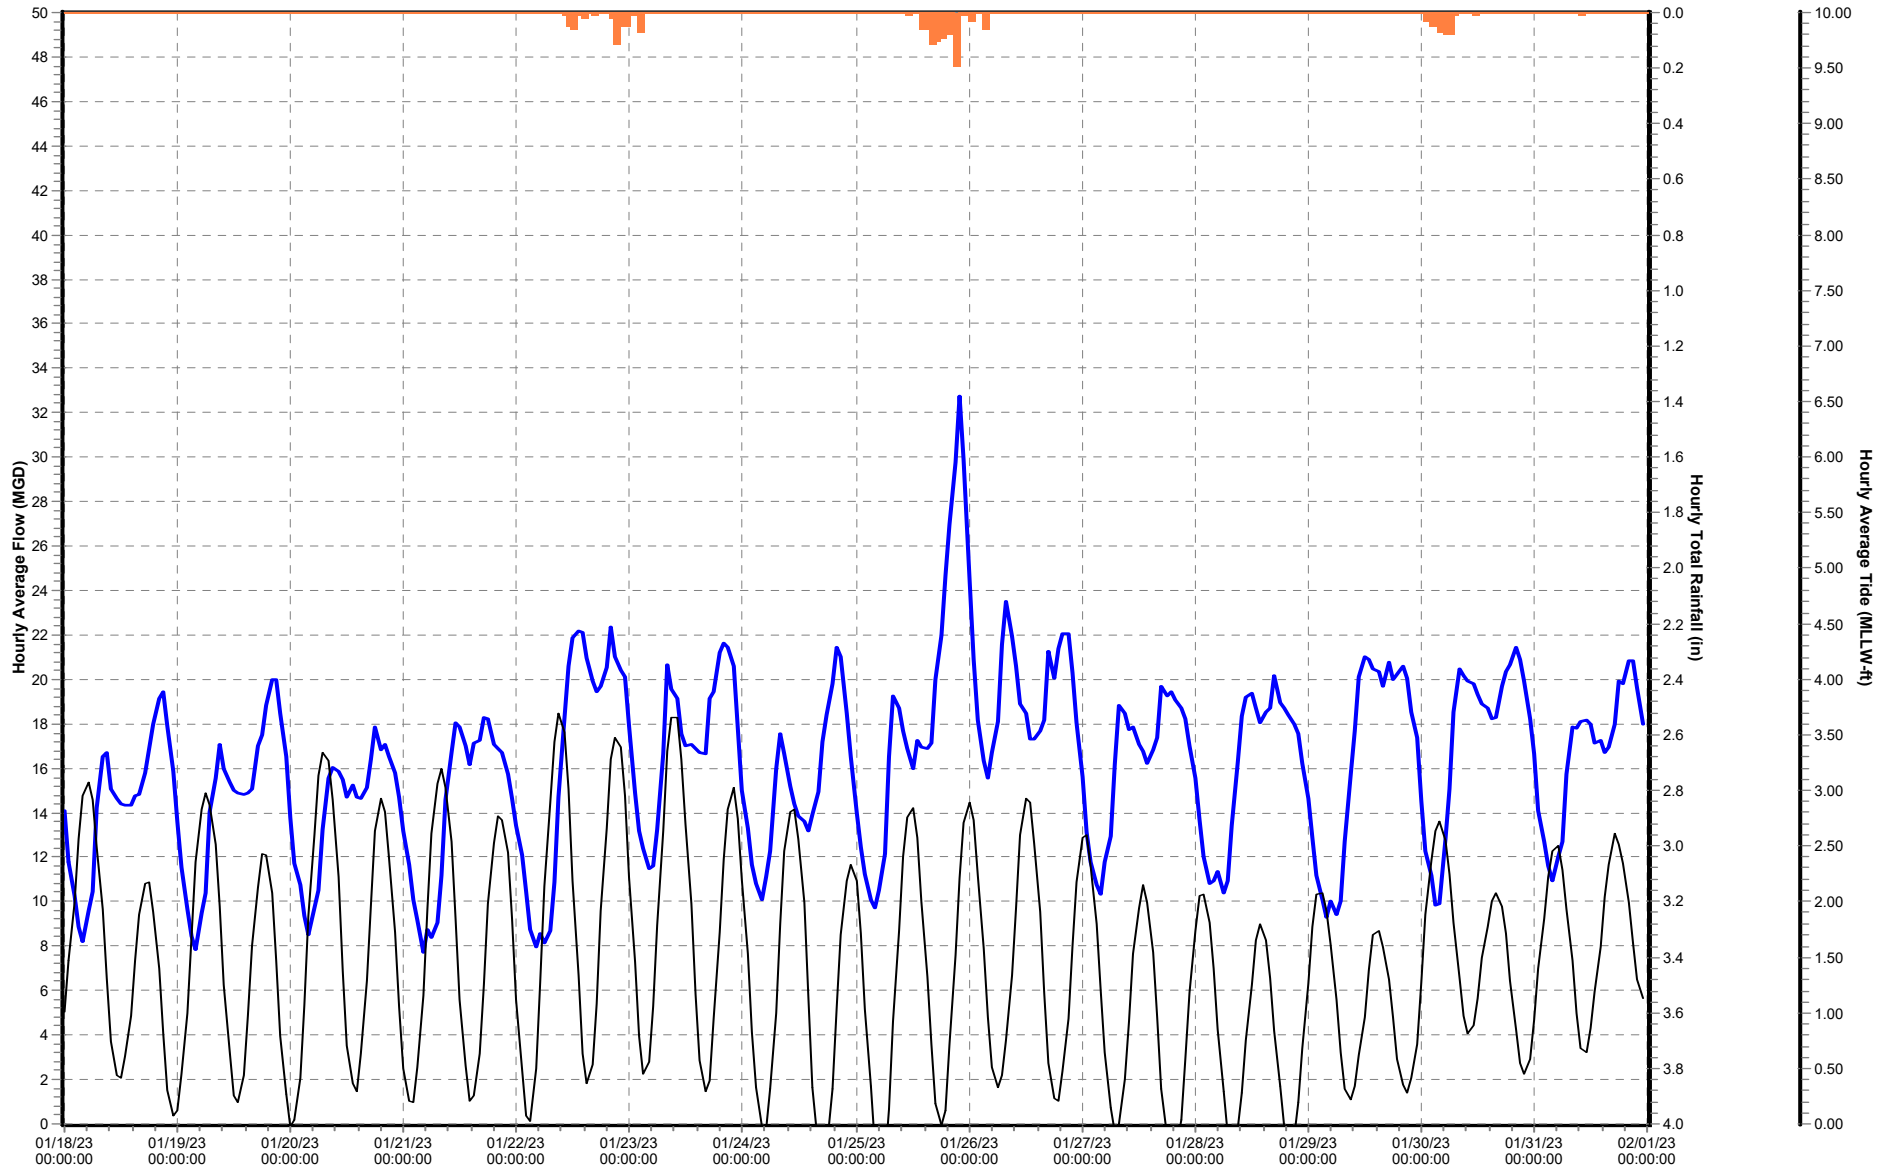
Nansemond Treatment Plant

Flow_Effluent (MGD) MMPS-202: Nansemond Main Flow_Effluent Rain Gauge SewellsPt Tide - MLLW Preliminary (ft)

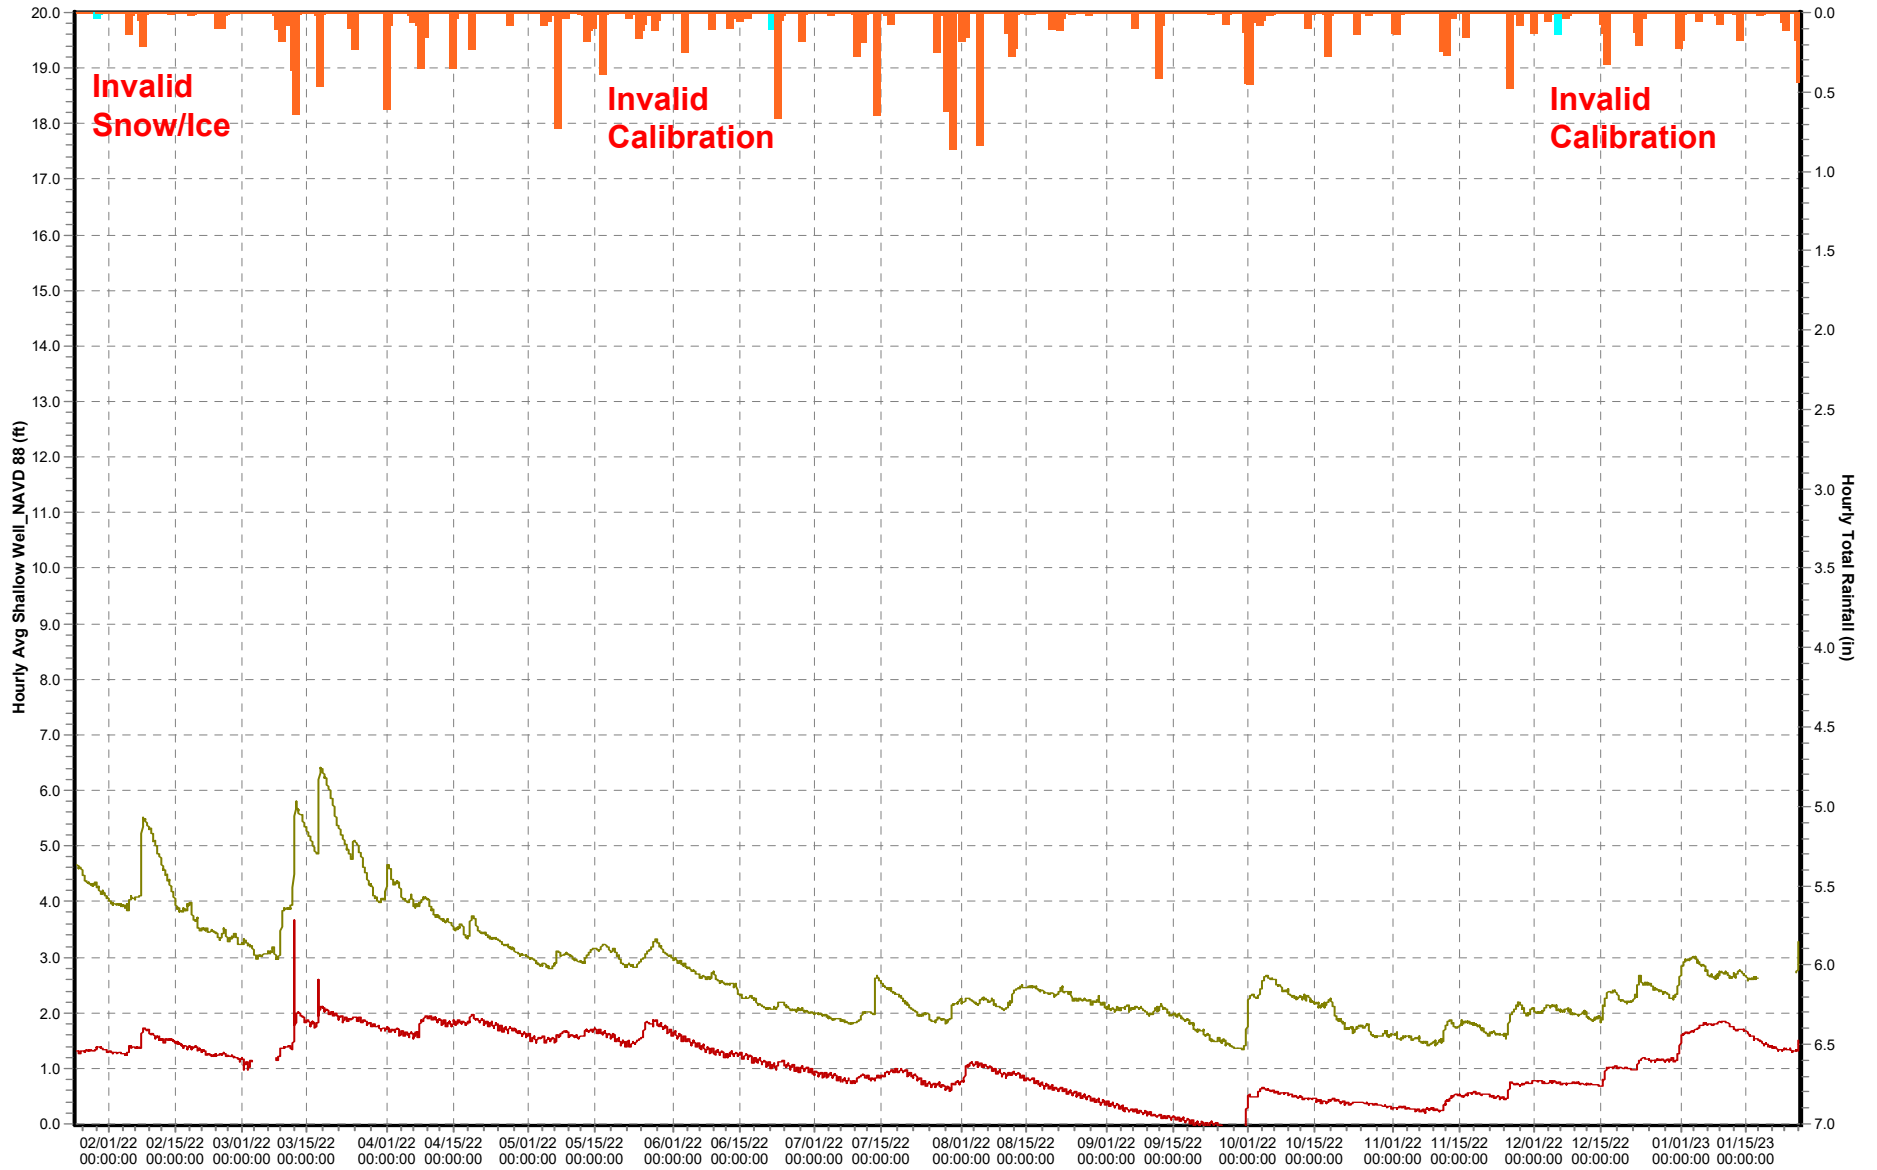
South Shore Shallow Well Graphs

1 Year

01/25/22 to 01/26/23

Shallow wells are located at/or near HRSD Pump Stations to measure groundwater levels. The water column is measured using a pressure transducer located near the bottom of the well. The installed sensor measures gauge pressure in inches of water. The Shallow Well_NAVD88 measurement referenced in Appendix C refers to the elevation (referenced as NAVD 88) of the sensor plus the gauge measurement in feet.

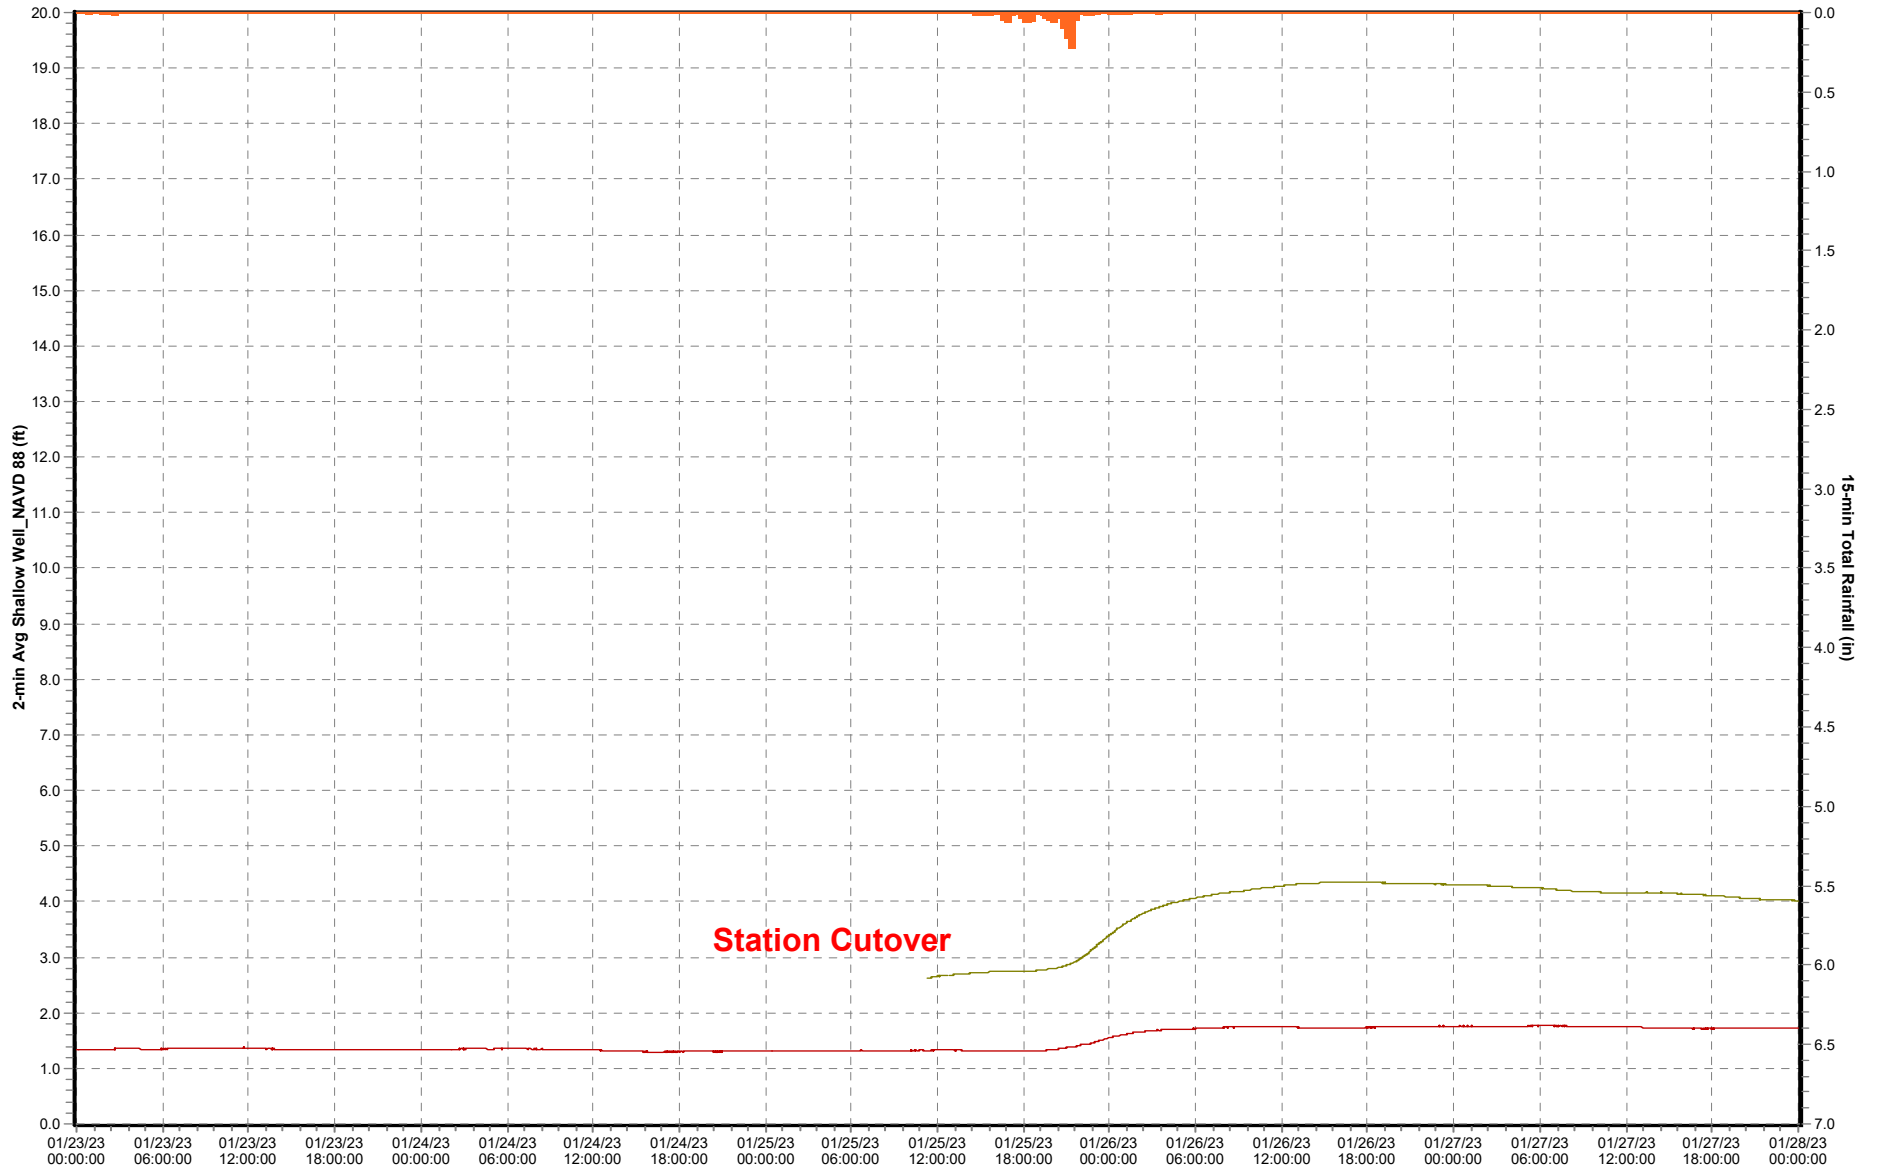
South Shore Shallow Well Graphs

5 Day

01/23/23 to 01/28/23
