QUARTERLY REPORT
JULY 1 – SEPTEMBER 30, 2023

Hampton Roads Sanitation District

November 28, 2023

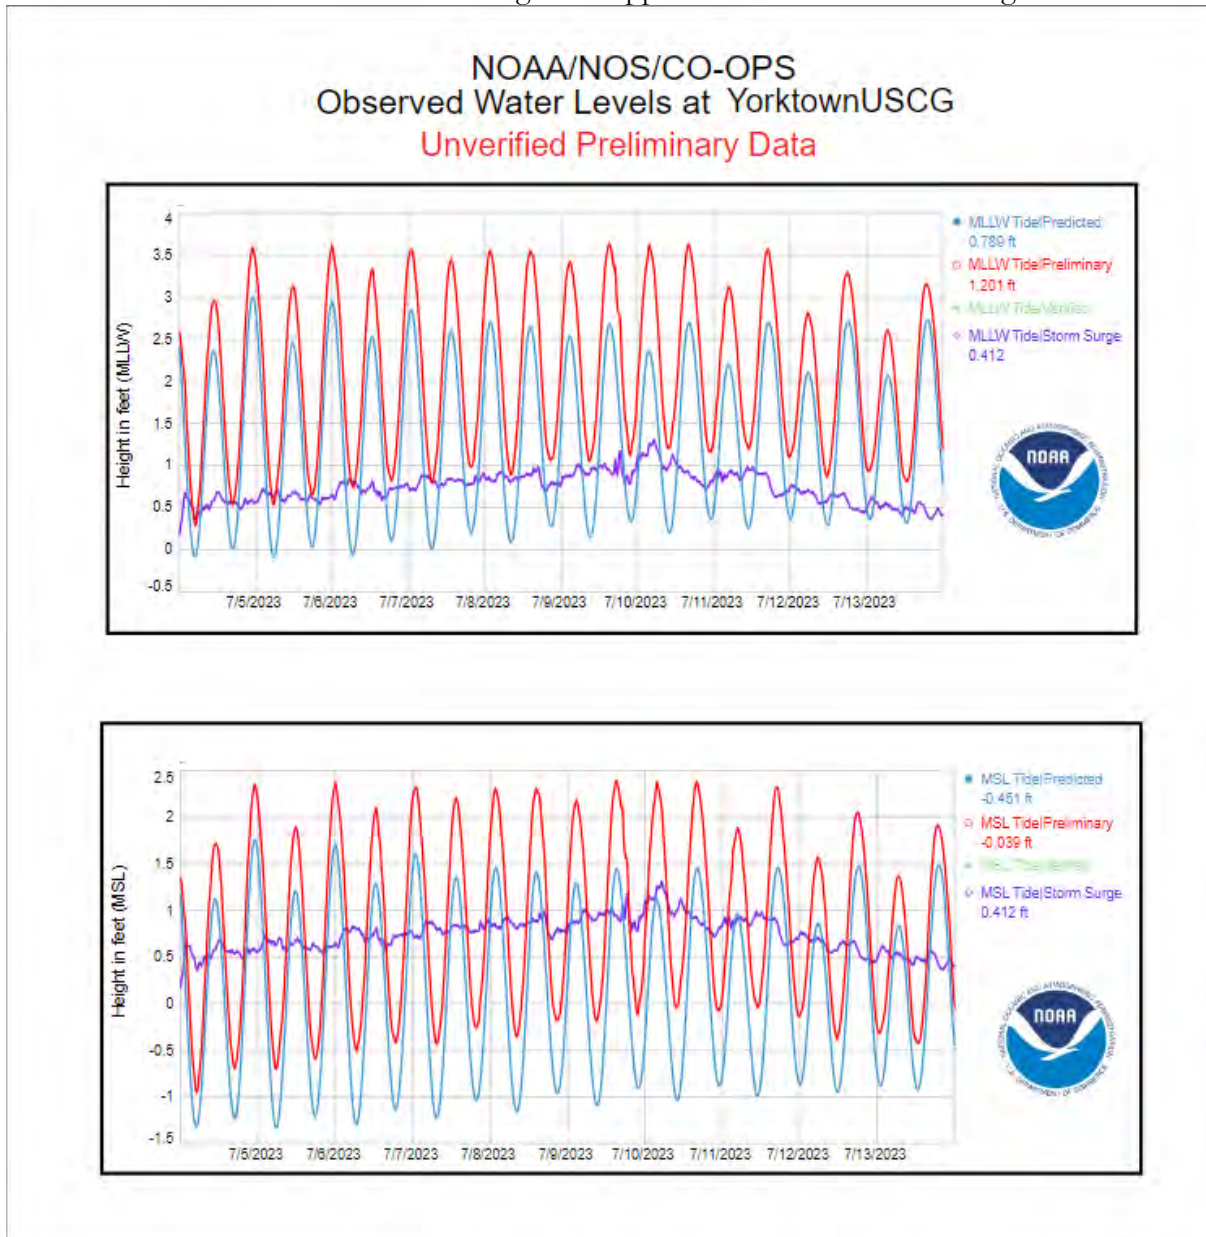
Figure 1. Preliminary data obtained from NOAA and a connection with Open Weather

- Yorktown USCG Training Center:
 - Storm Surge: An approximate 1.2-foot storm surge was observed.

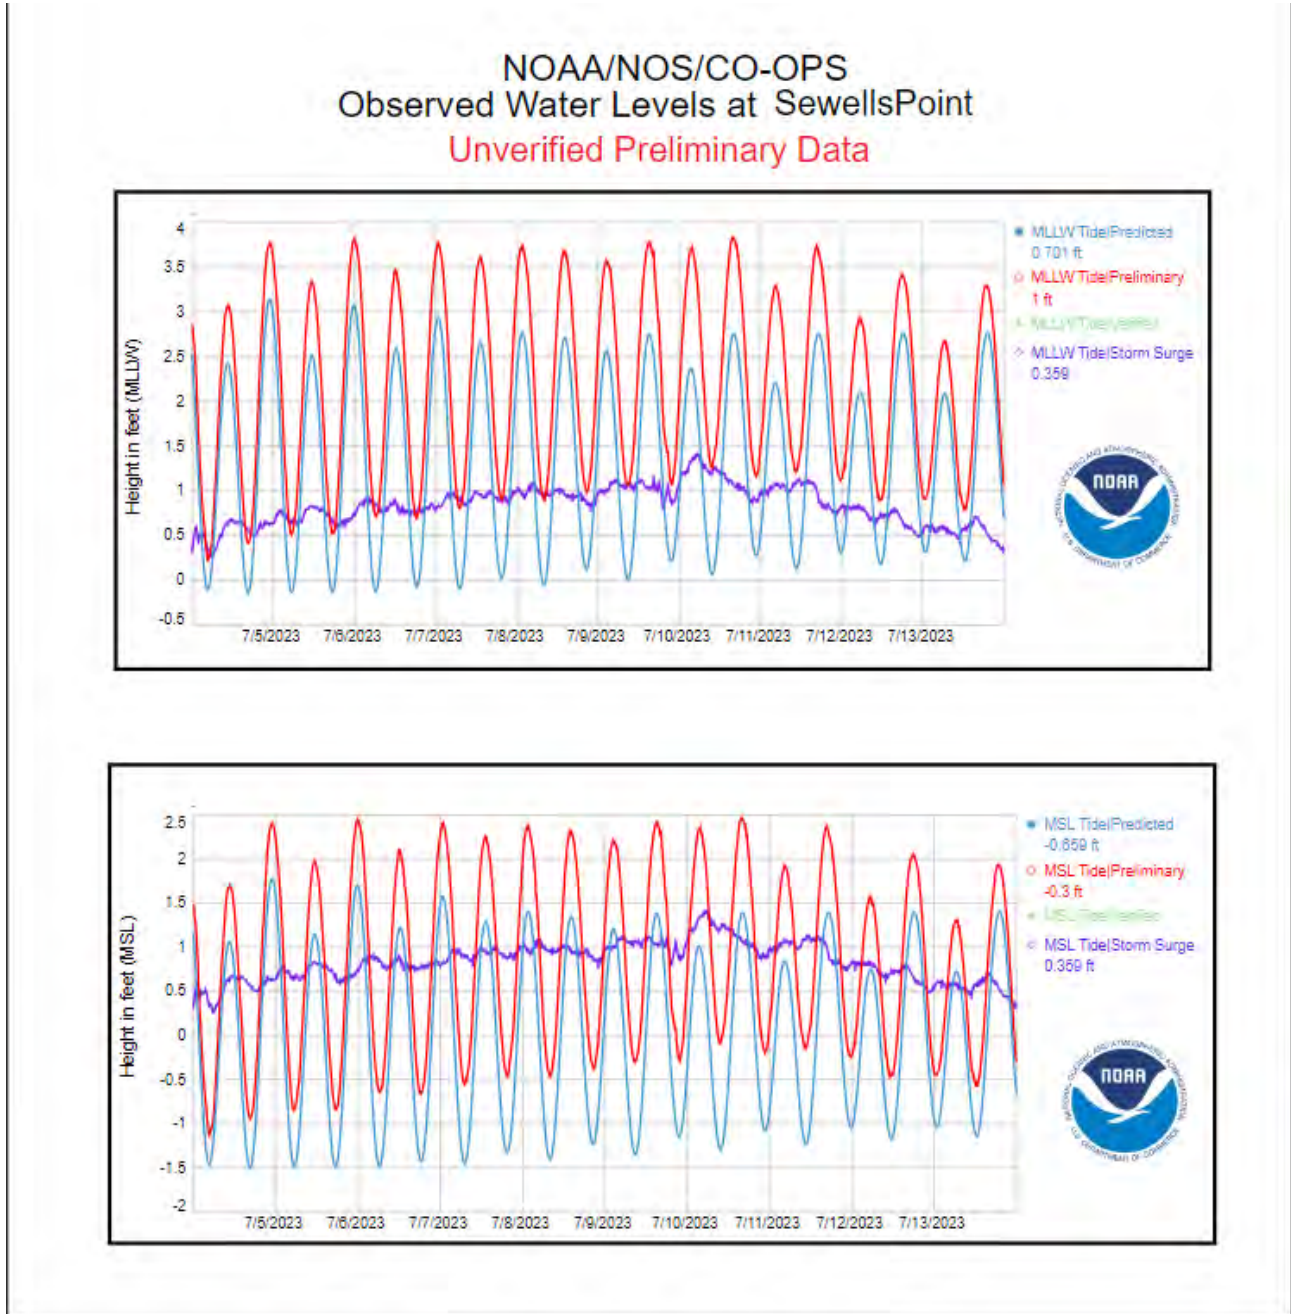
Figure 2. Preliminary data obtained from NOAA and a connection with Open Weather

- Sewells Point Tide Station:
 - Storm Surge: An approximate 1.0 foot storm surge was observed.

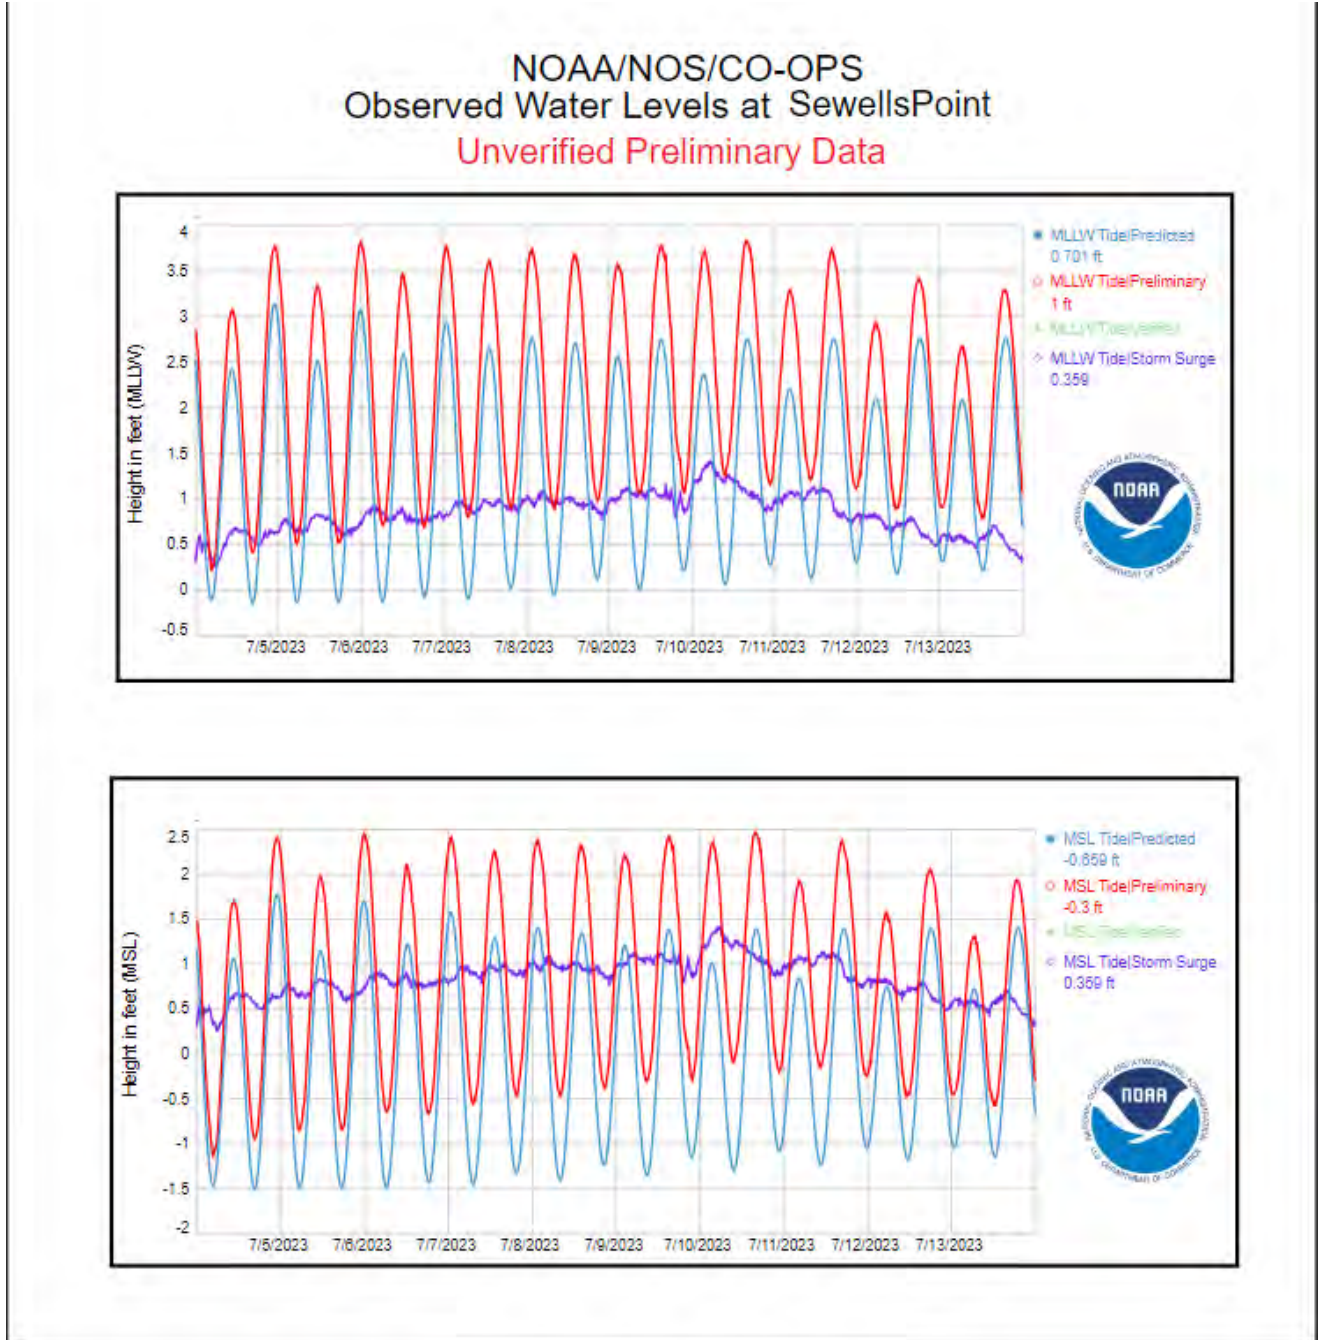
Figure 3. Preliminary data obtained from NOAA and a connection with Open Weather

- Sewells Point Tide Station:
 - Storm Surge: An approximate 1.0 foot storm surge was observed.

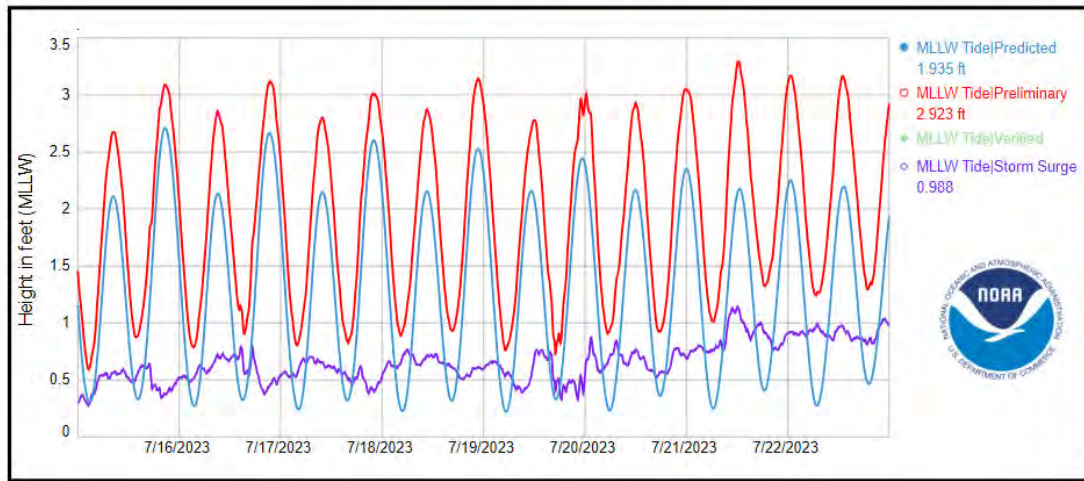
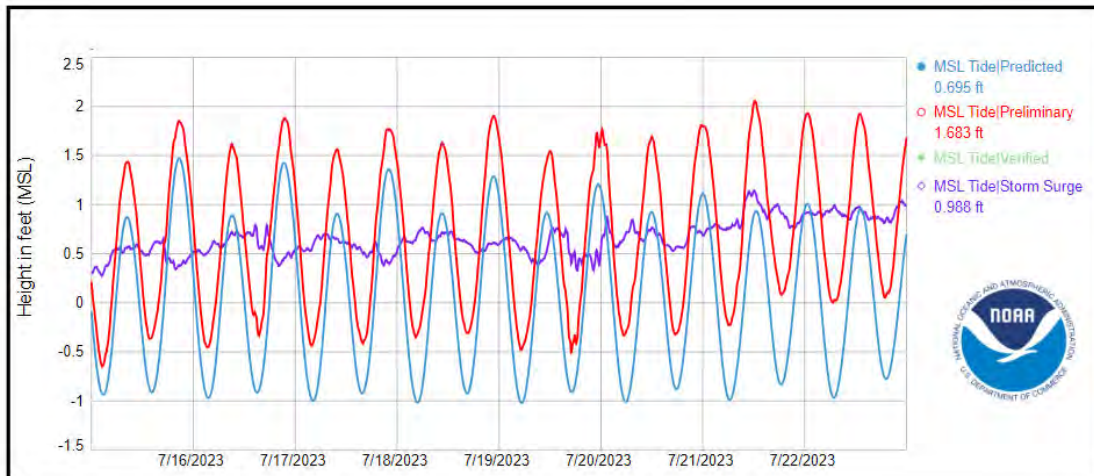
Figure 1. Preliminary data obtained from NOAA and a connection with Open Weather

- Yorktown USCG Training Center:
 - Storm Surge: An approximate 0.75-foot storm surge was observed.

NOAA/NOS/CO-OPS Observed Water Levels at YorktownUSCG Unverified Preliminary Data

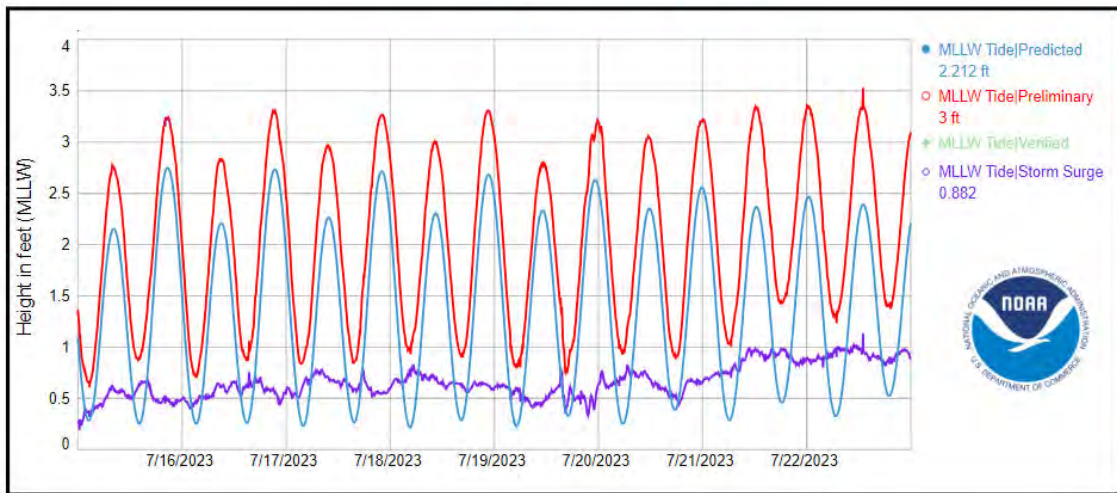
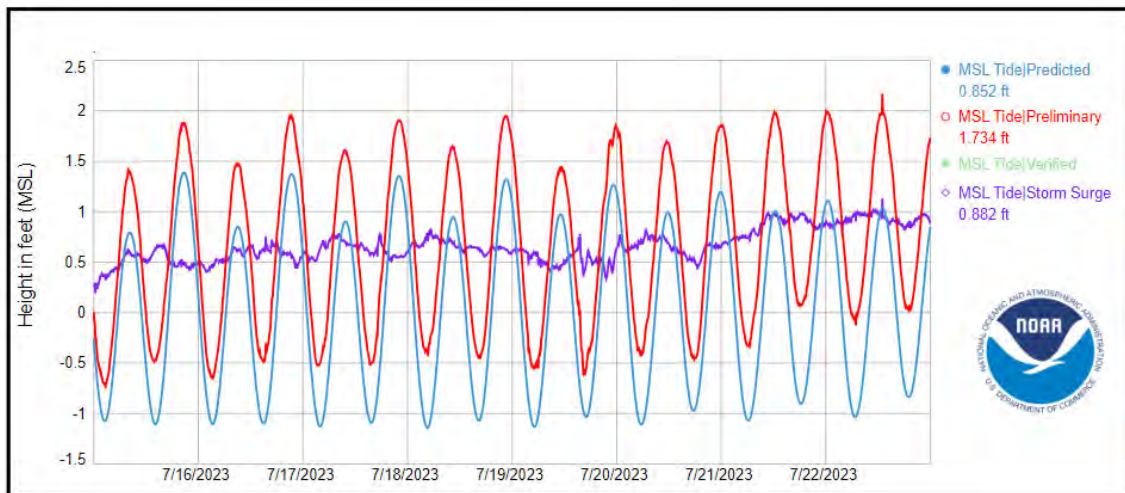
Figure 2. Preliminary data obtained from NOAA and a connection with Open Weather

- Sewells Point Tide Station:
 - Storm Surge: An approximate 0.75 foot storm surge was observed.

NOAA/NOS/CO-OPS Observed Water Levels at SewellsPoint Unverified Preliminary Data

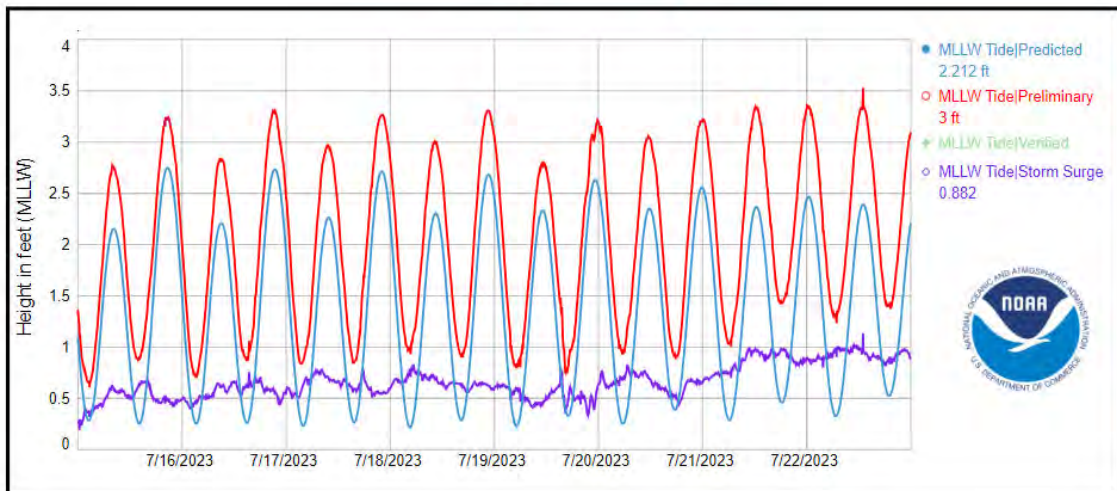
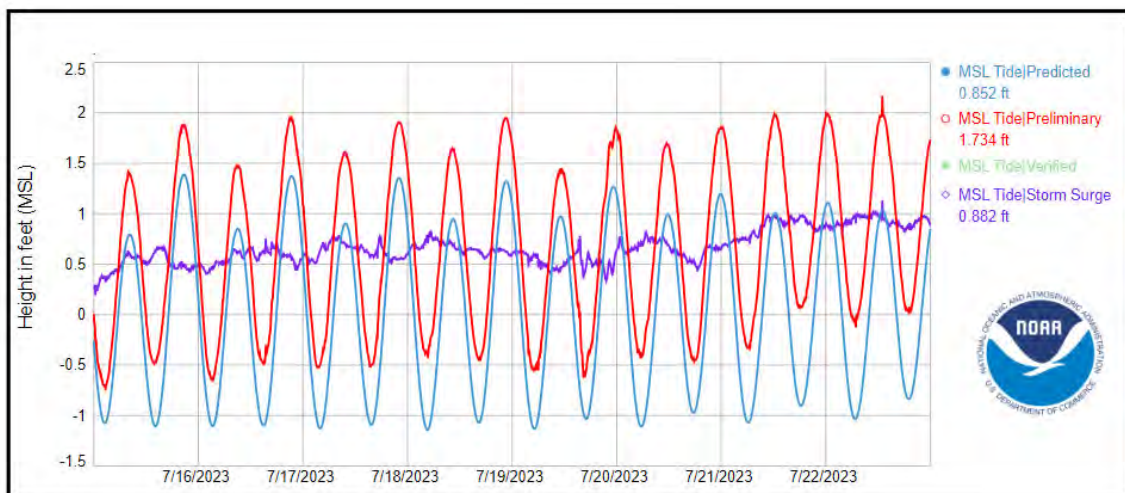
Figure 3. Preliminary data obtained from NOAA and a connection with Open Weather

- Sewells Point Tide Station:
 - Storm Surge: An approximate 0.75 foot storm surge was observed.

NOAA/NOS/CO-OPS Observed Water Levels at SewellsPoint Unverified Preliminary Data

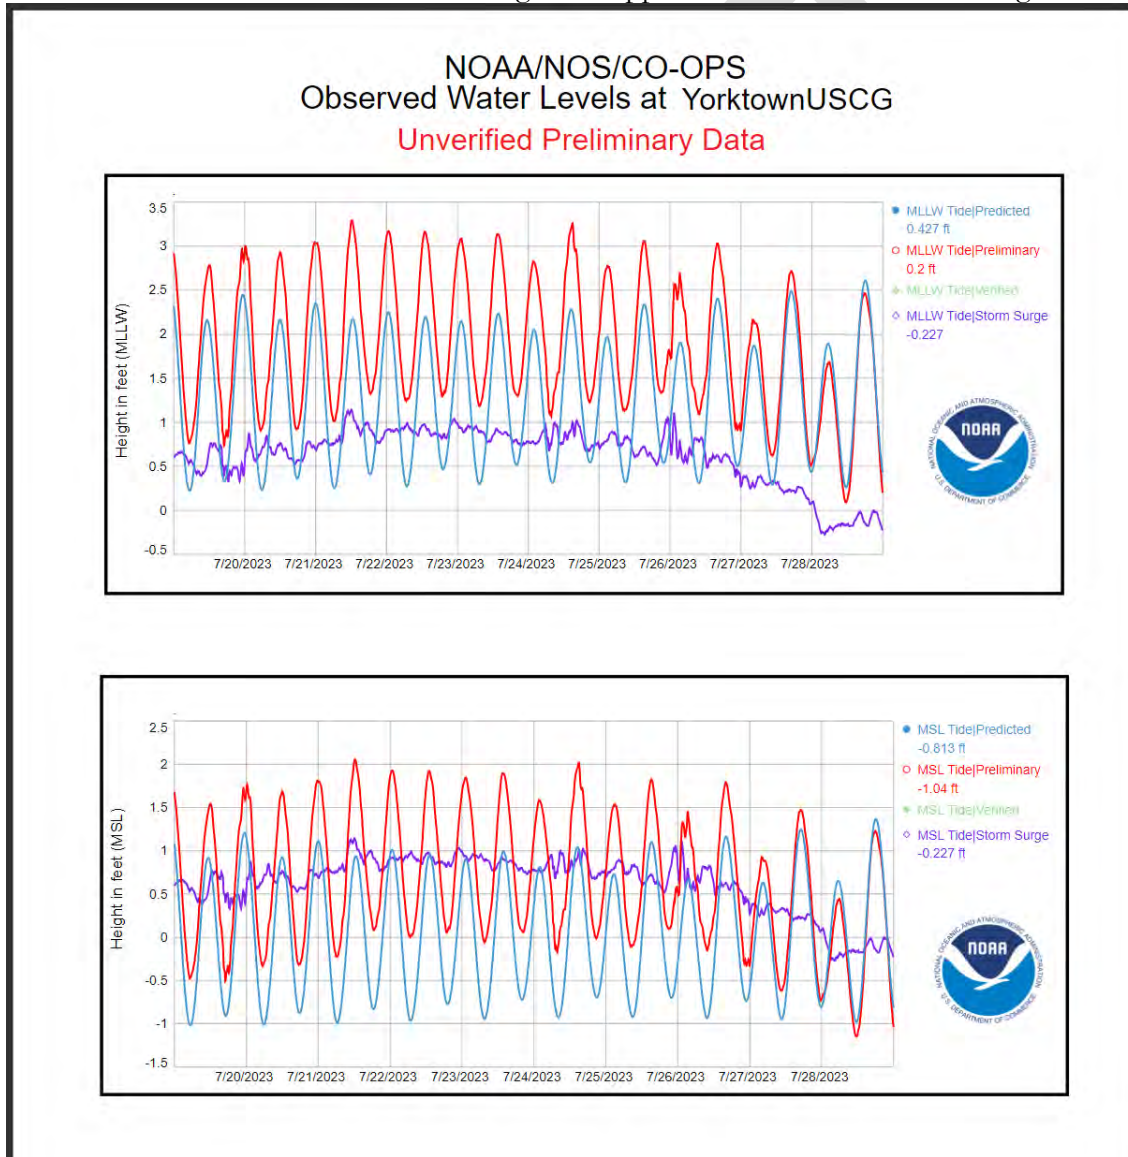
Figure 1. Preliminary data obtained from NOAA and a connection with Open Weather

- Yorktown USCG Training Center:
 - Storm Surge: An approximate 1.01-foot storm surge was observed.

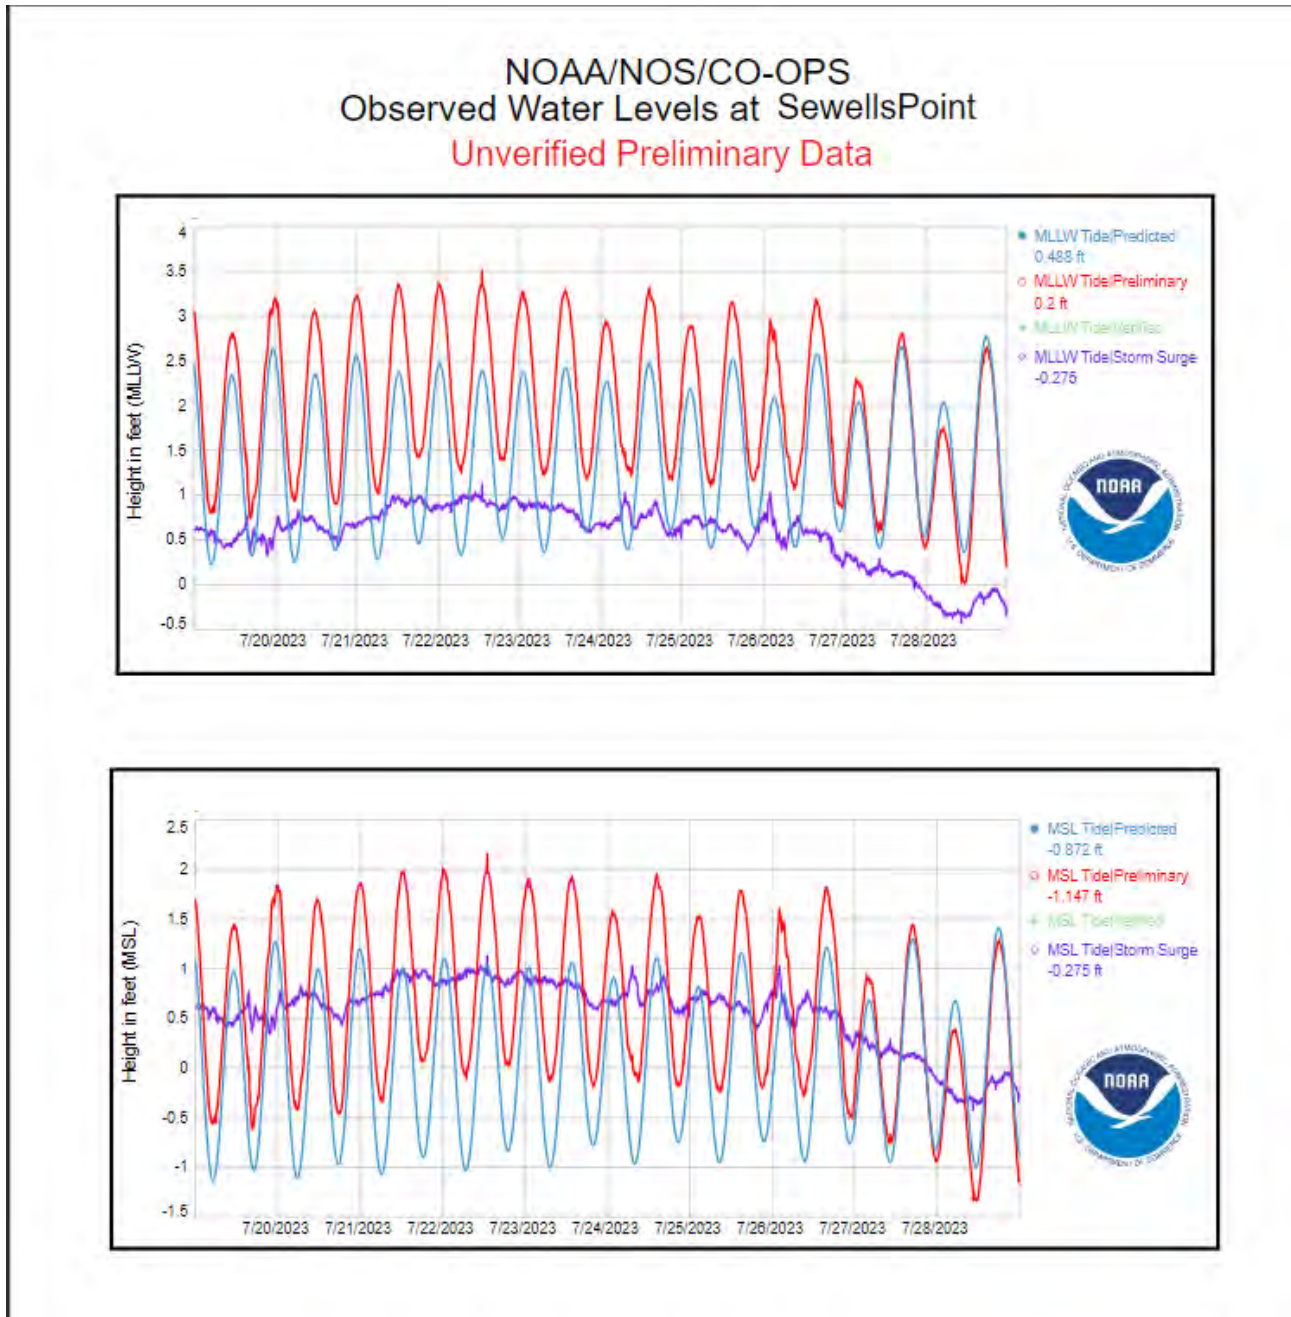
Figure 2. Preliminary data obtained from NOAA and a connection with Open Weather

- Sewells Point Tide Station:
 - Storm Surge: An approximate 1.02 foot storm surge was observed.

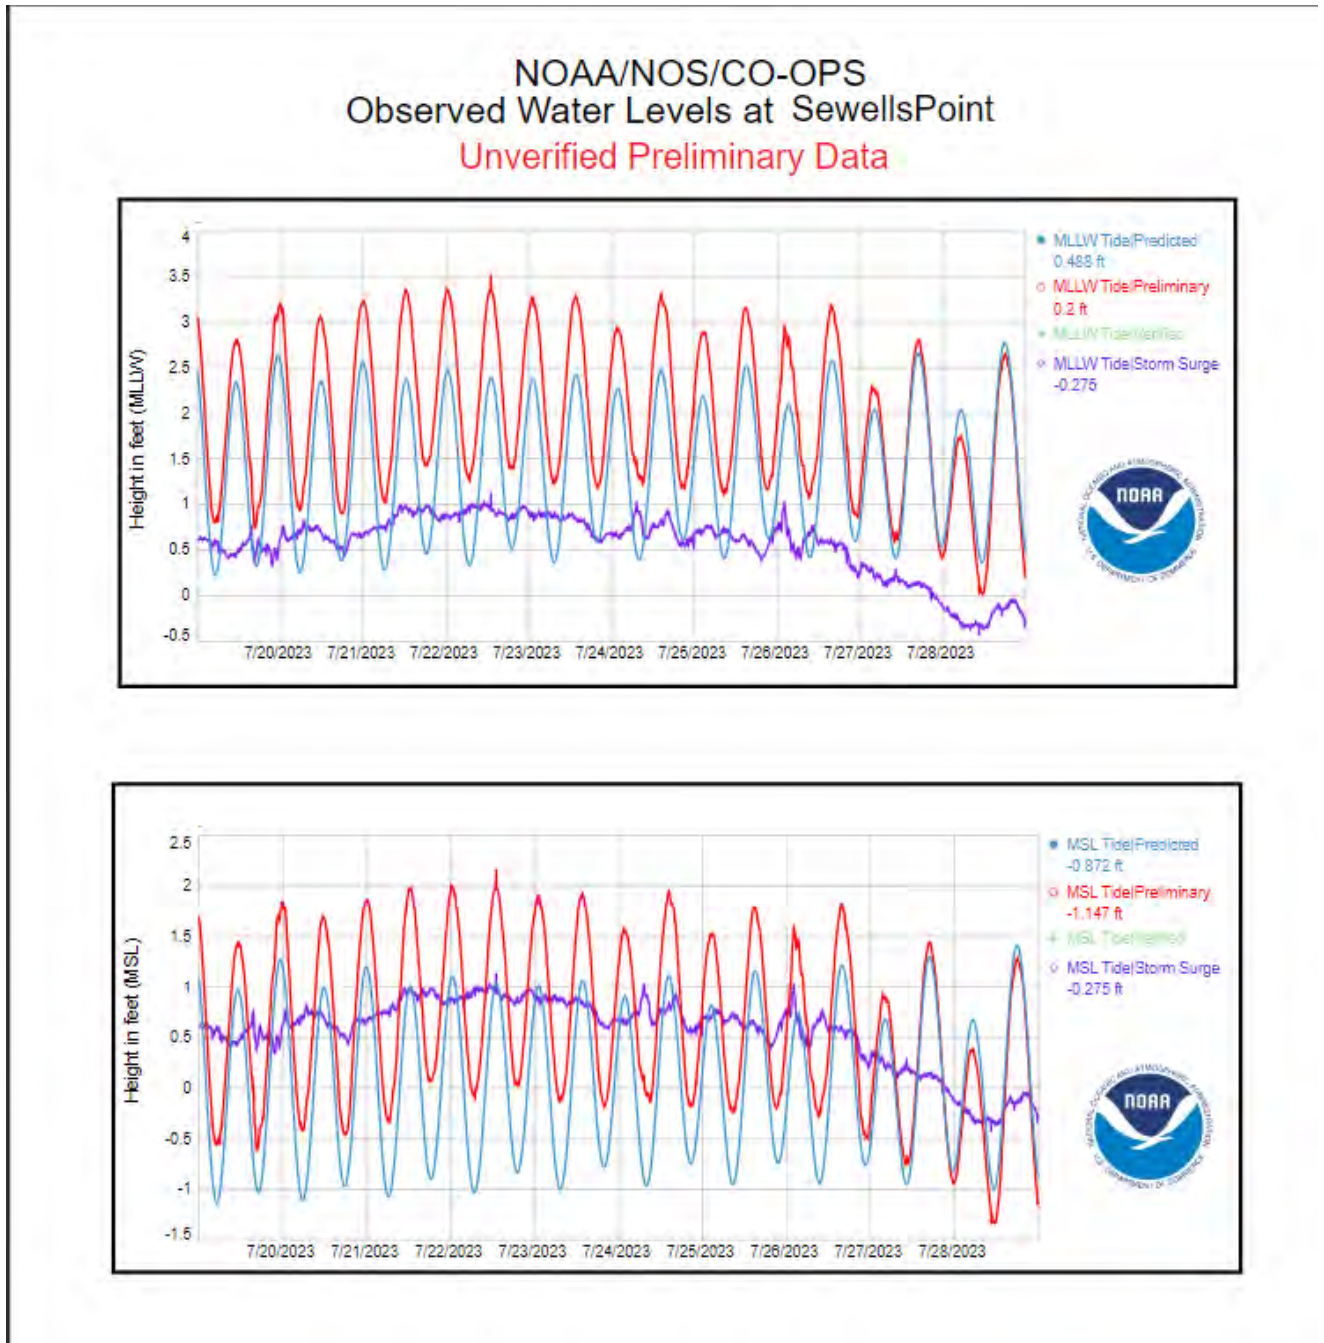
Figure 3. Preliminary data obtained from NOAA and a connection with Open Weather

- Sewells Point Tide Station:
 - Storm Surge: An approximate 1.02 foot storm surge was observed.

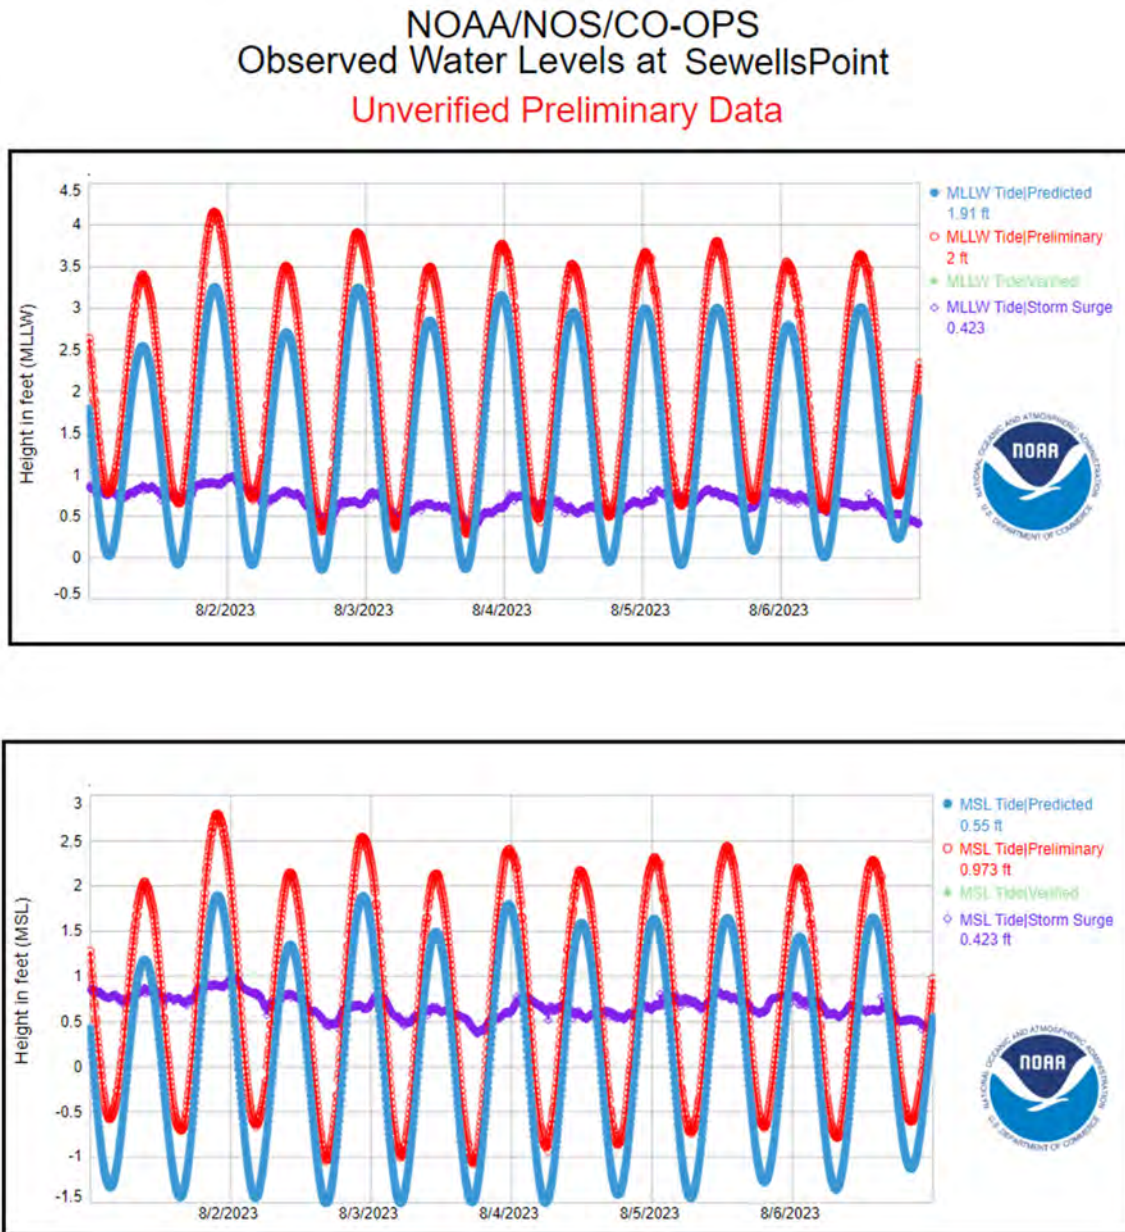
Figure 3. Preliminary data obtained from NOAA and a connection with Open Weather

- Sewells Point Tide Station:
 - Storm Surge: An approximate 0.75 foot storm surge was observed.

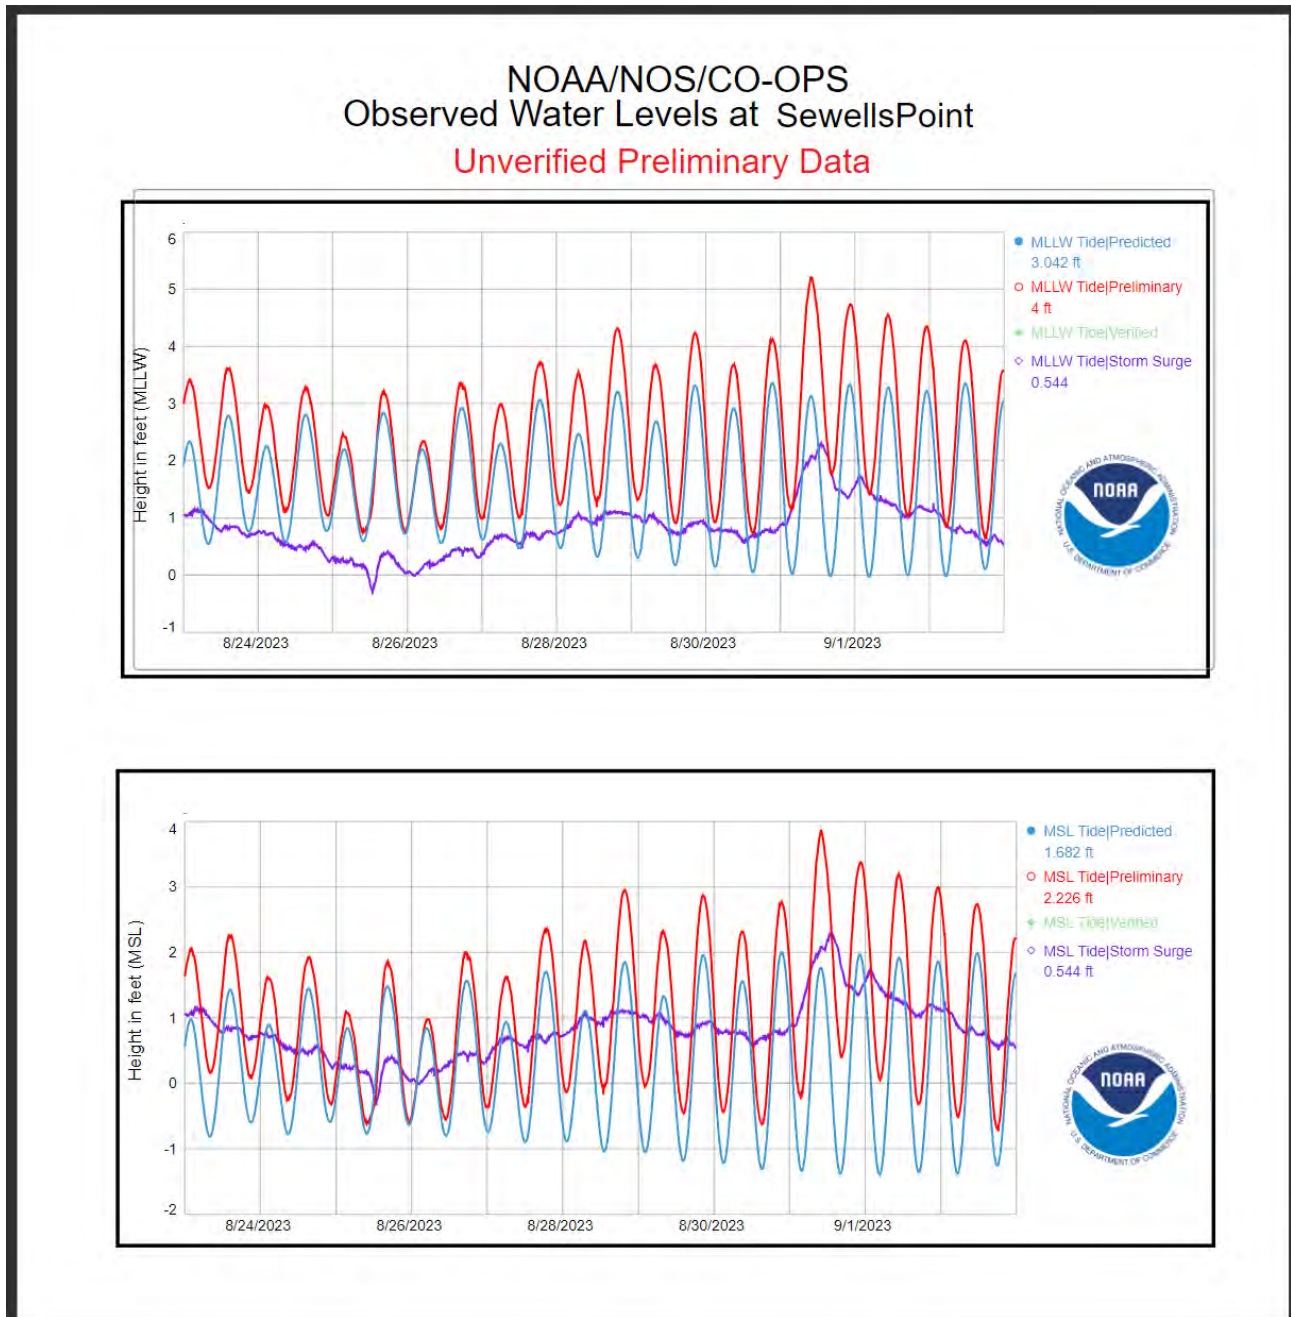
Figure 2. Preliminary data obtained from NOAA and a connection with Open Weather

- Sewells Point Tide Station:
 - Storm Surge: An approximate 1.08 foot storm surge was observed.

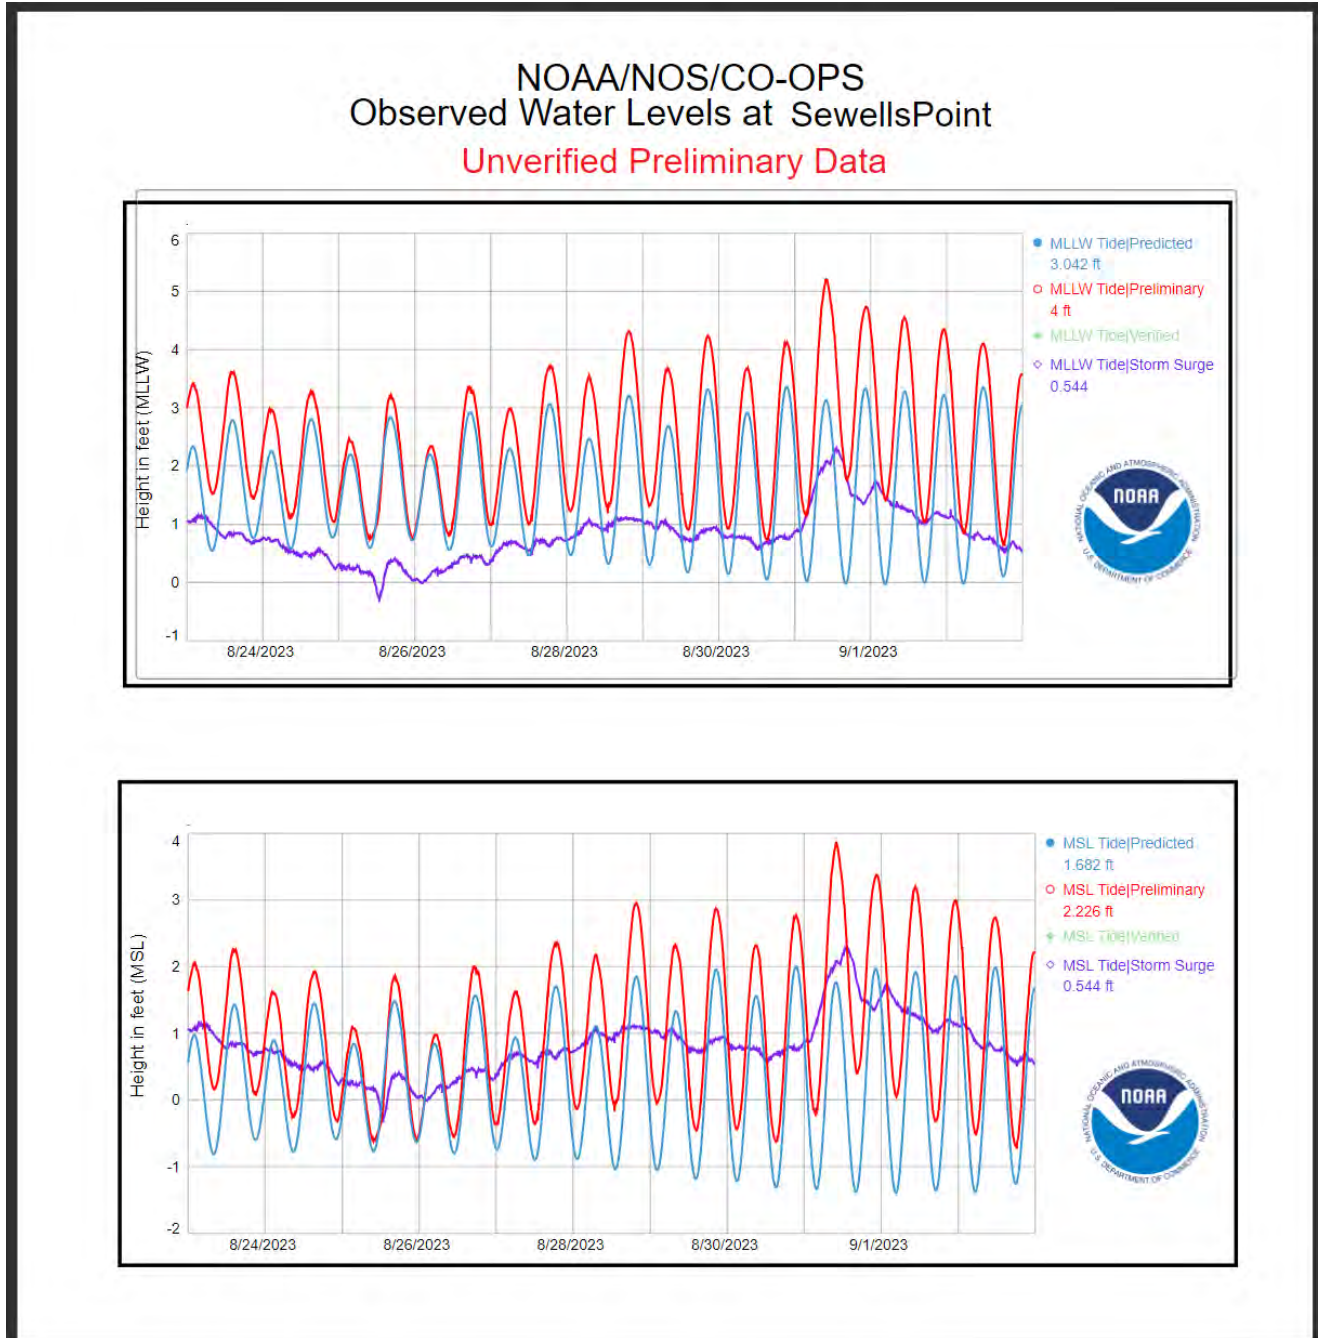
Figure 3. Preliminary data obtained from NOAA and a connection with Open Weather

- Sewells Point Tide Station:
 - Storm Surge: An approximate 1.08 foot storm surge was observed.

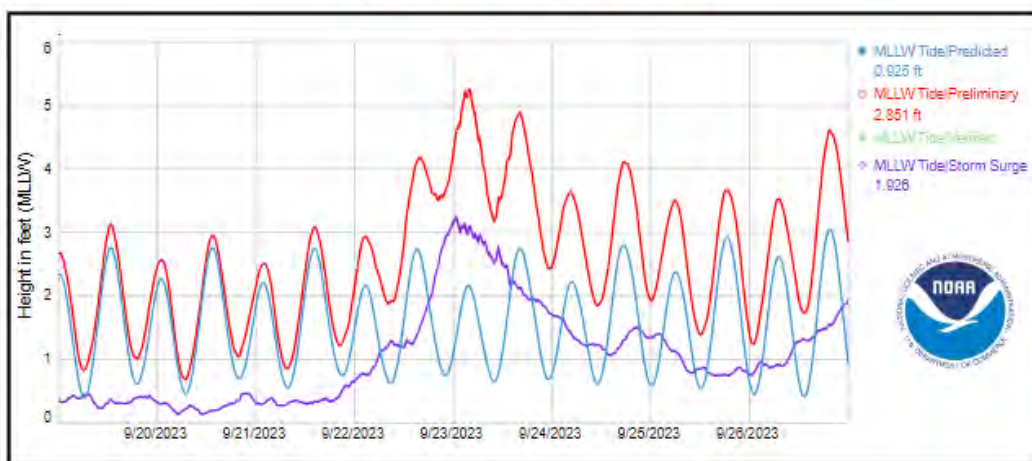
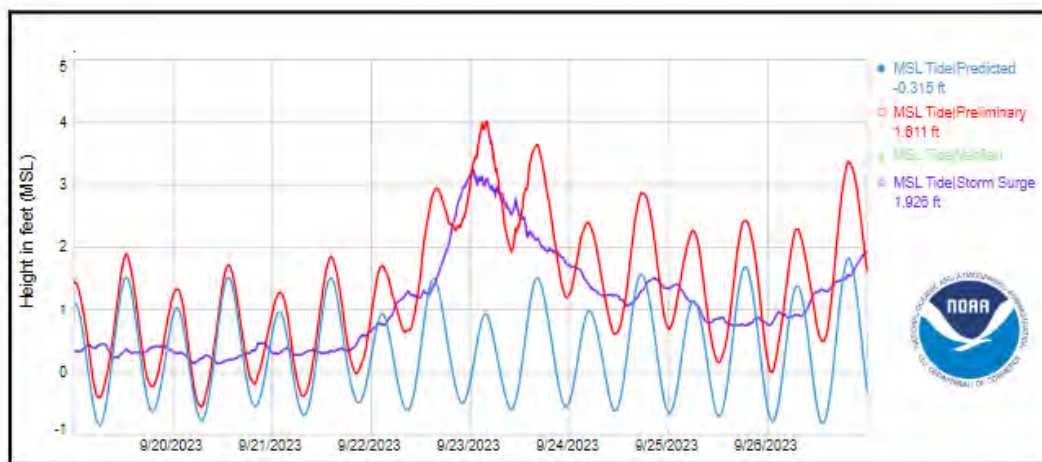
Figure 1. Preliminary data obtained from NOAA and a connection with Open Weather

- Yorktown USCG Training Center:
 - Storm Surge: An approximate 3.2-foot storm surge was observed.

NOAA/NOS/CO-OPS Observed Water Levels at YorktownUSCG Unverified Preliminary Data

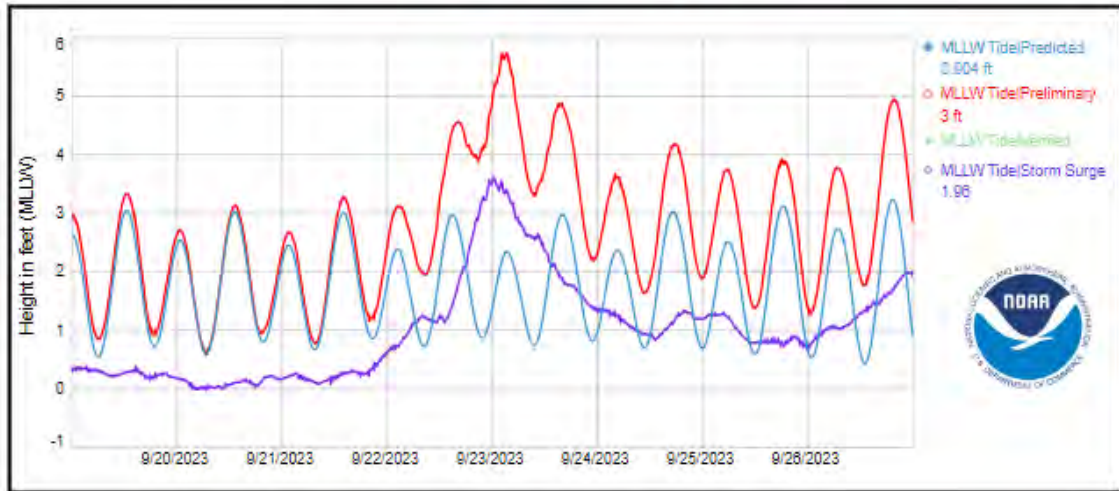
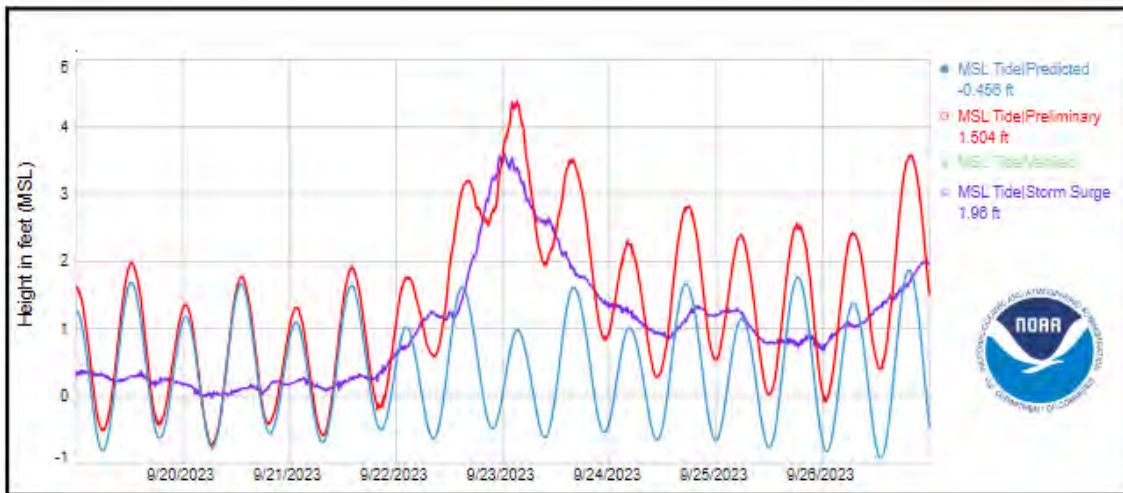
Figure 2. Preliminary data obtained from NOAA and a connection with Open Weather

- Sewells Point Tide Station:
 - Storm Surge: An approximate 3.6 foot storm surge was observed.

NOAA/NOS/CO-OPS Observed Water Levels at SewellsPoint Unverified Preliminary Data

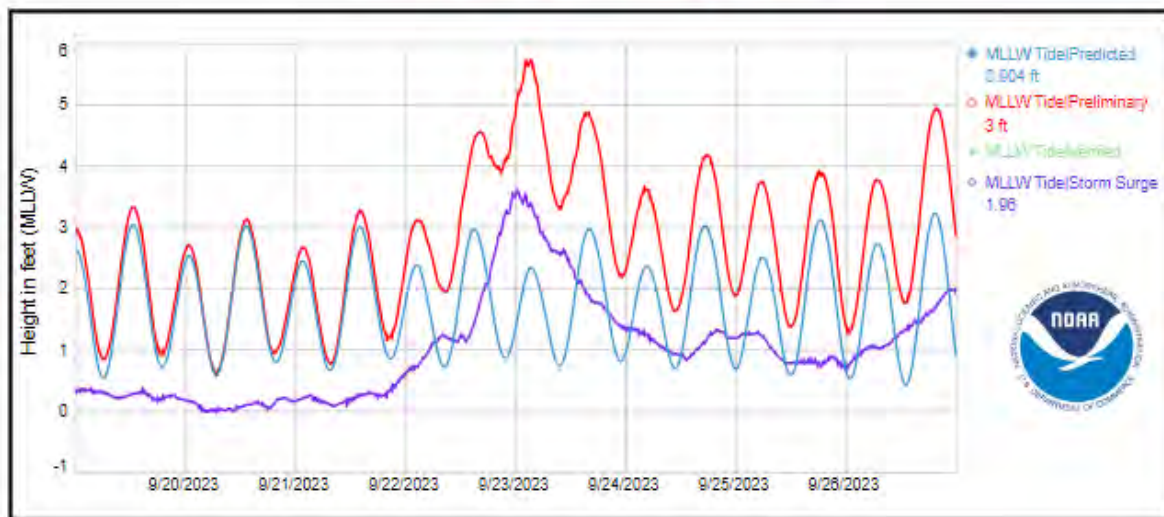
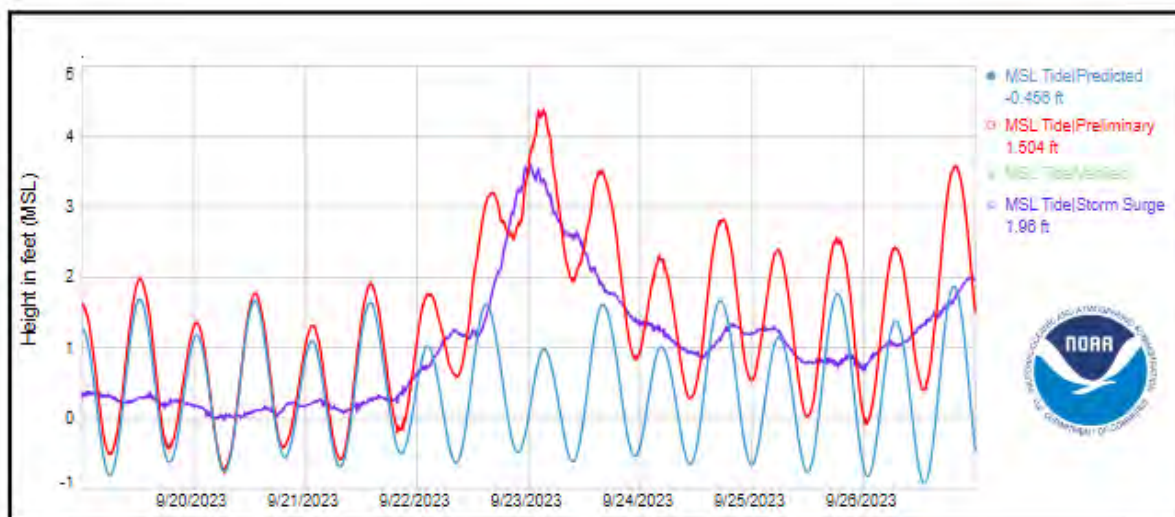
Figure 3. Preliminary data obtained from NOAA and a connection with Open Weather

- Sewells Point Tide Station:
 - Storm Surge: An approximate 3.6 foot storm surge was observed.

NOAA/NOS/CO-OPS
Observed Water Levels at SewellsPoint
Unverified Preliminary Data
