QUARTERLY REPORT
JULY 1 – SEPTEMBER 30, 2023

Hampton Roads Sanitation District

November 28, 2023

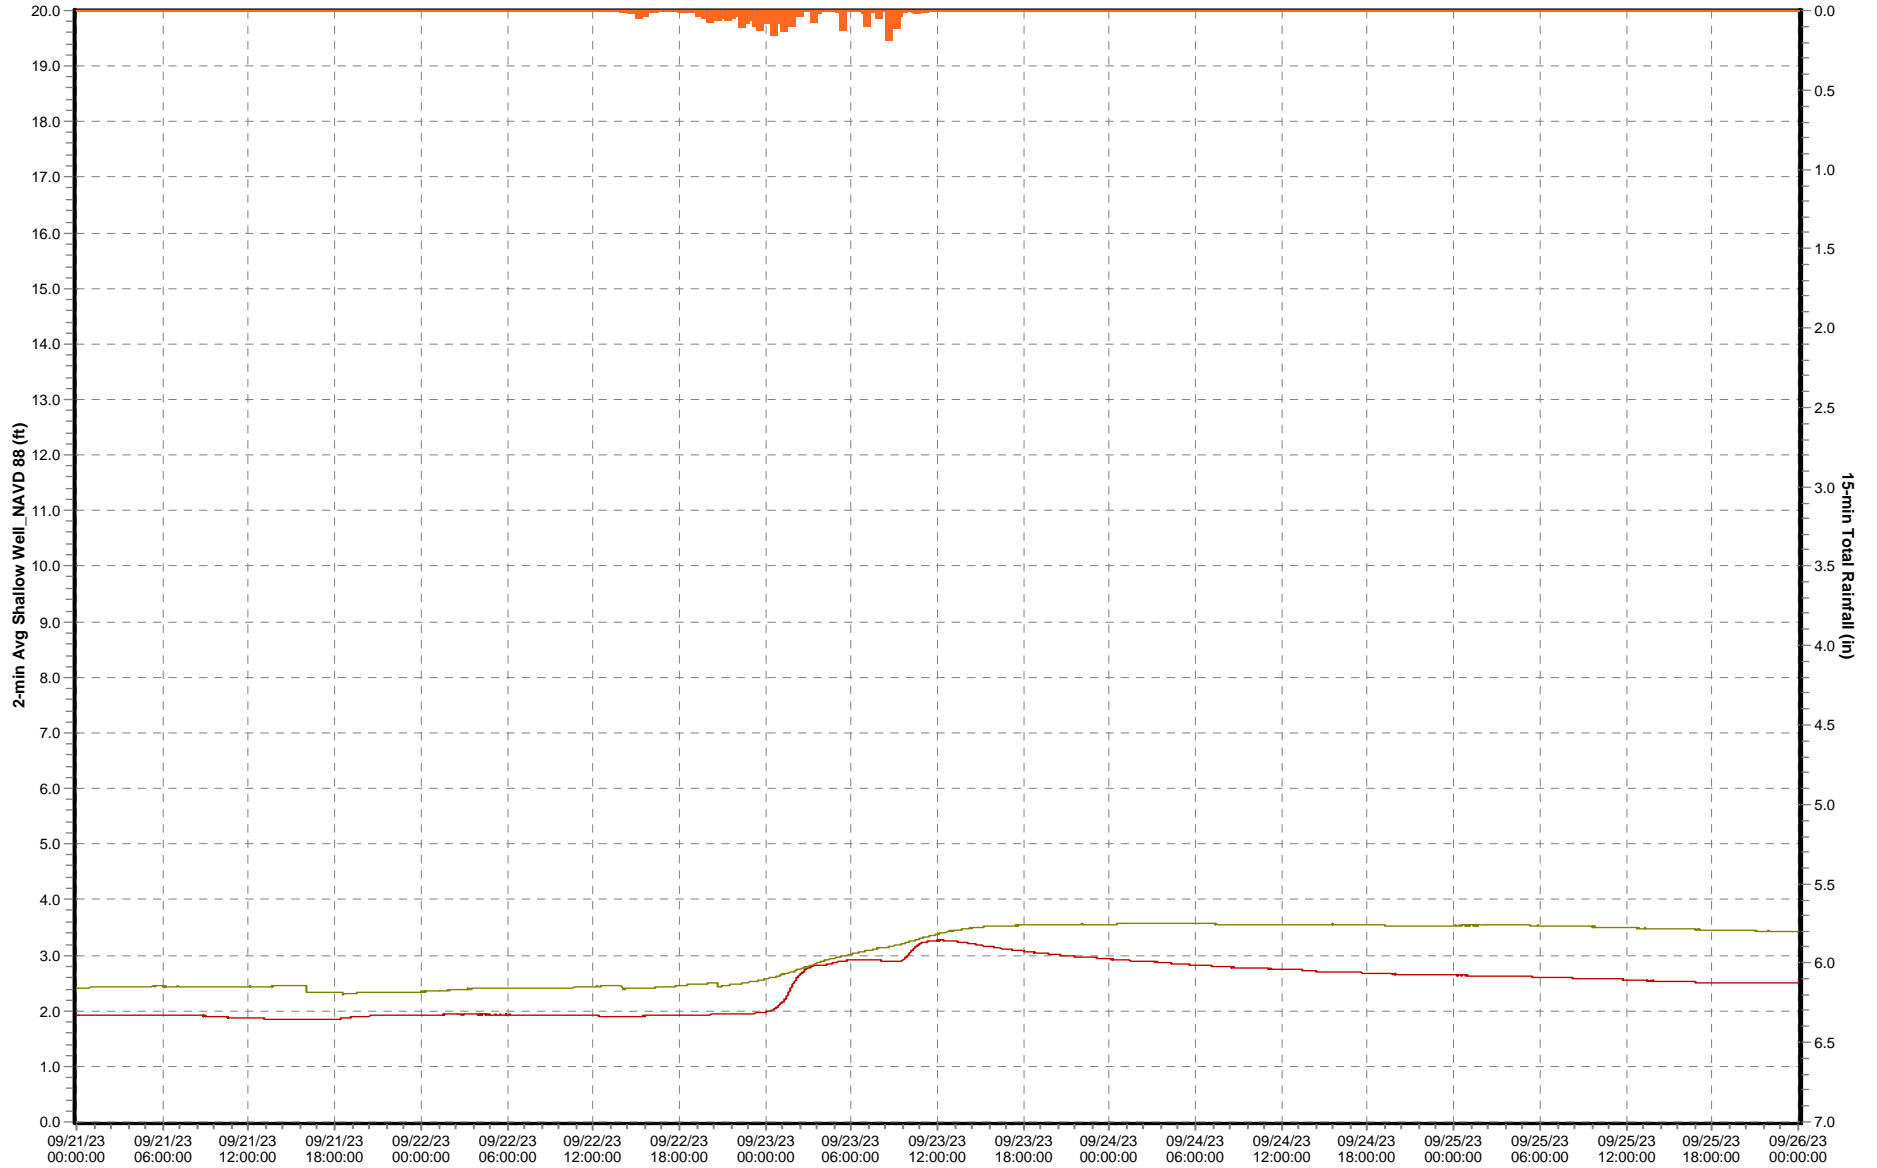
5-day
South Shore Shallow Well Graphs
09/21/23 to 09/26/23

North Shore Rd PS.Shallow Well_NAVD88 (ft) Camden Ave PS.Shallow Well_NAVD 88 (ft) Rodman Ave PS. Rain Gauge (in)
