QUARTERLY REPORT
JANUARY 1 – MARCH 31, 2022

Hampton Roads Sanitation District
1434 Air Rail Avenue
Virginia Beach, VA 23455

June 17, 2022

Post-Storm Report

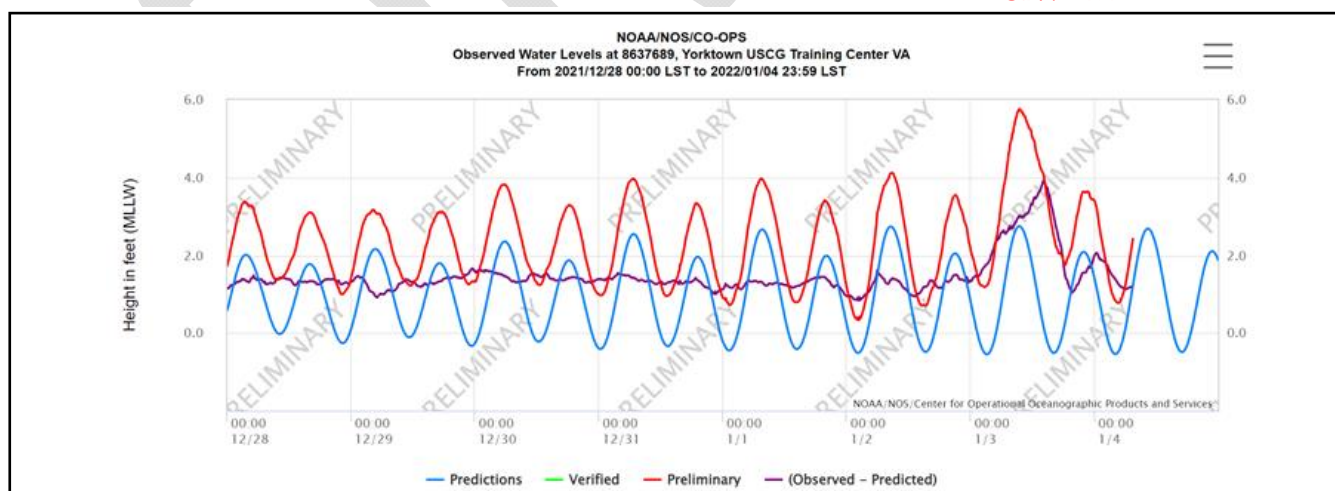
Figure 1. Preliminary data obtained from <http://tidesandcurrents.noaa.gov>

- Yorktown USCG Training Center:
 - Storm Surge: An approximate 3.9-foot storm surge was observed.

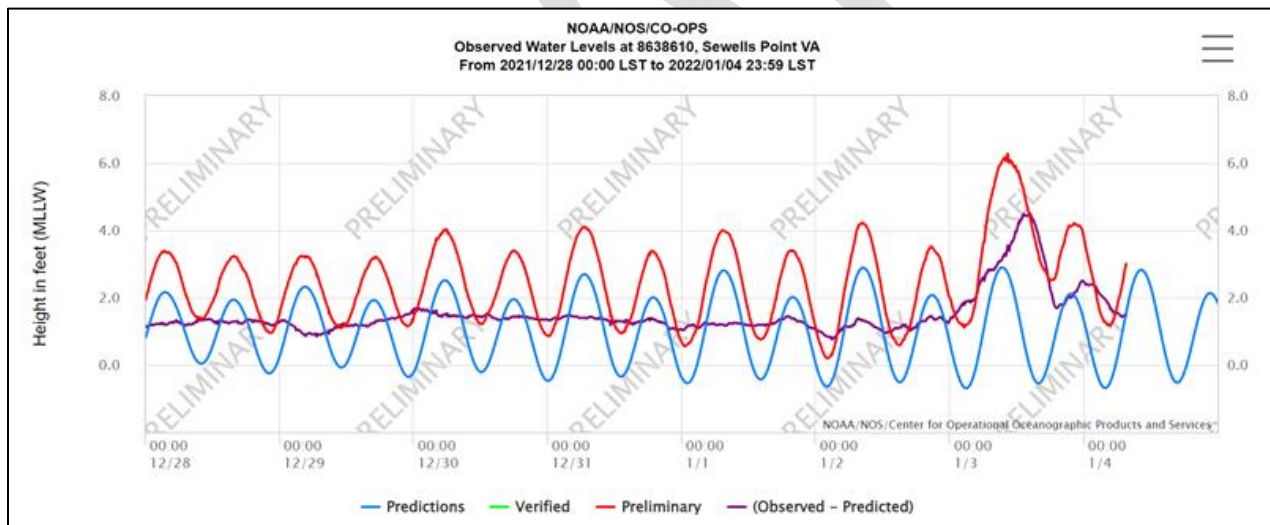
Figure 3. Preliminary data obtained from <http://tidesandcurrents.noaa.gov>

- Sewells Point Tide Station:
 - Storm Surge: An approximate 4.4 foot storm surge was observed.

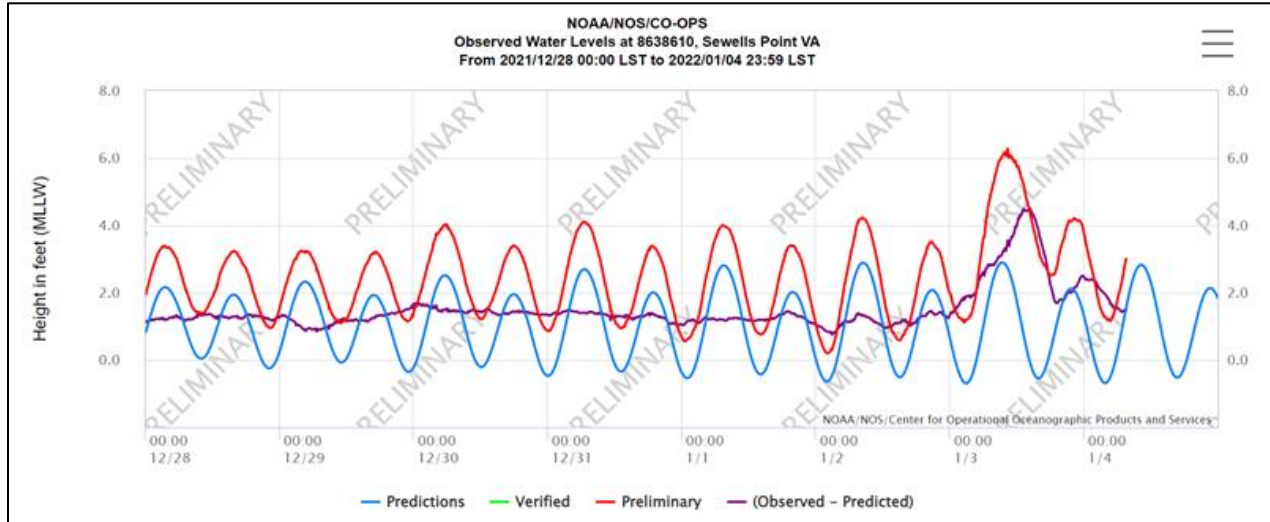
Figure 5. Preliminary data obtained from <http://tidesandcurrents.noaa.gov>

- Sewells Point Tide Station:
 - Storm Surge: An approximate 3.9-foot storm surge was observed.

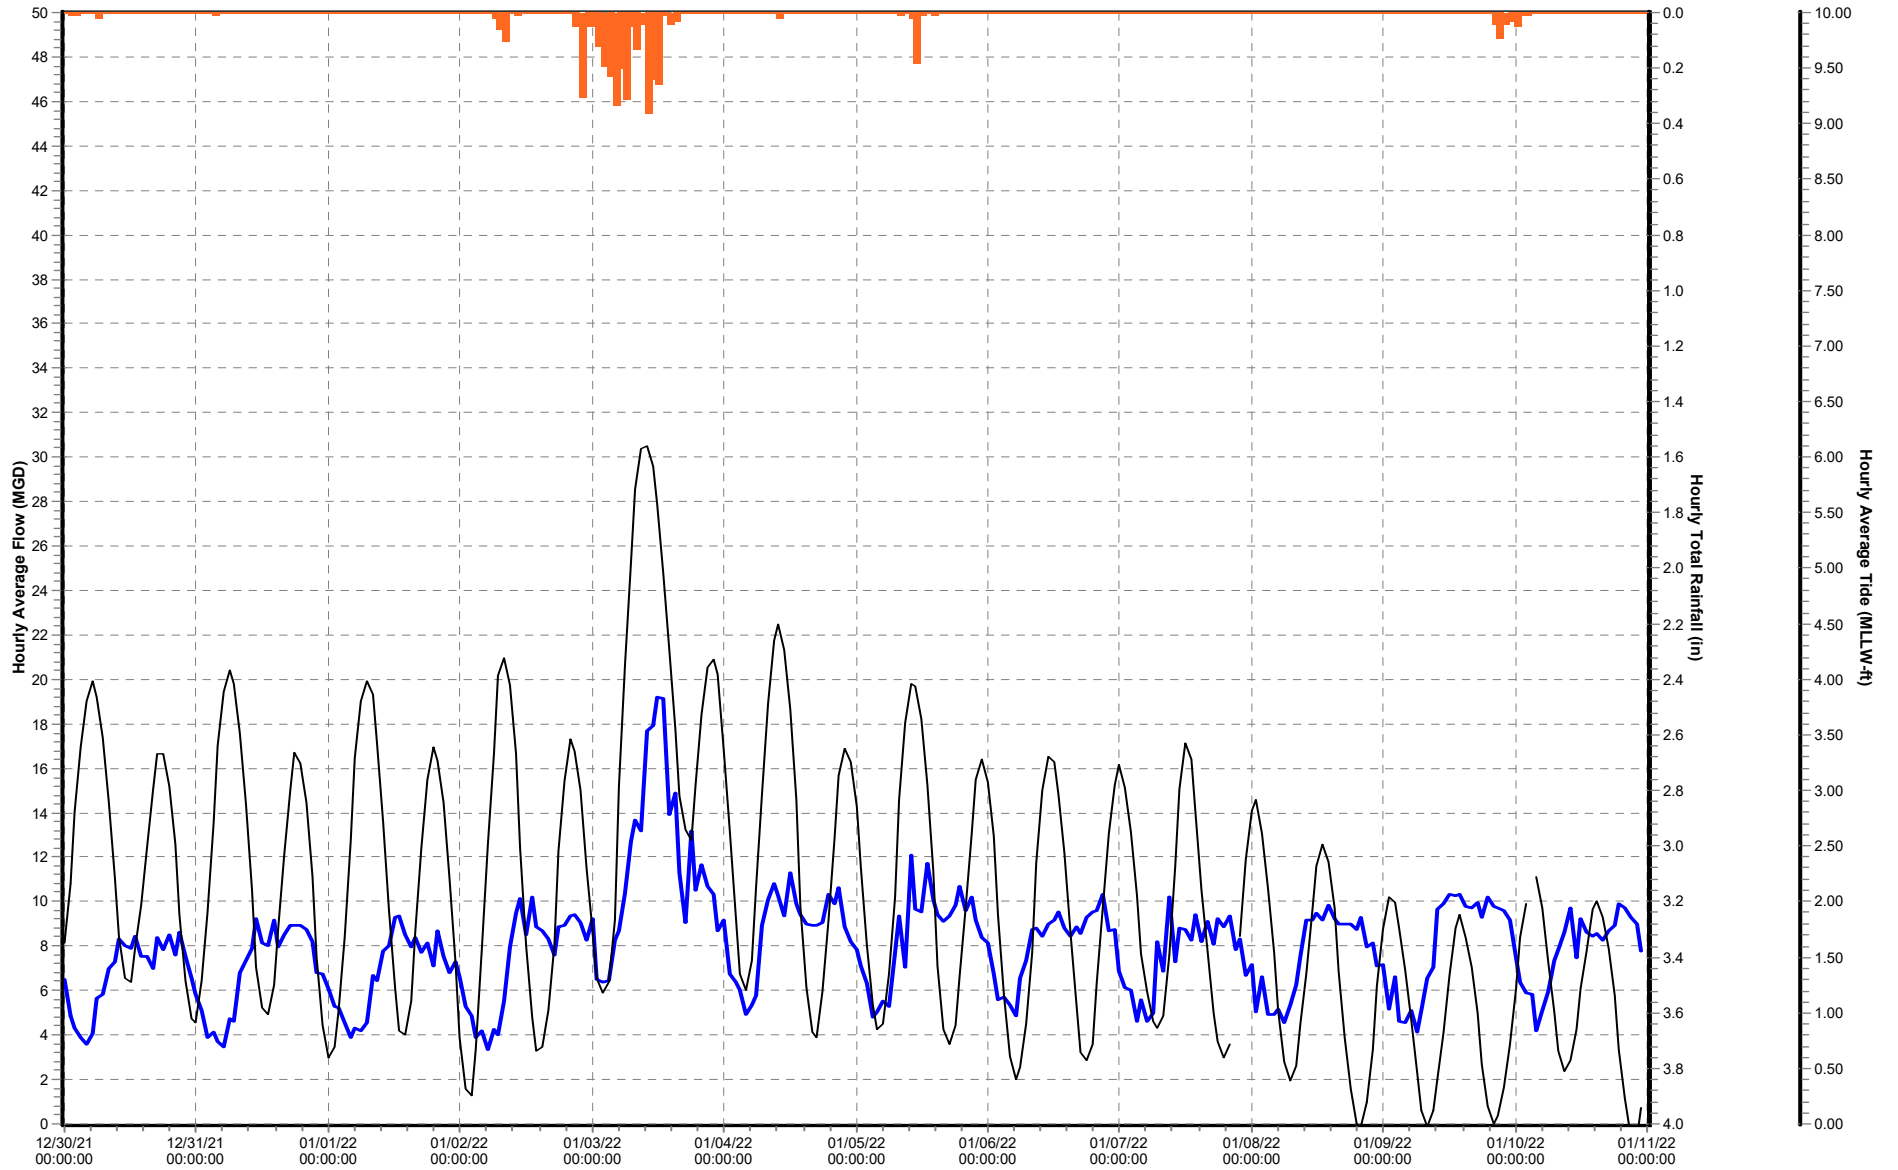
MMPS-035 (12/30/21 to 01/11/22)

MMPS-035.Flow_Effluent (MGD) MMPS-175: Taussig Blvd PS Rain Gauge SewellsPt Tide - MLLW Preliminary (ft)

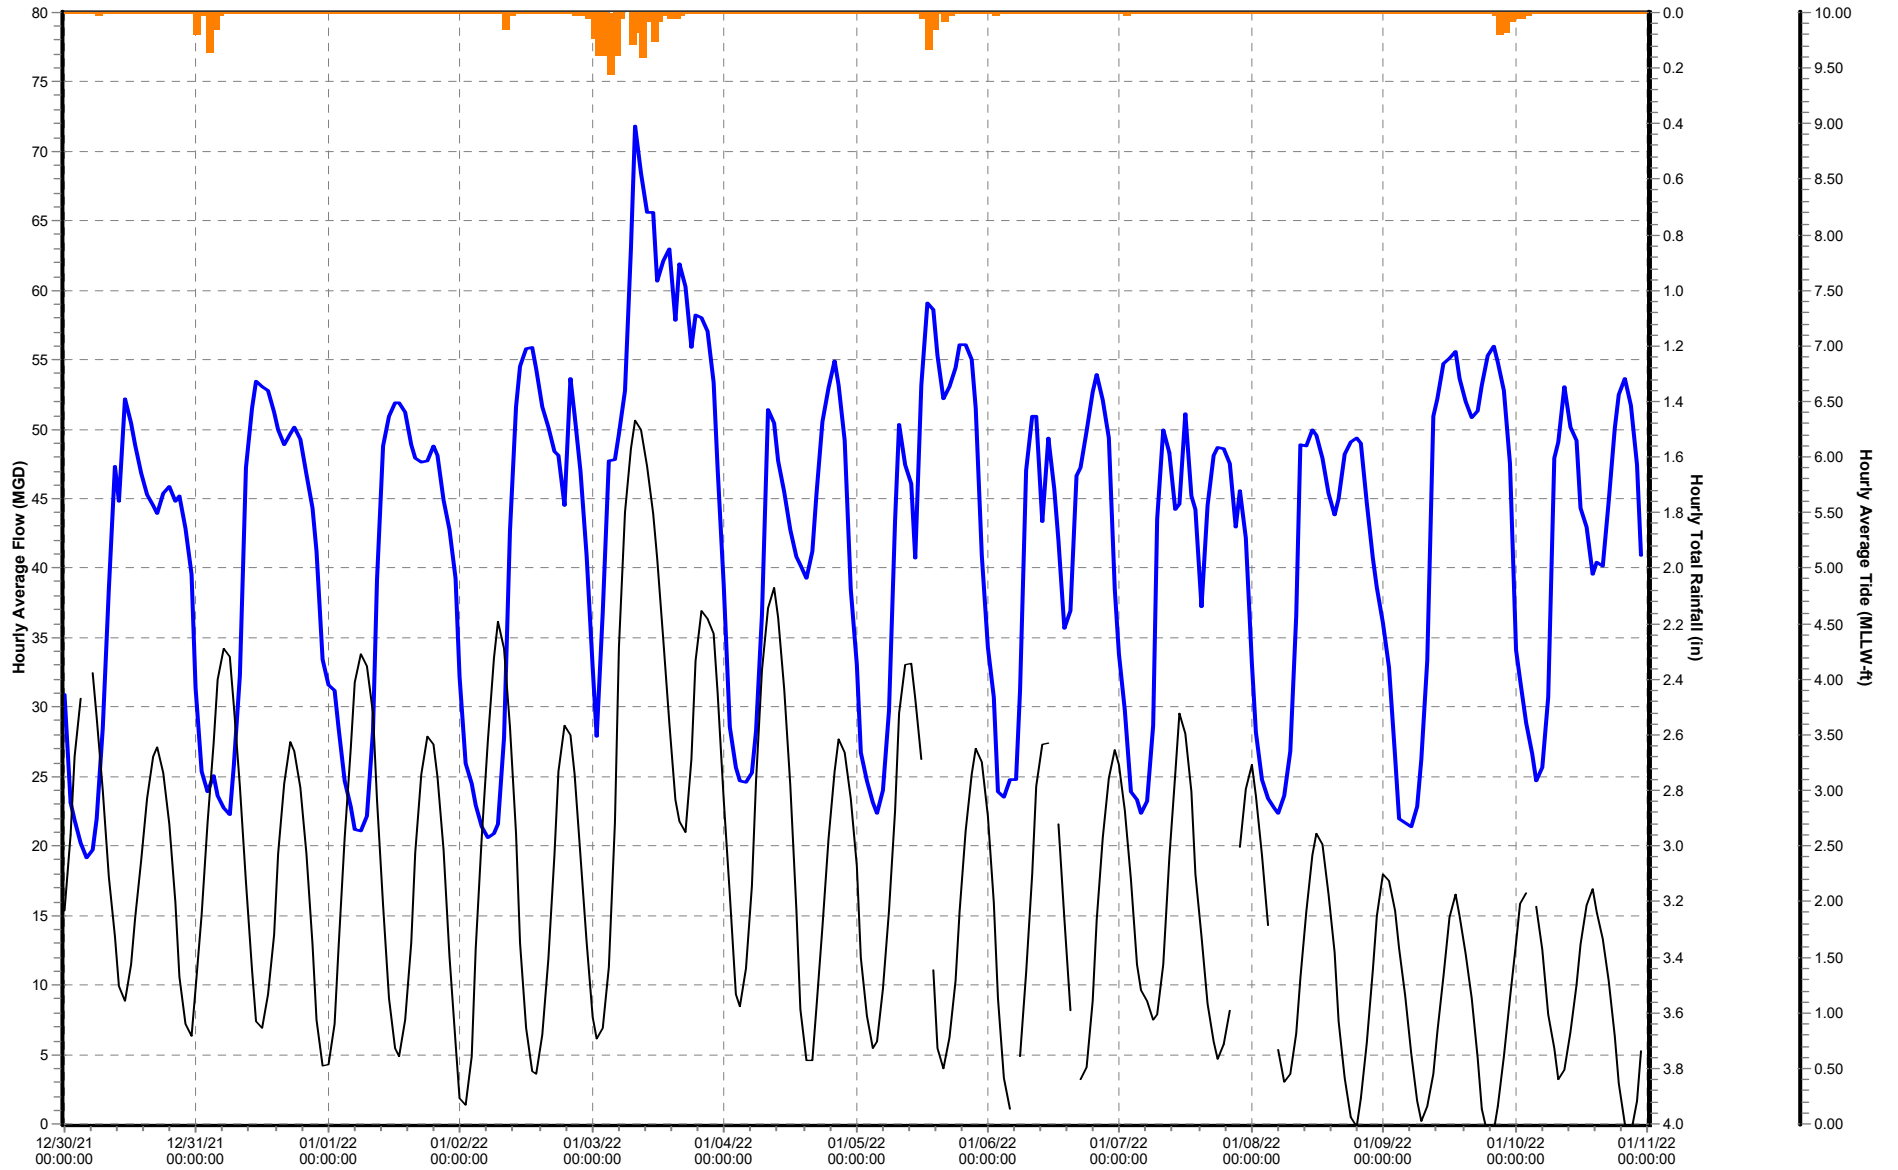
Atlantic Treatment Plant
MMPS-071 (12/30/21 to 01/11/22)

Flow_Effluent (MGD) MMPS-185: Lagomar IFM at Atlantic TP Rain Gauge CBBT Tide - MLLW Preliminary (ft)

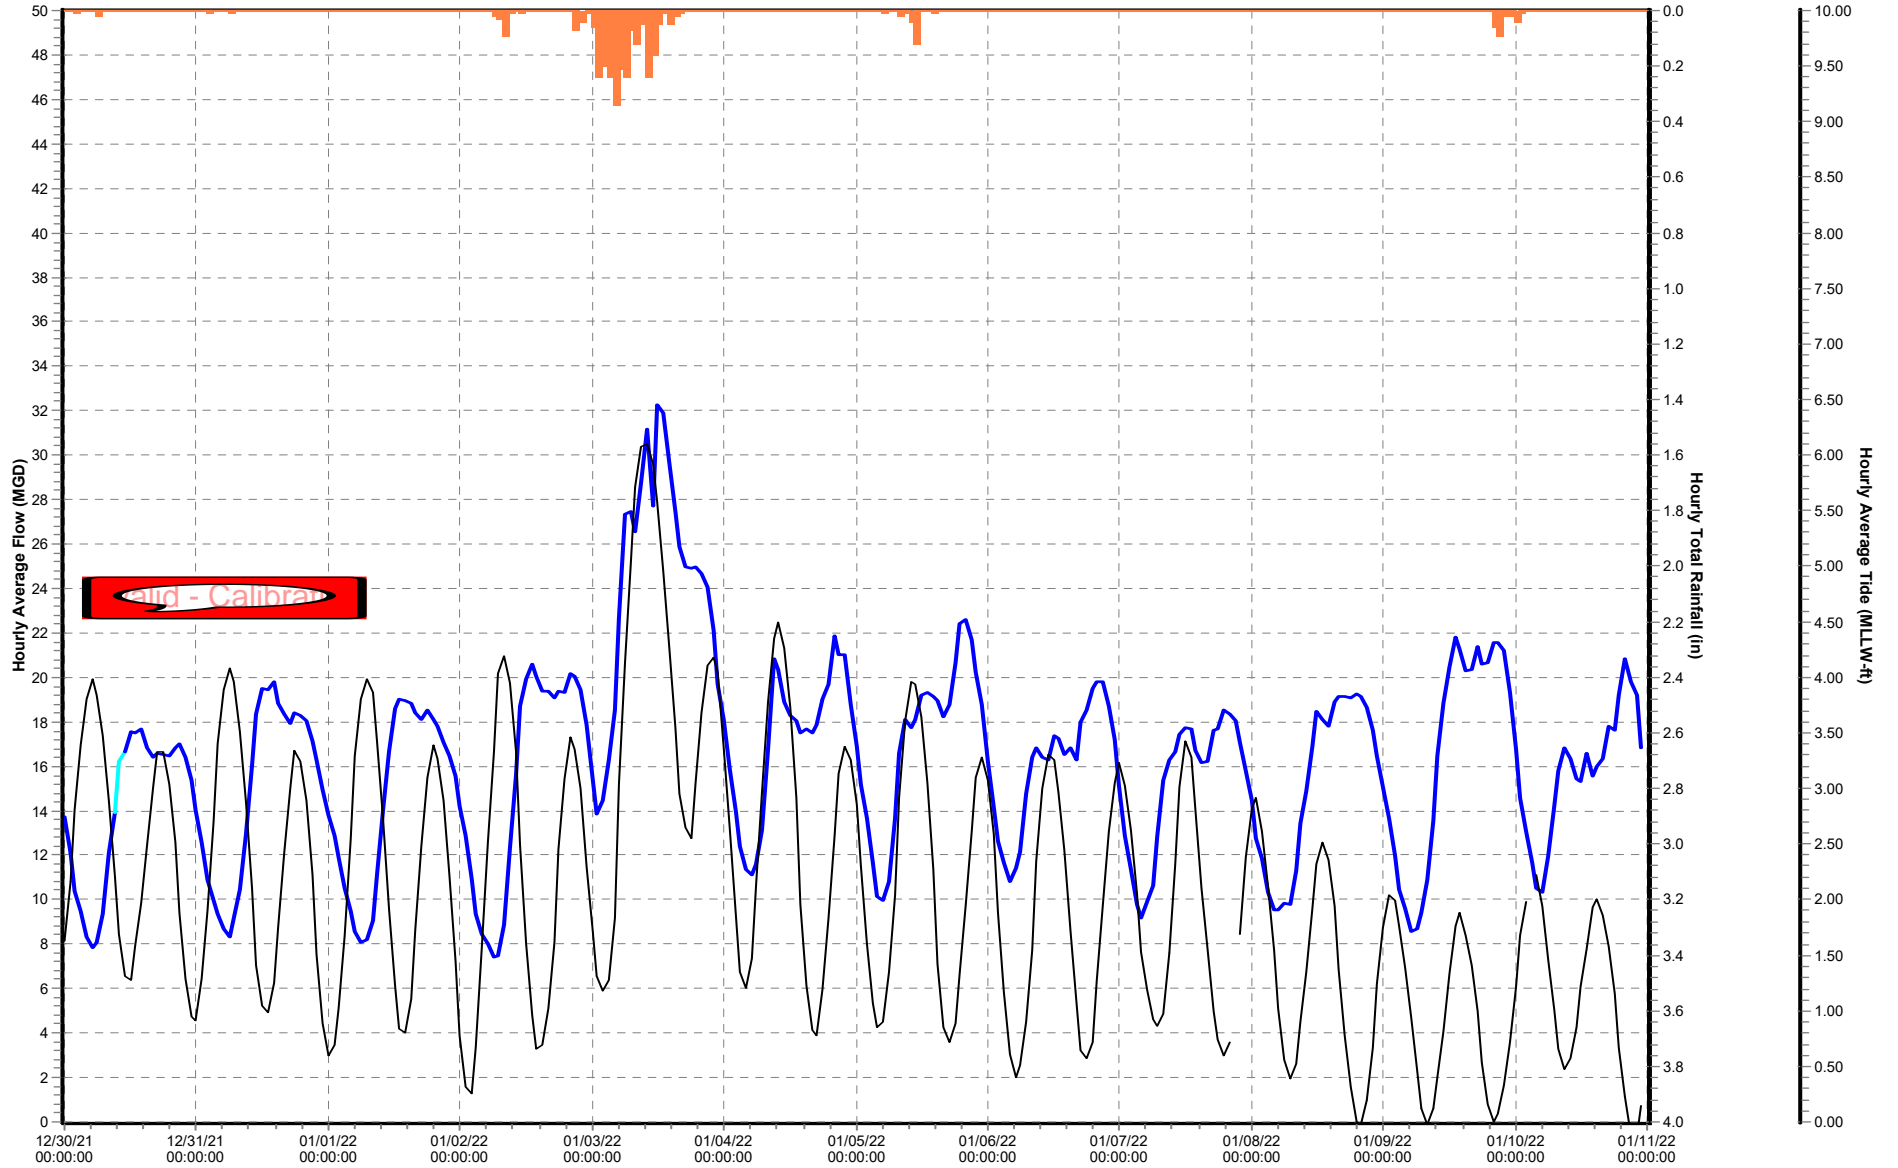
MMPS-202 (12/30/21 to 01/11/22)

Flow_Effluent (MGD) MMPS-202: Nansemond Main Flow_Effluent Rain Gauge SewellsPt Tide - MLLW Preliminary (ft)

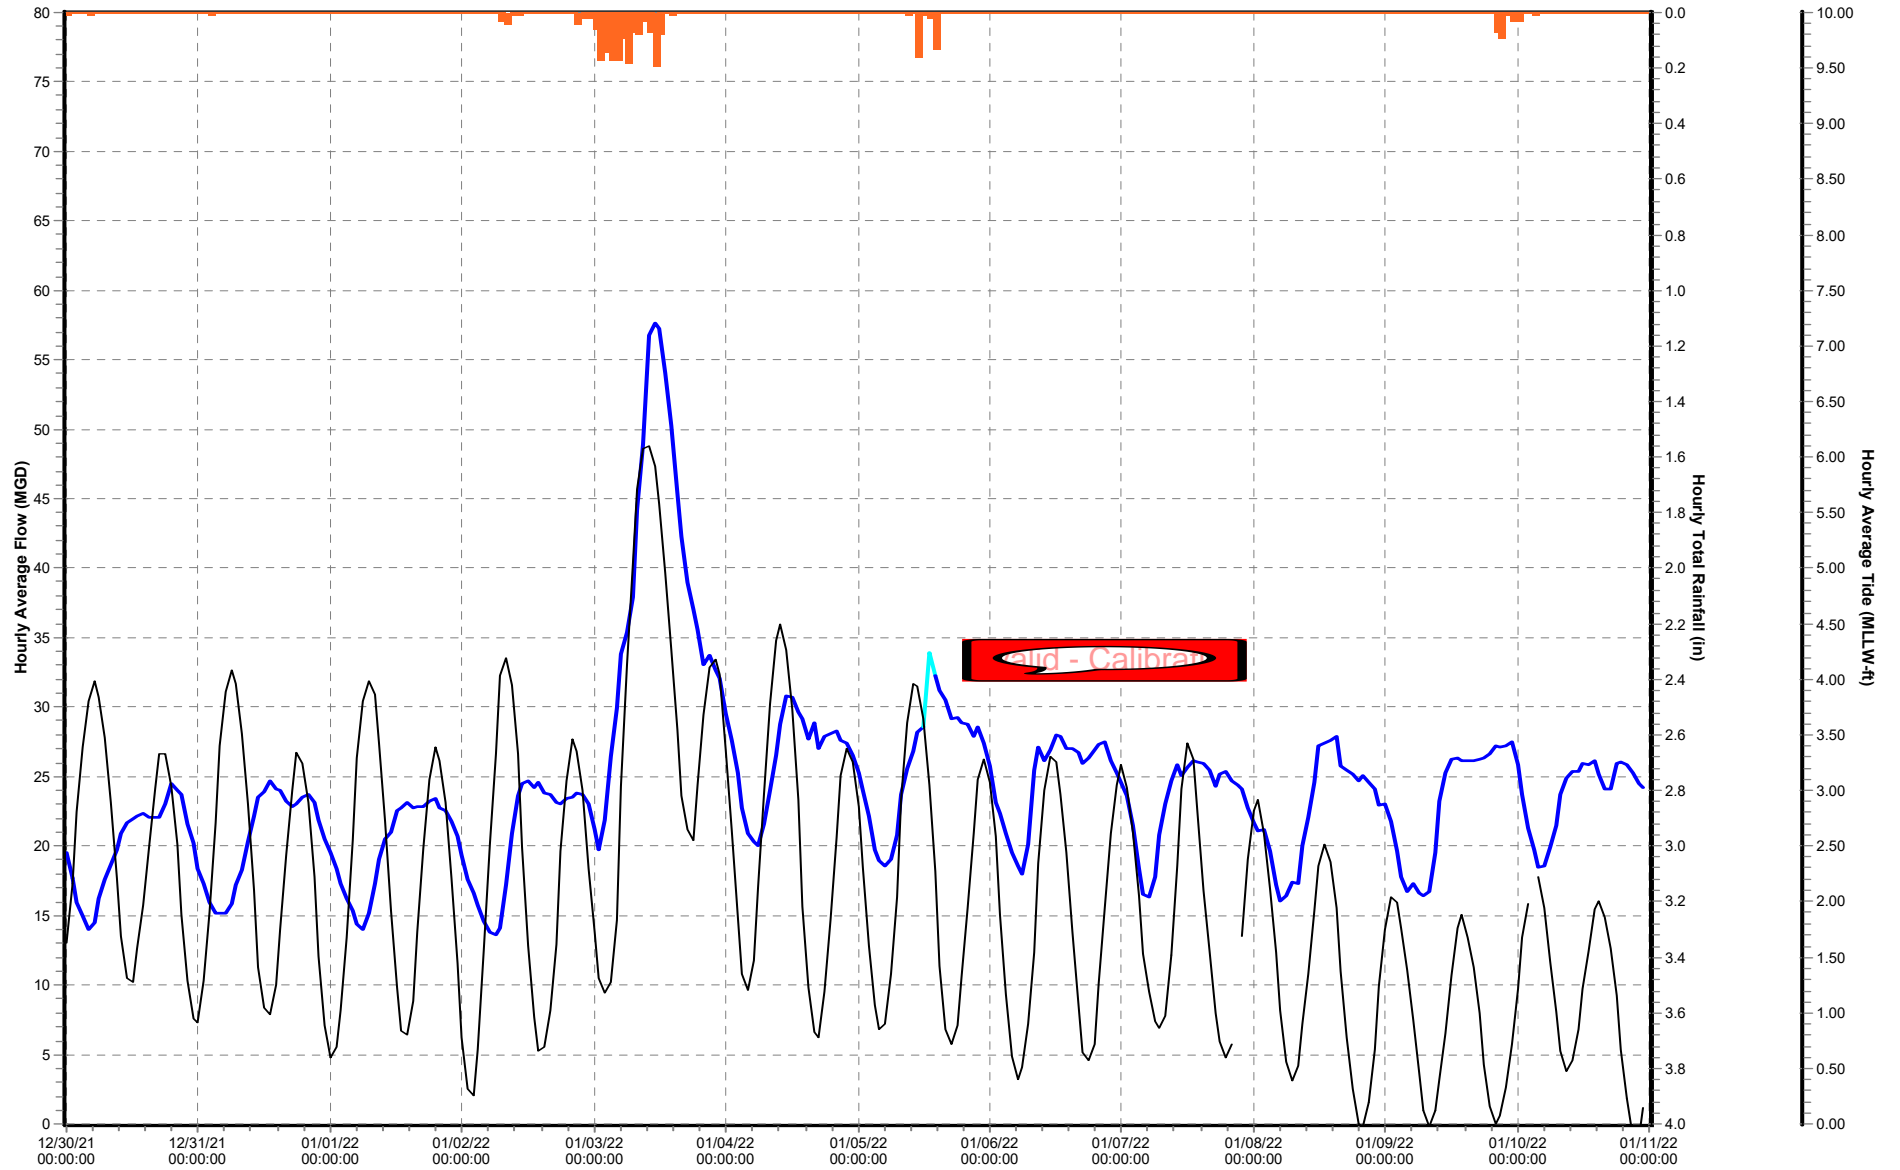
VIP Treatment Plant
MMPS-003 (12/30/21 to 01/11/22)

Flow_Effluent (MGD) MMPS-003: VIP Treatment Plant Rain Gauge SewellsPt Tide - MLLW Preliminary

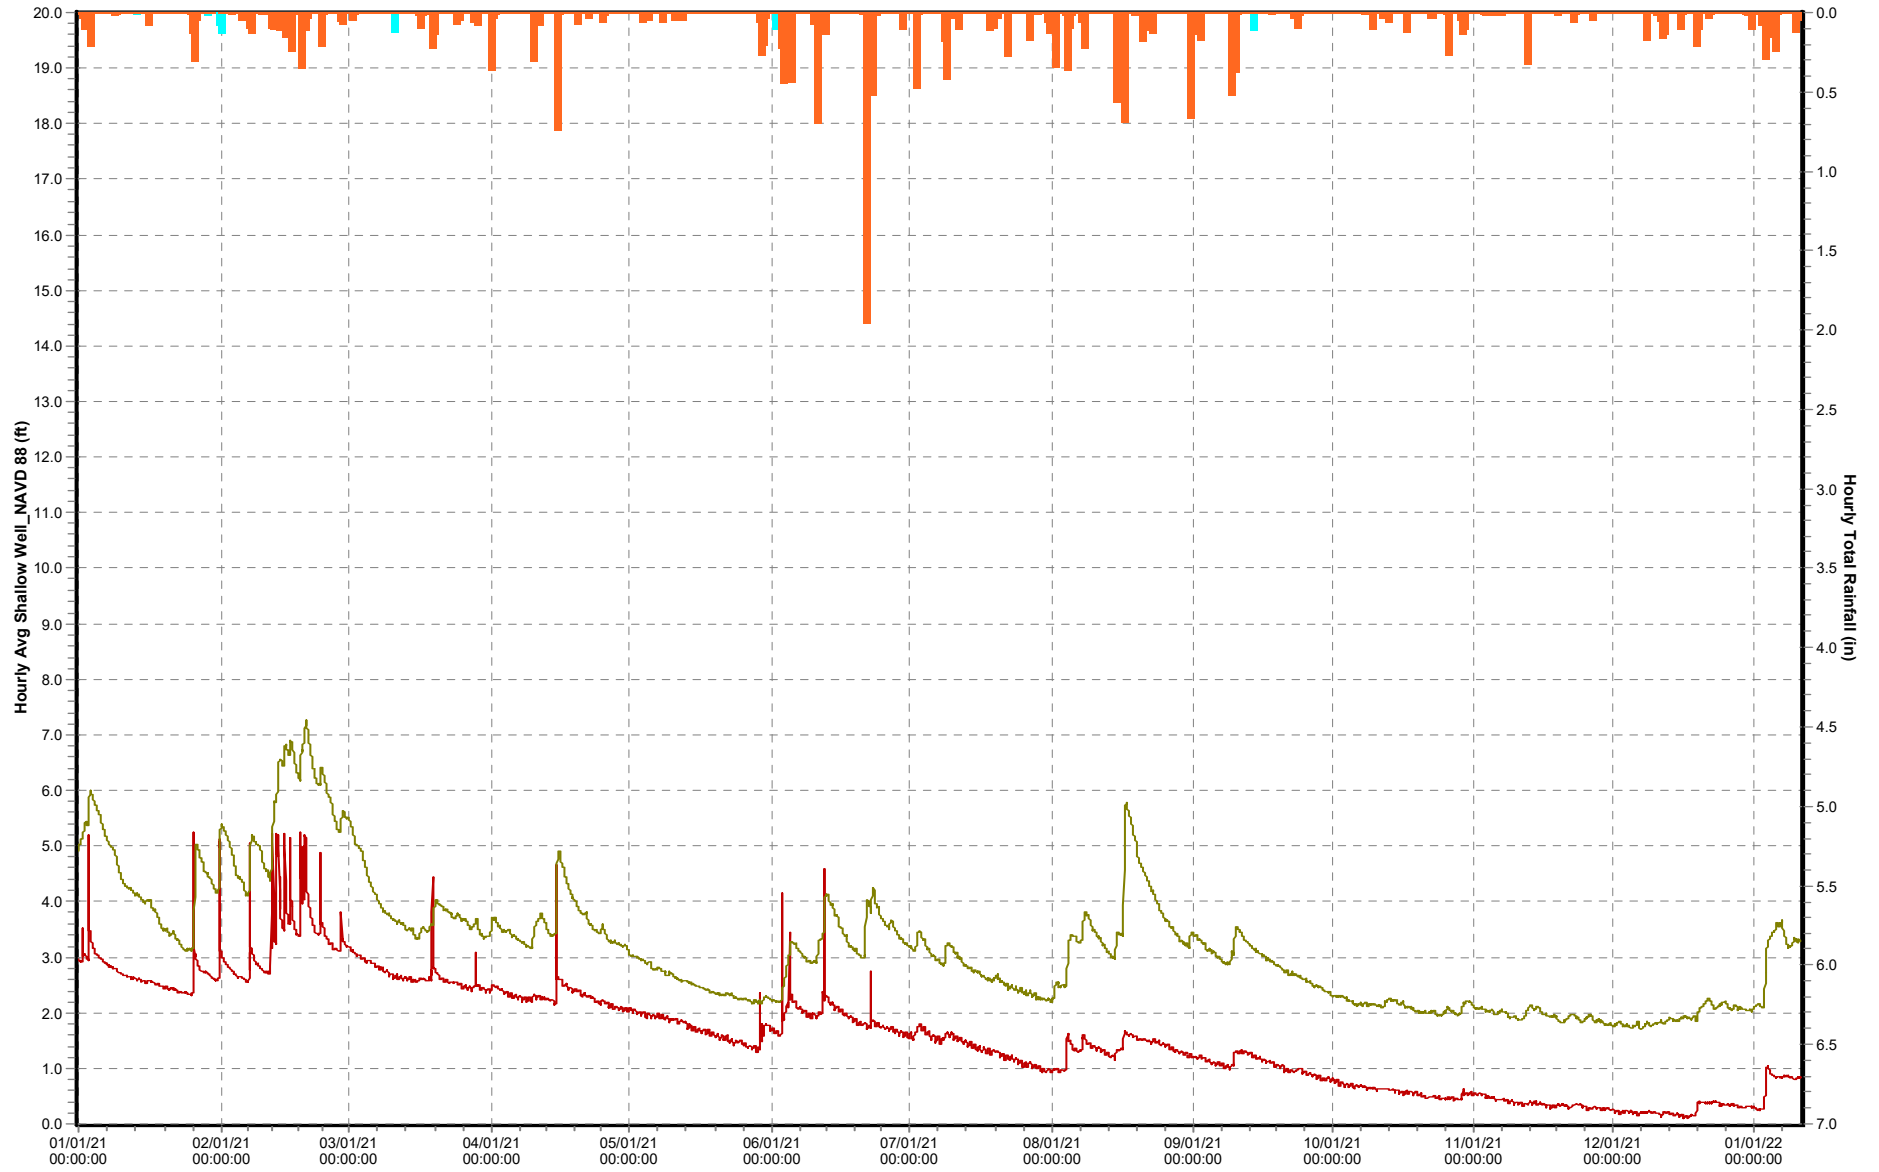
01/01/21 to 01/11/22

MMPS-155.Shallow Well_NAVD 88 (ft) Camden Ave PS.Shallow Well_NAVD 88 (ft) Rodman Ave PS. Rain Gauge (in)

Shallow wells are located at/or near HRSD Pump Stations to measure groundwater levels. The water column is measured using a pressure transducer located near the bottom of the well. The installed sensor measures gauge pressure in inches of water. The Shallow Well_NAVD88 measurement referenced in Appendix D refers to the elevation (referenced as NAVD 88) of the sensor plus the gauge measurement in feet.

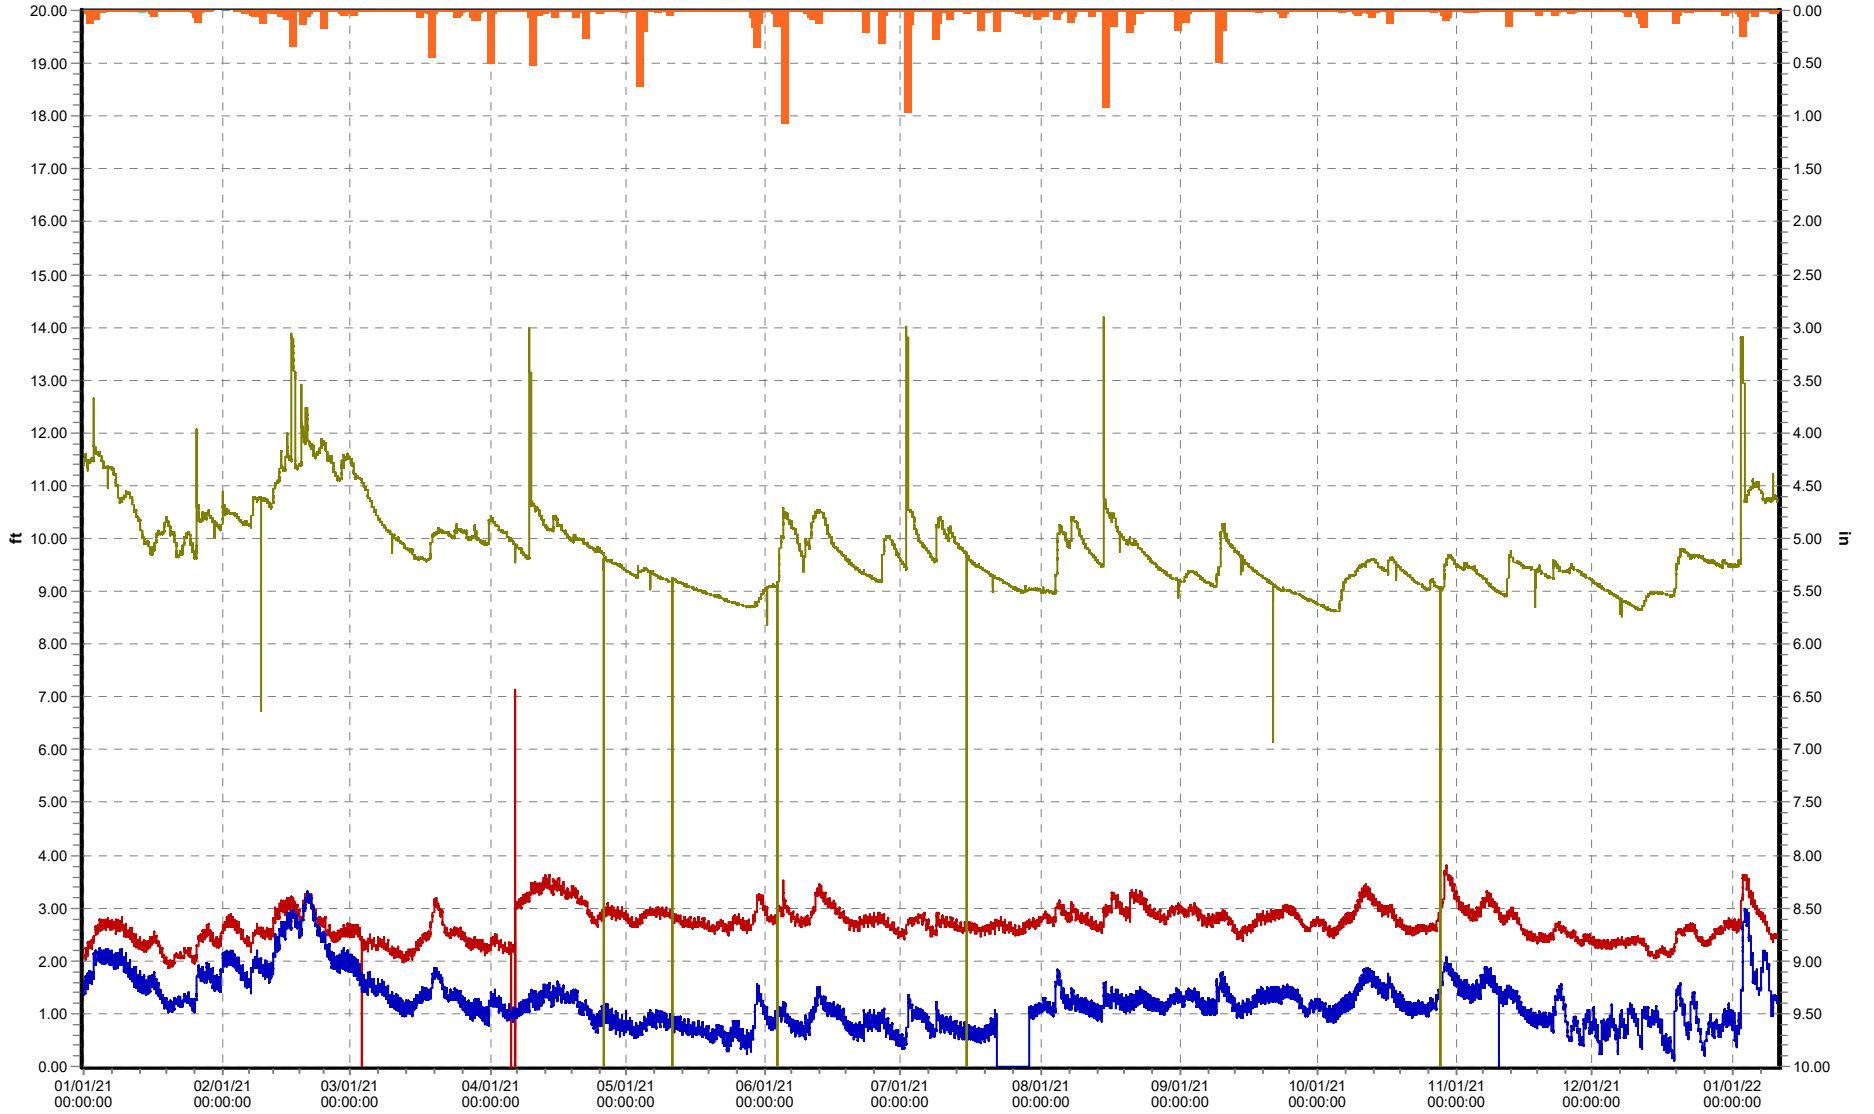
01/01/21 to 01/11/22

- MMPS - 148 Lucas Creek PS Shallow Well NAVD88
- MMPS - 180 Willard Ave PS Shallow Well NAVD88
- MMPS - 011 Copeland Park PS Shallow Well NAVD88
- MMPS - 116 Bayshore PS Rain Guage (in)

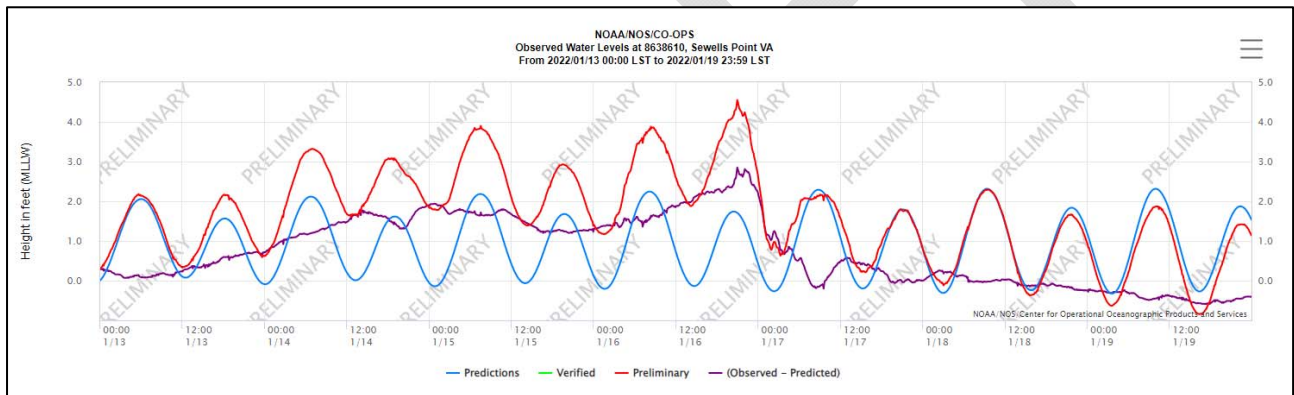
Figure 5. Preliminary data obtained from <http://tidesandcurrents.noaa.gov>

- Sewells Point Tide Station:
 - Storm Surge: An approximate 2.85-foot storm surge was observed.

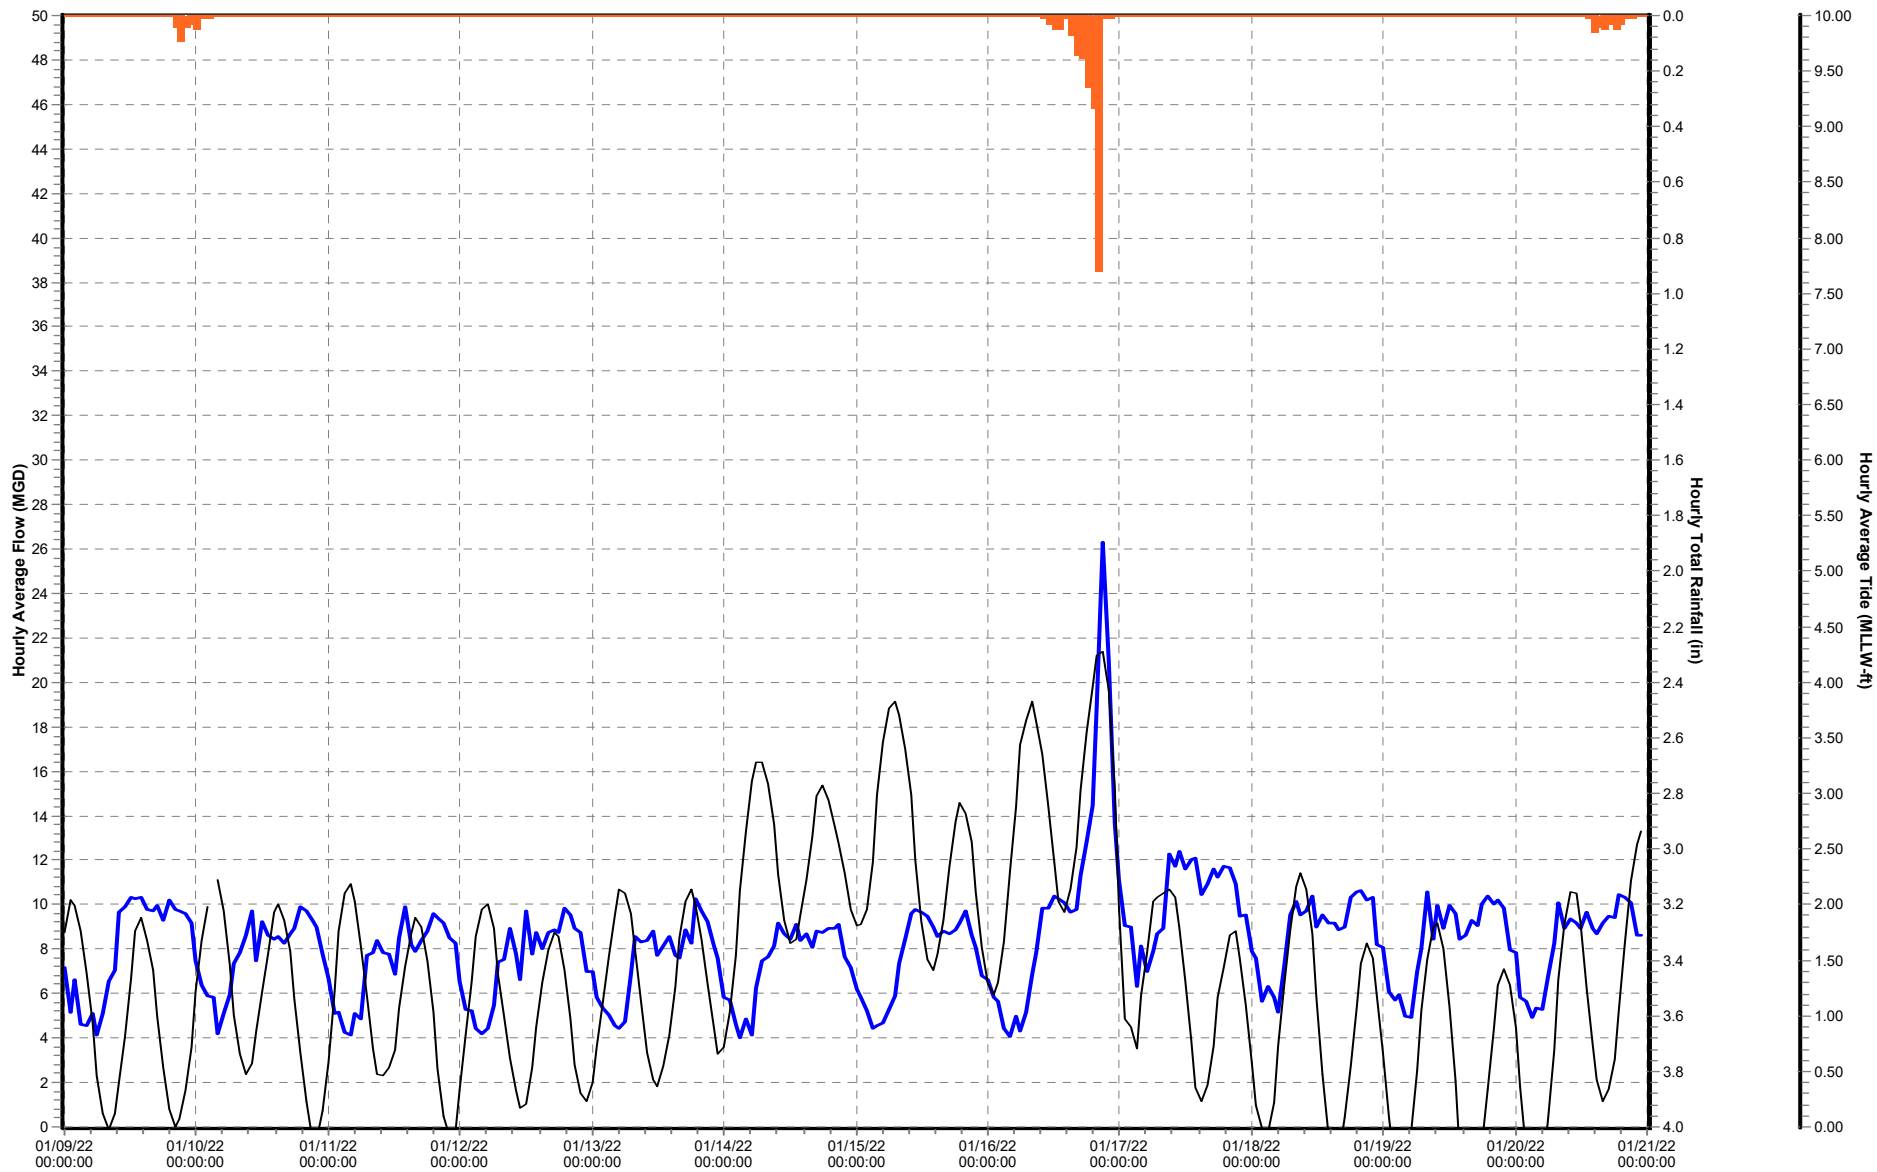
MMPS-035 (01/09/22 to 01/21/22)

MMPS-035.Flow_Effluent (MGD) MMPS-175: Taussig Blvd PS Rain Gauge SewellsPt Tide - MLLW Preliminary (ft)

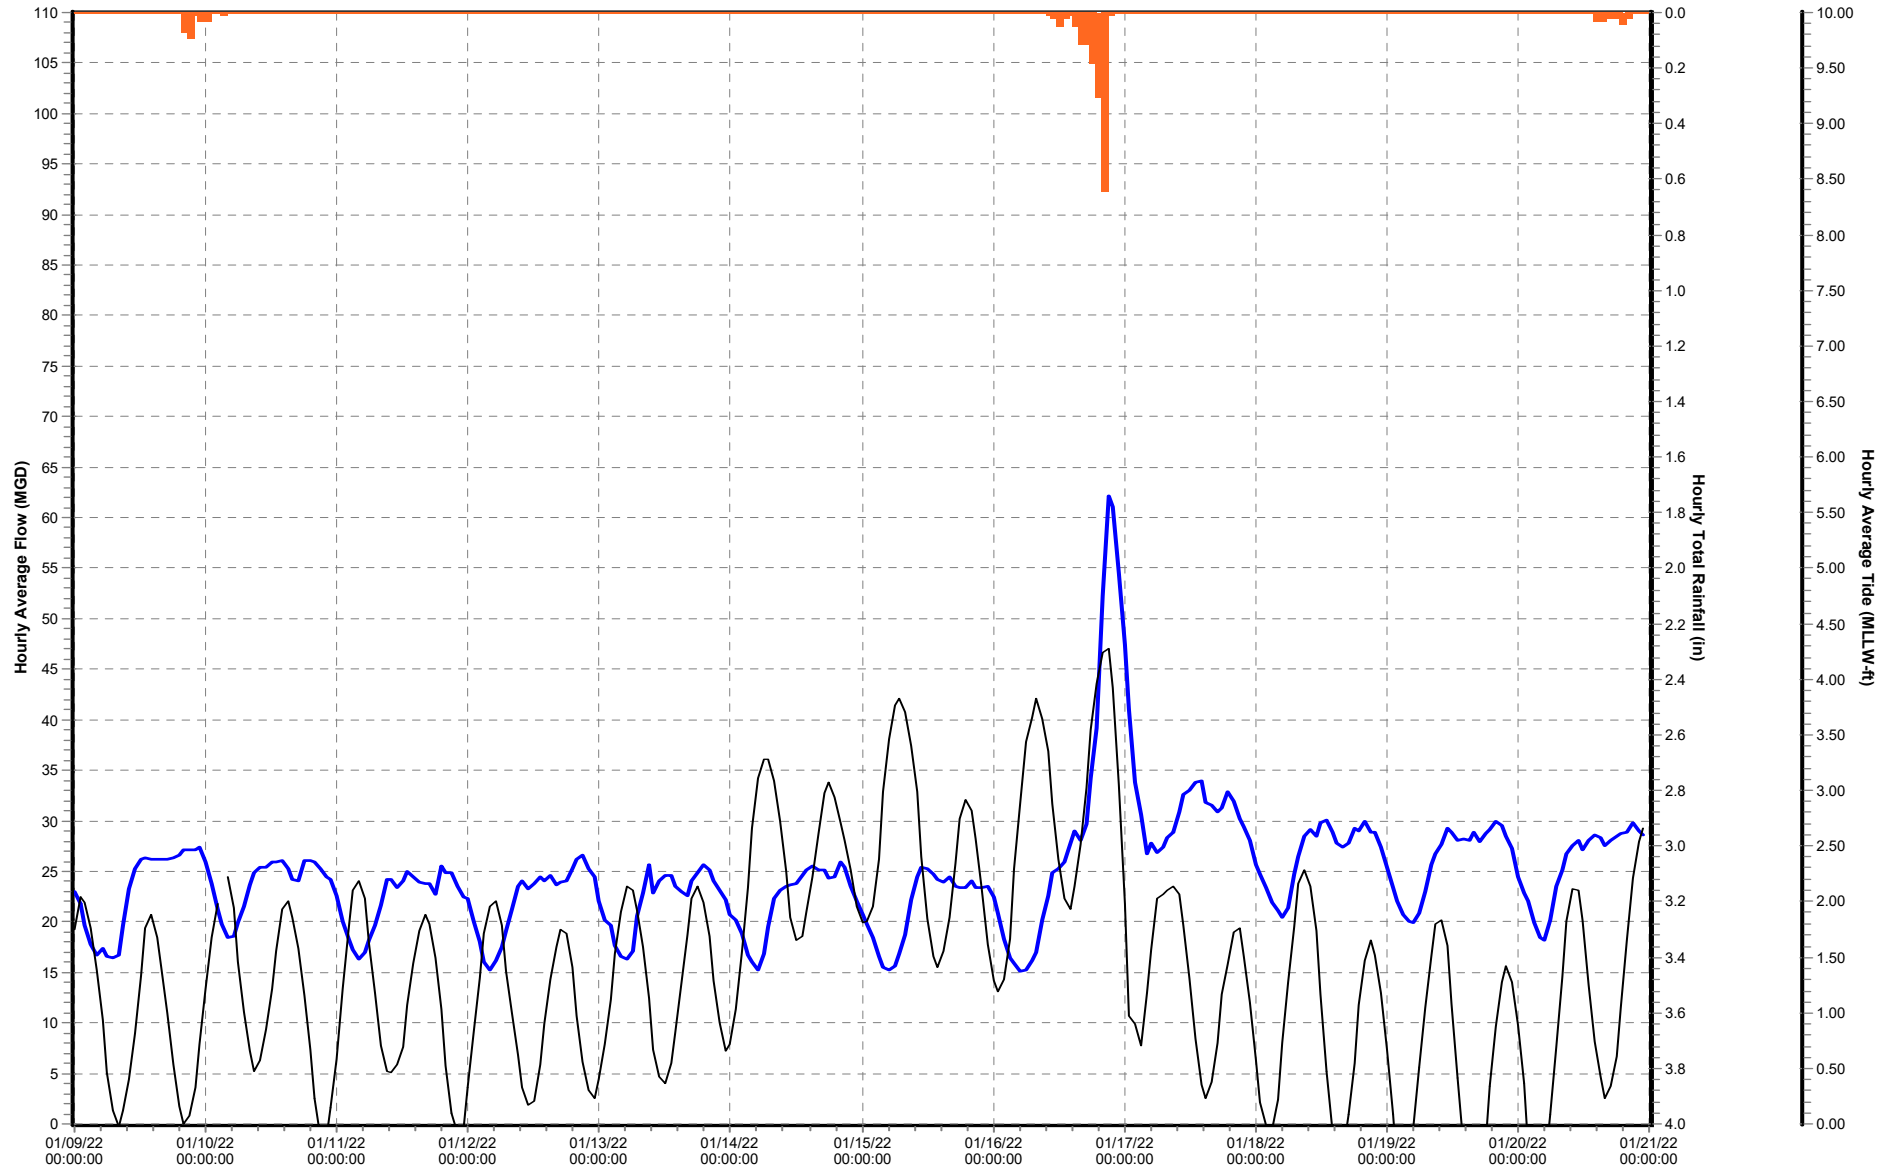
VIP Treatment Plant
MMPS-003 (01/09/22 to 01/21/22)

Flow_Effluent (MGD) MMPS-003: VIP Treatment Plant Rain Gauge SewellsPt Tide - MLLW Preliminary

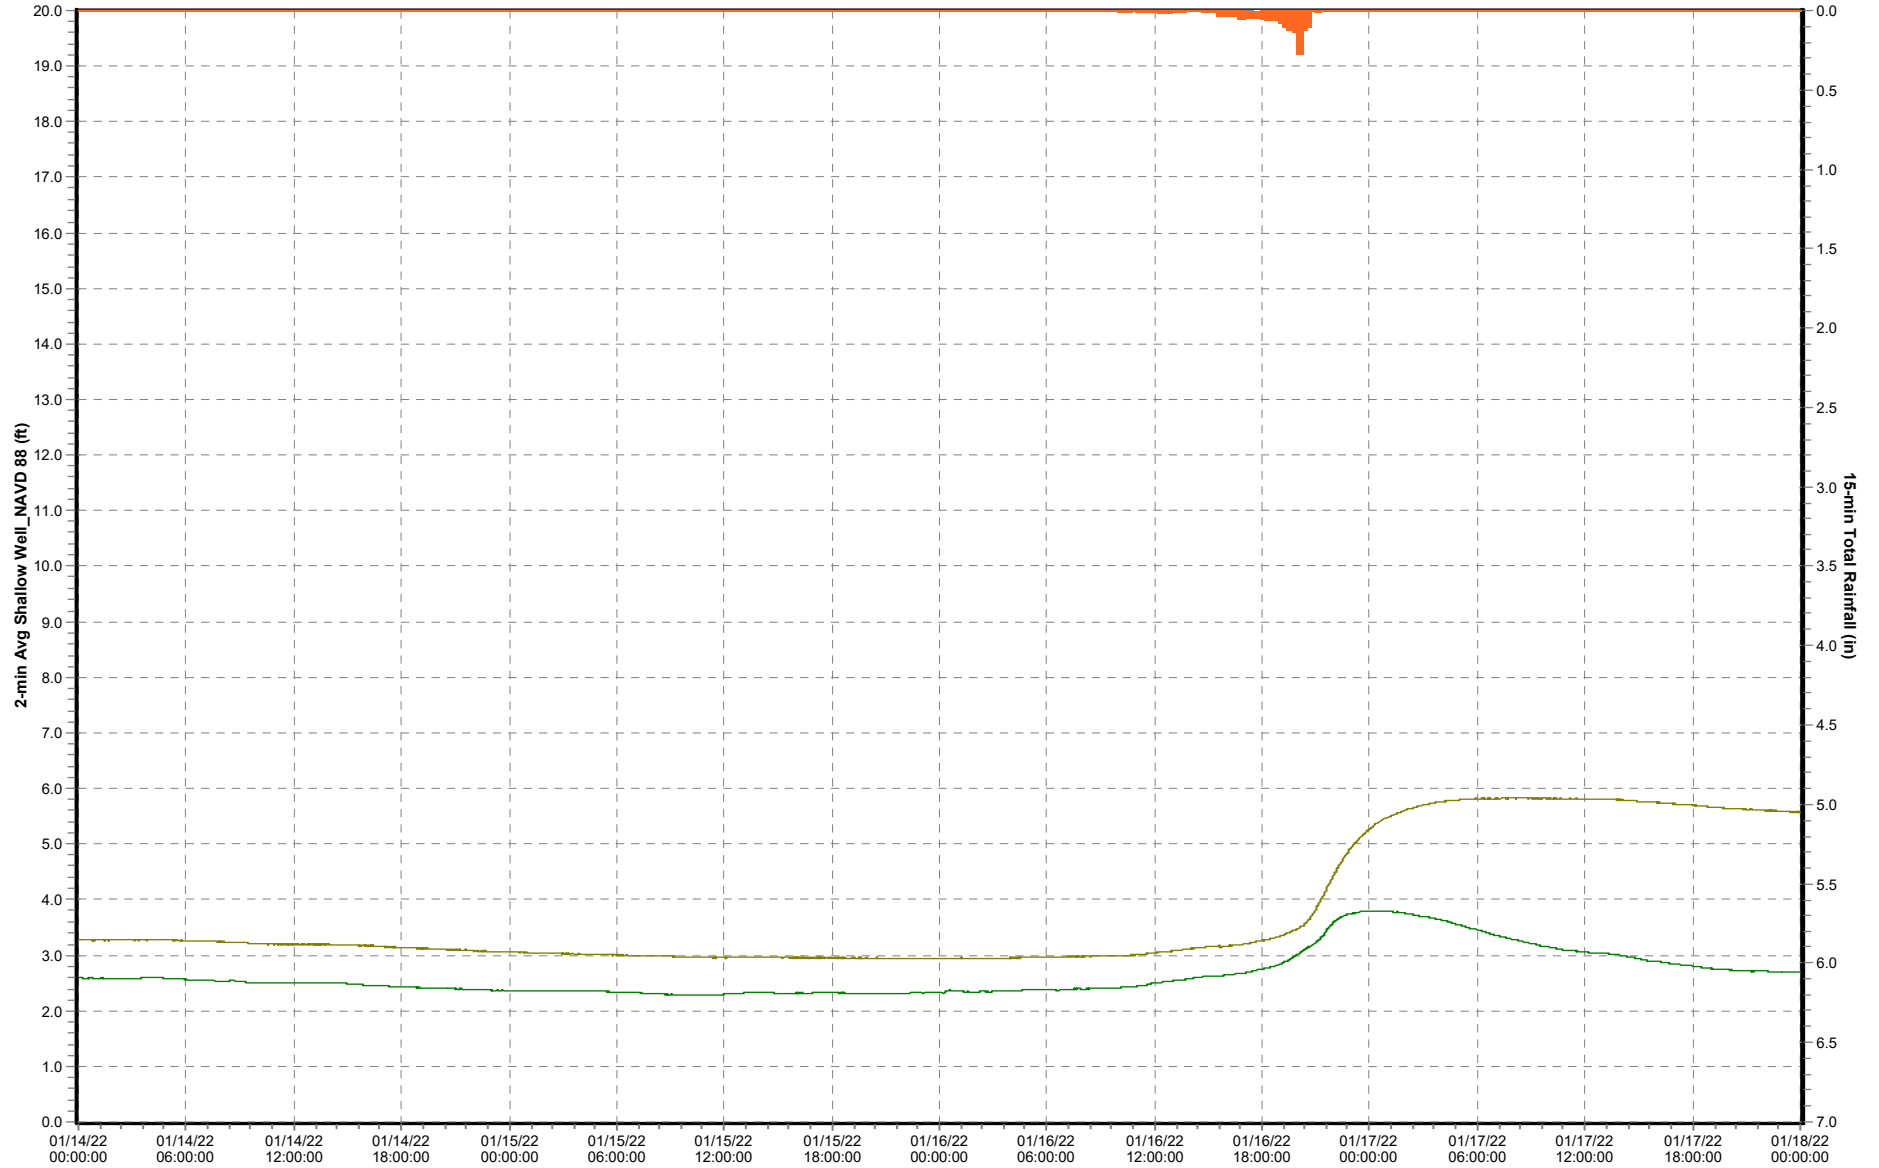
5-day
South Shore Shallow Well Graphs
01/14/22 to 01/18/22

Camden Ave PS.Shallow Well_NAVD 88 (ft) Newtown Rd PS.Shallow Well_NAVD 88 (ft) Rodman Ave PS. Rain Gauge (in)
