QUARTERLY REPORT
JANUARY 1 – MARCH 31, 2022

Hampton Roads Sanitation District
1434 Air Rail Avenue
Virginia Beach, VA 23455

June 17, 2022

Post-Storm Report

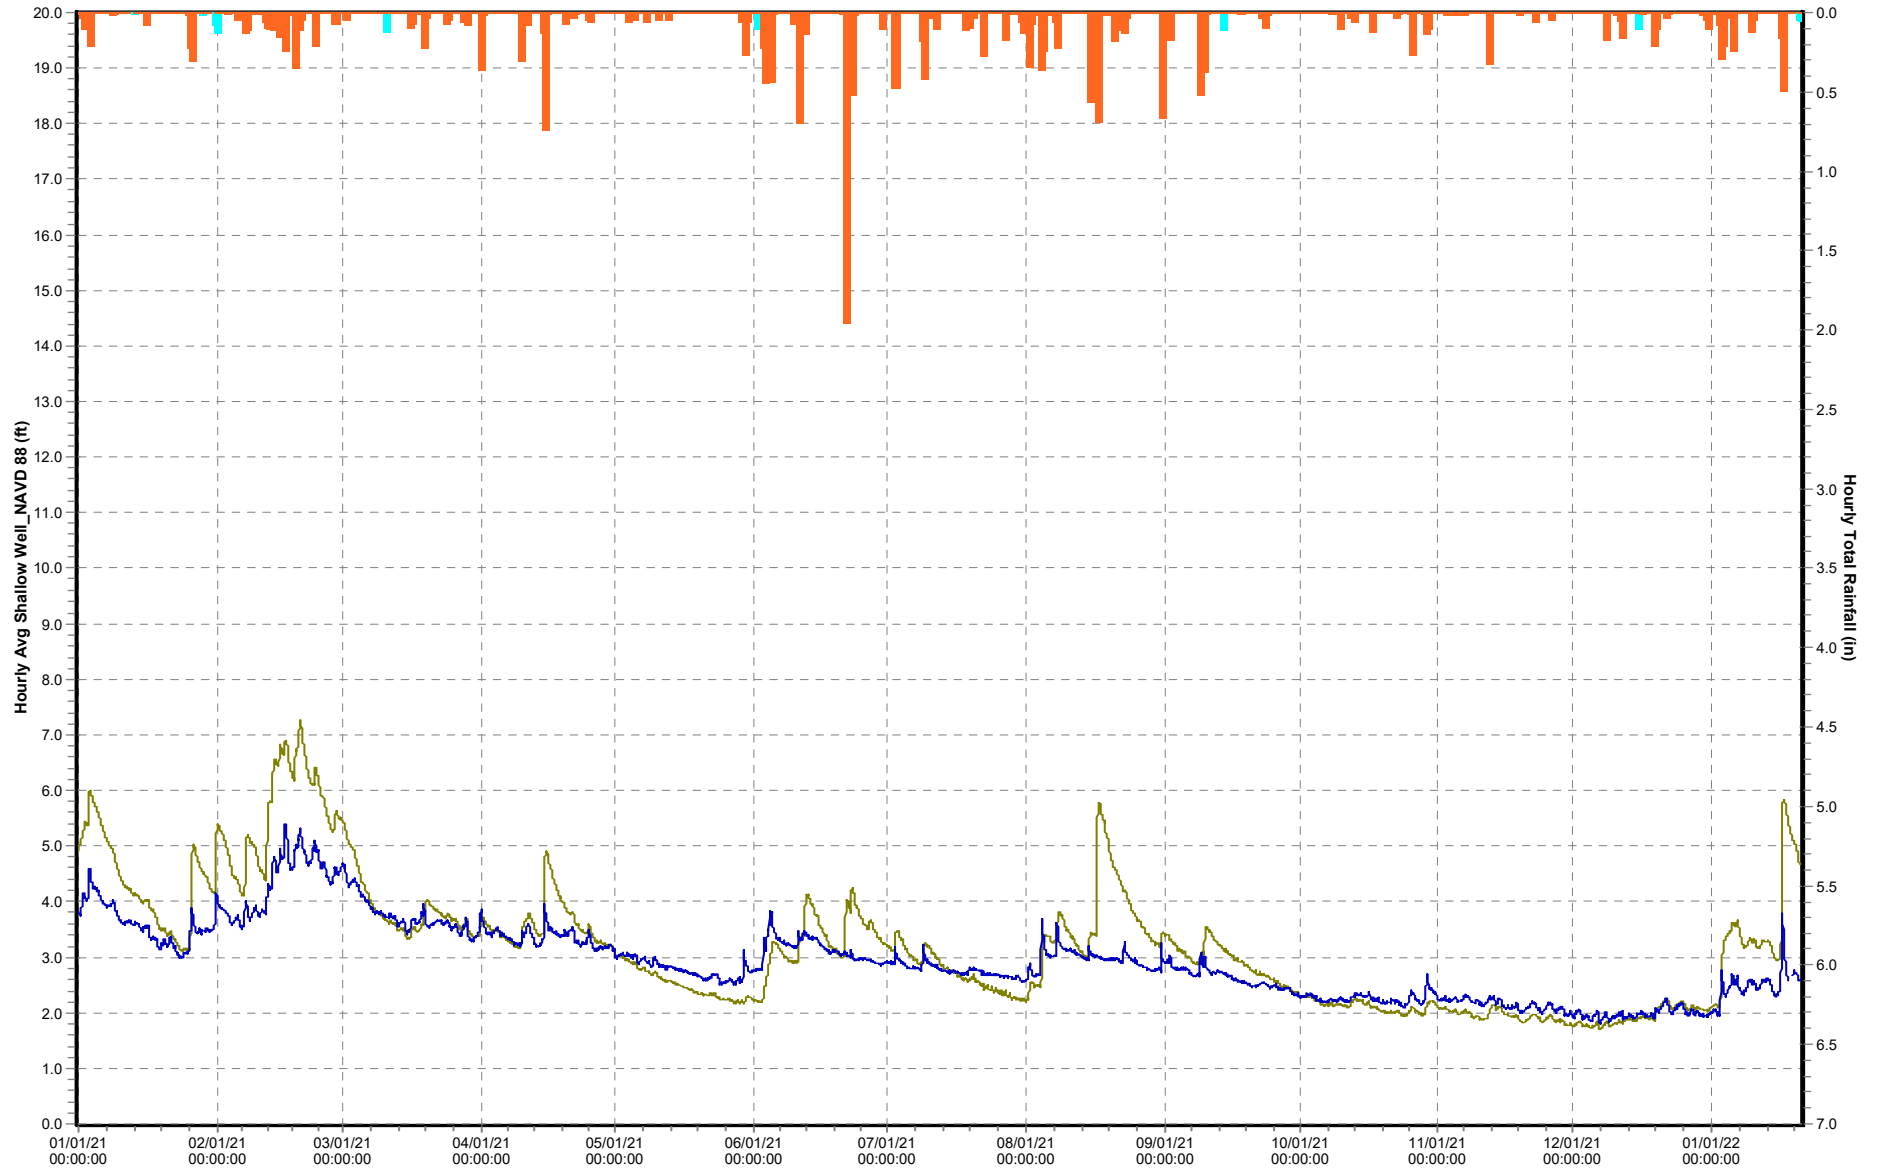
1-year
South Shore Shallow Well Graphs
01/01/21 to 01/21/22

Camden Ave PS.Shallow Well_NAVD 88 (ft) Newtown Rd PS.Shallow Well_NAVD 88 (ft) Rodman Ave PS. Rain Gauge (in)

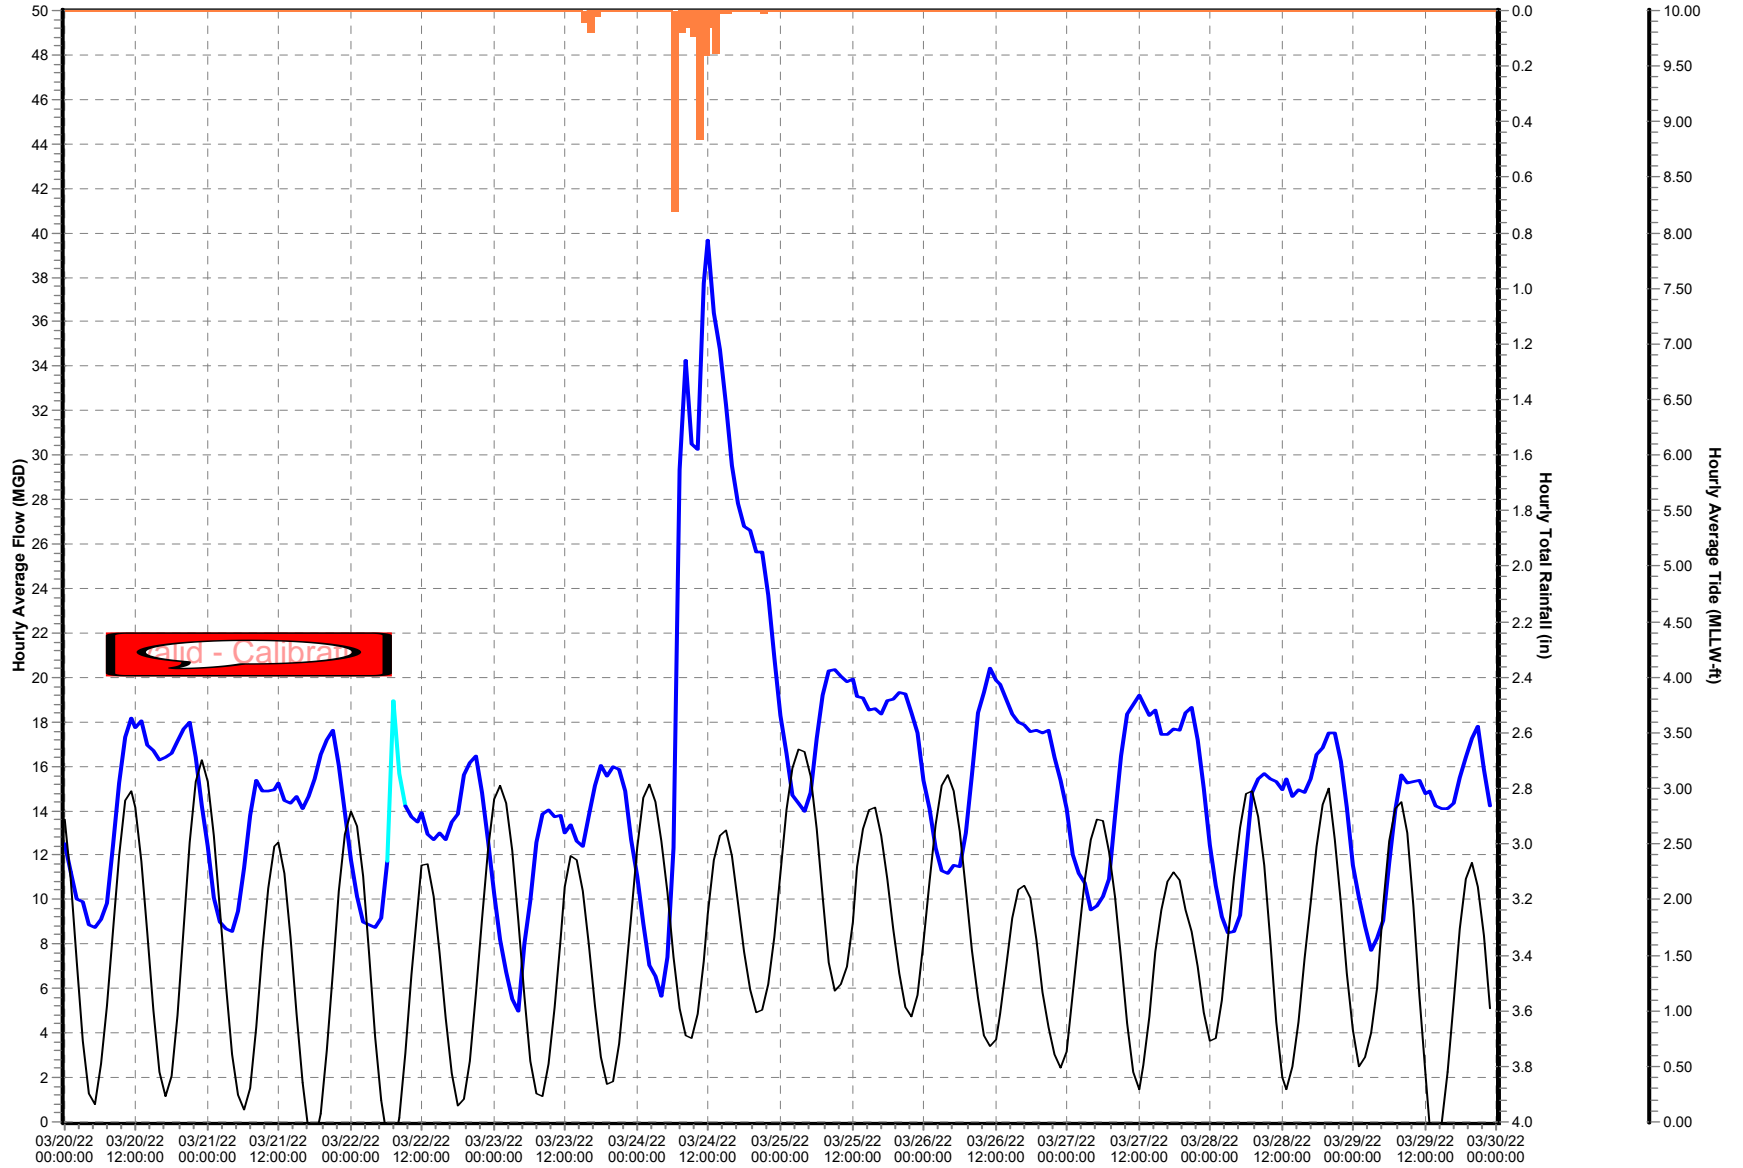
James River Treatment Plant
MMPS-184 (03/20/22 to 03/30/22)

Flow_Influent (MGD) Rainfall @ JRTP SewellsPt Tide - MLLW Preliminary (ft)

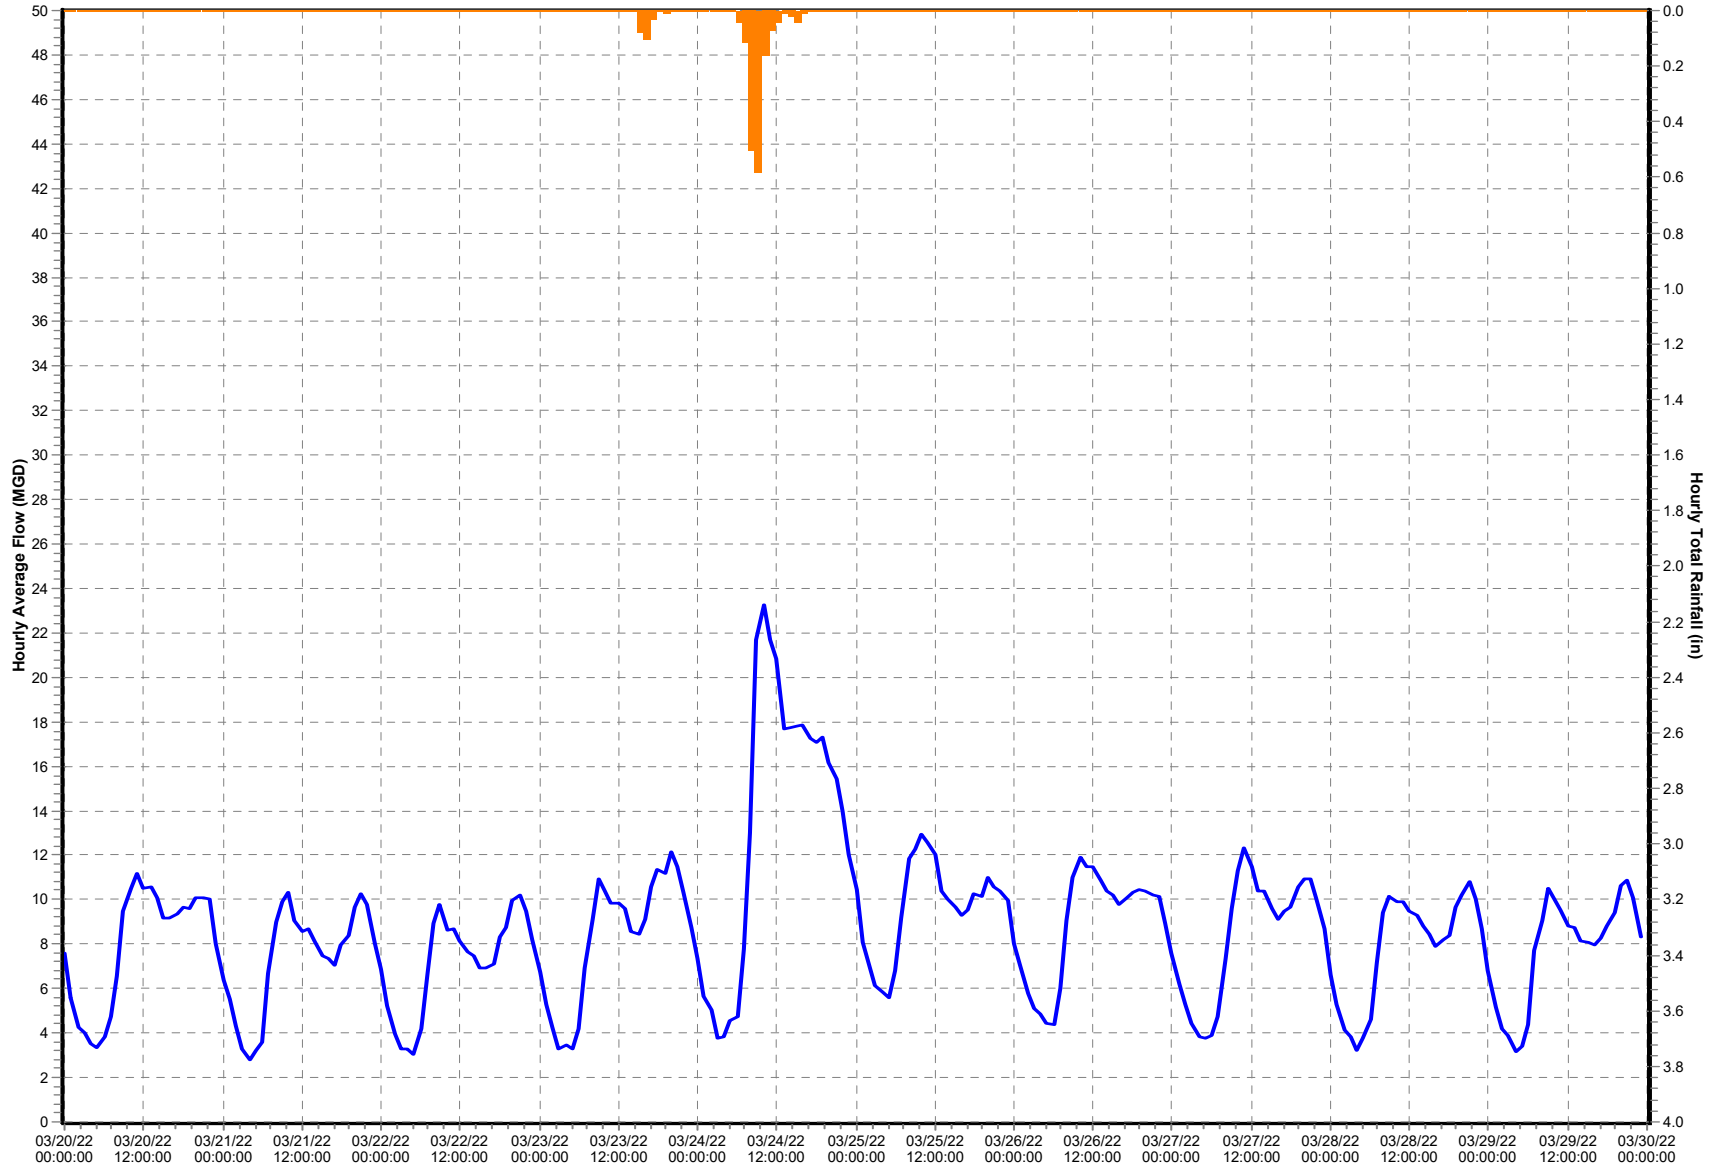
MMPS-222 (03/20/22 to 03/30/22)

Flow_Effluent (MGD) Rainfall @ WBTP

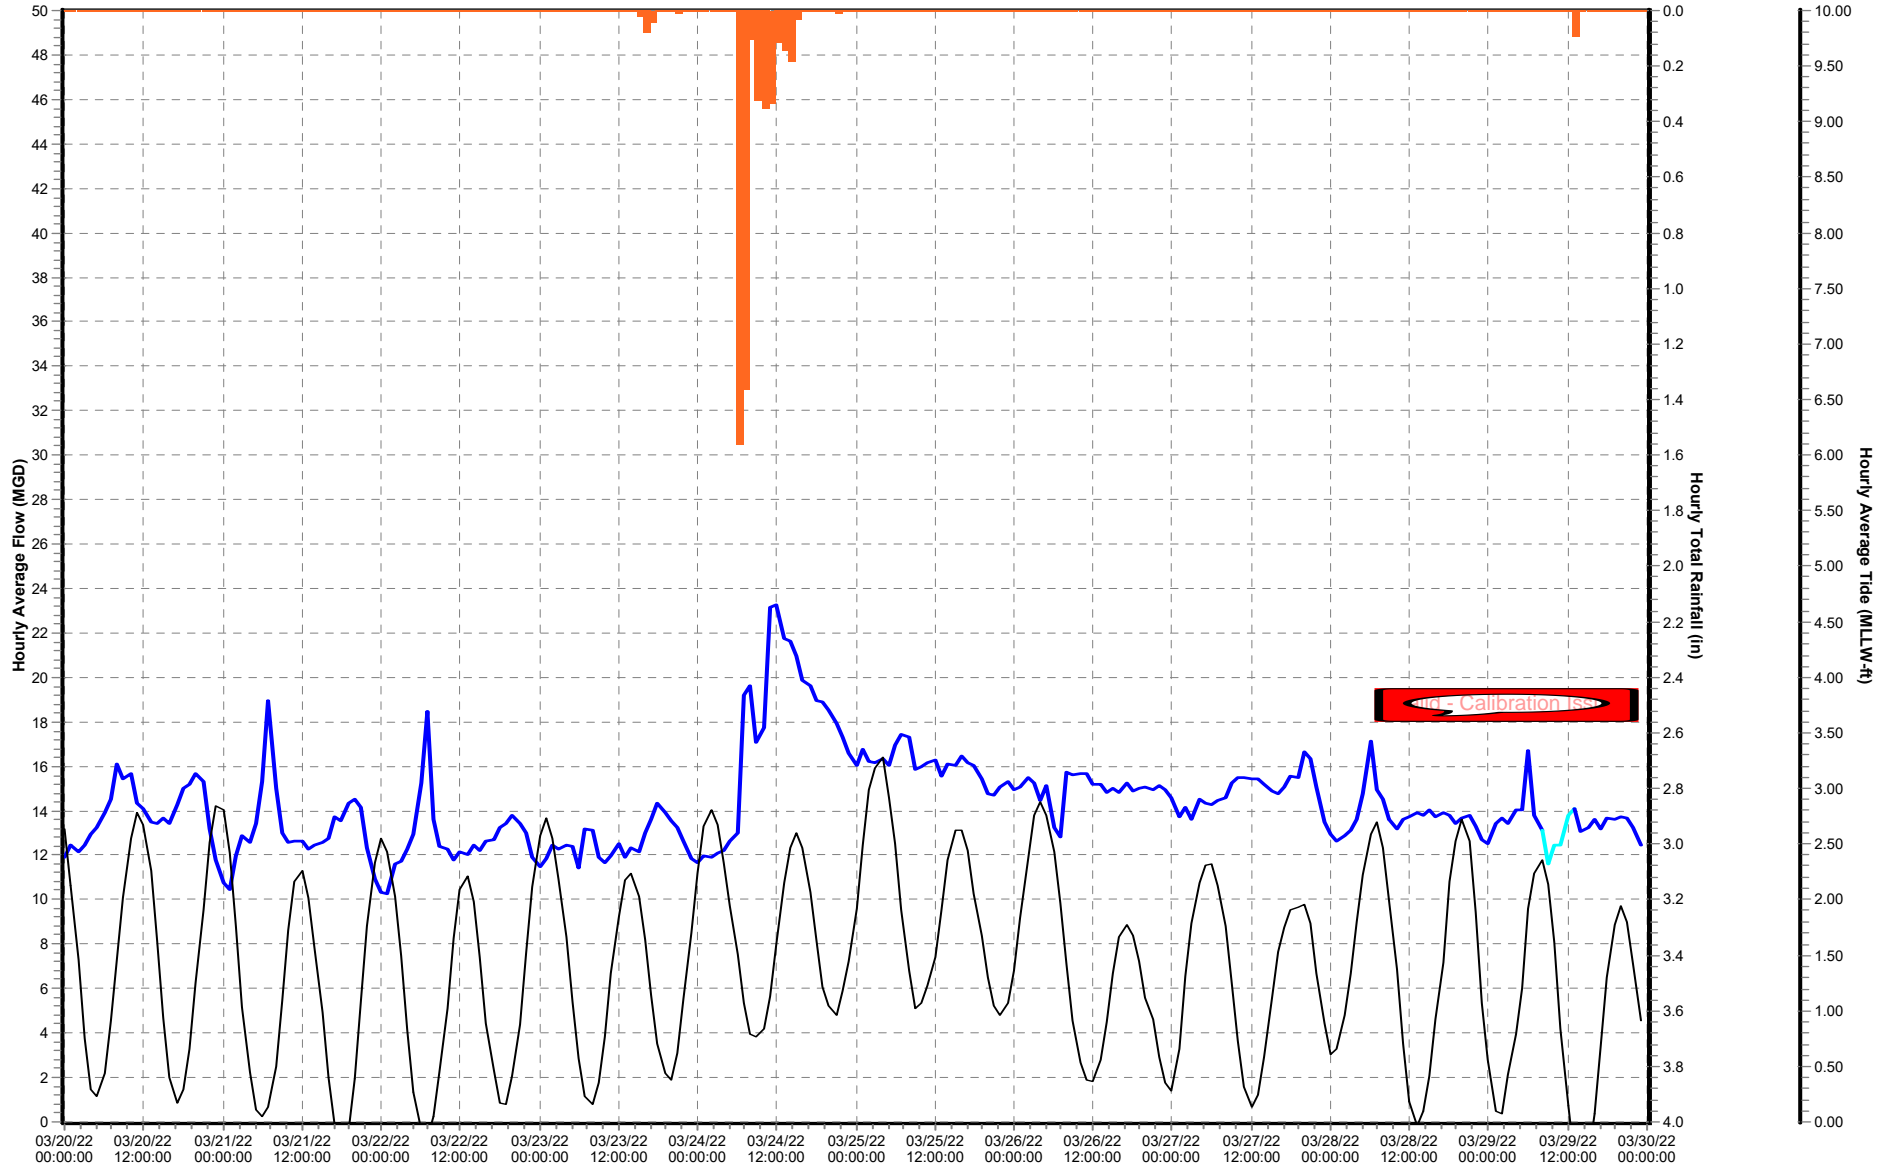
MMPS-235 (03/20/22 to 03/30/22)

Flow_Influent (MGD) Rain Gauge (in) YorktownUSCG Tide - MLLW Preliminary (ft)

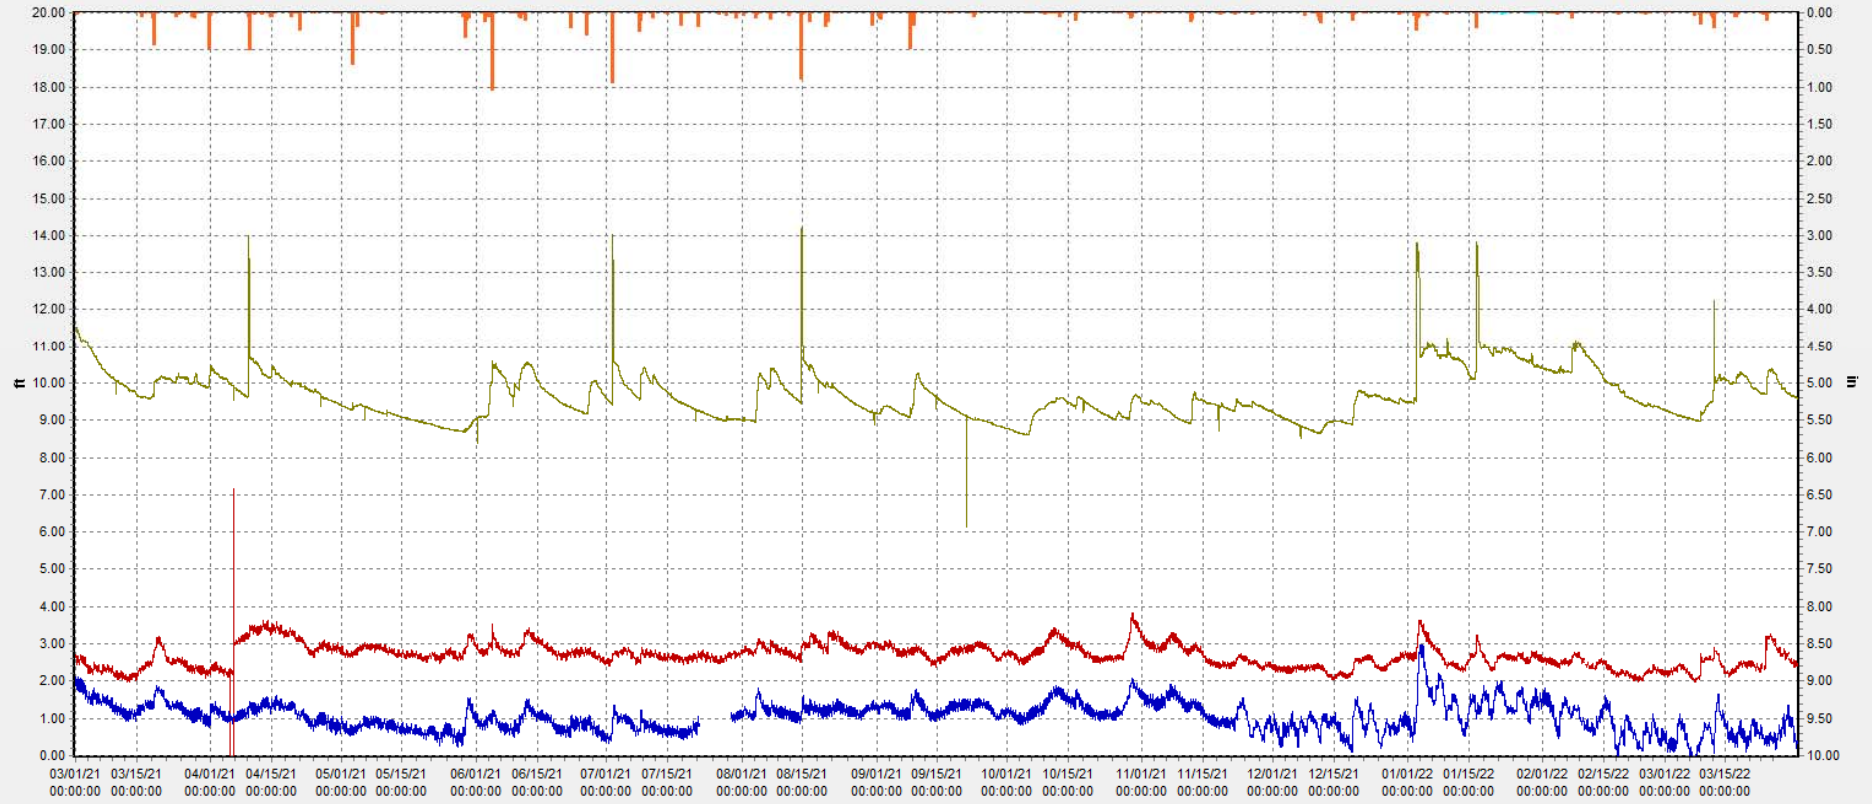
MMPS-148 (03/01/21 to 03/31/22)

MMPS - 148 Lucas Creek PS Shallow Well NAVD88 MMPS - 180 Willard Ave PS Shallow Well NAVD88 MMPS - 011 Copeland Park PS Shallow Well NAVD88 MMPS - 116 Bayshore PS Rain Guage (in)
