QUARTERLY REPORT
JULY 1 – SEPTEMBER 30, 2022

Hampton Roads Sanitation District

APPENDIX A. POST-STORM SYNOPSES REPORTS

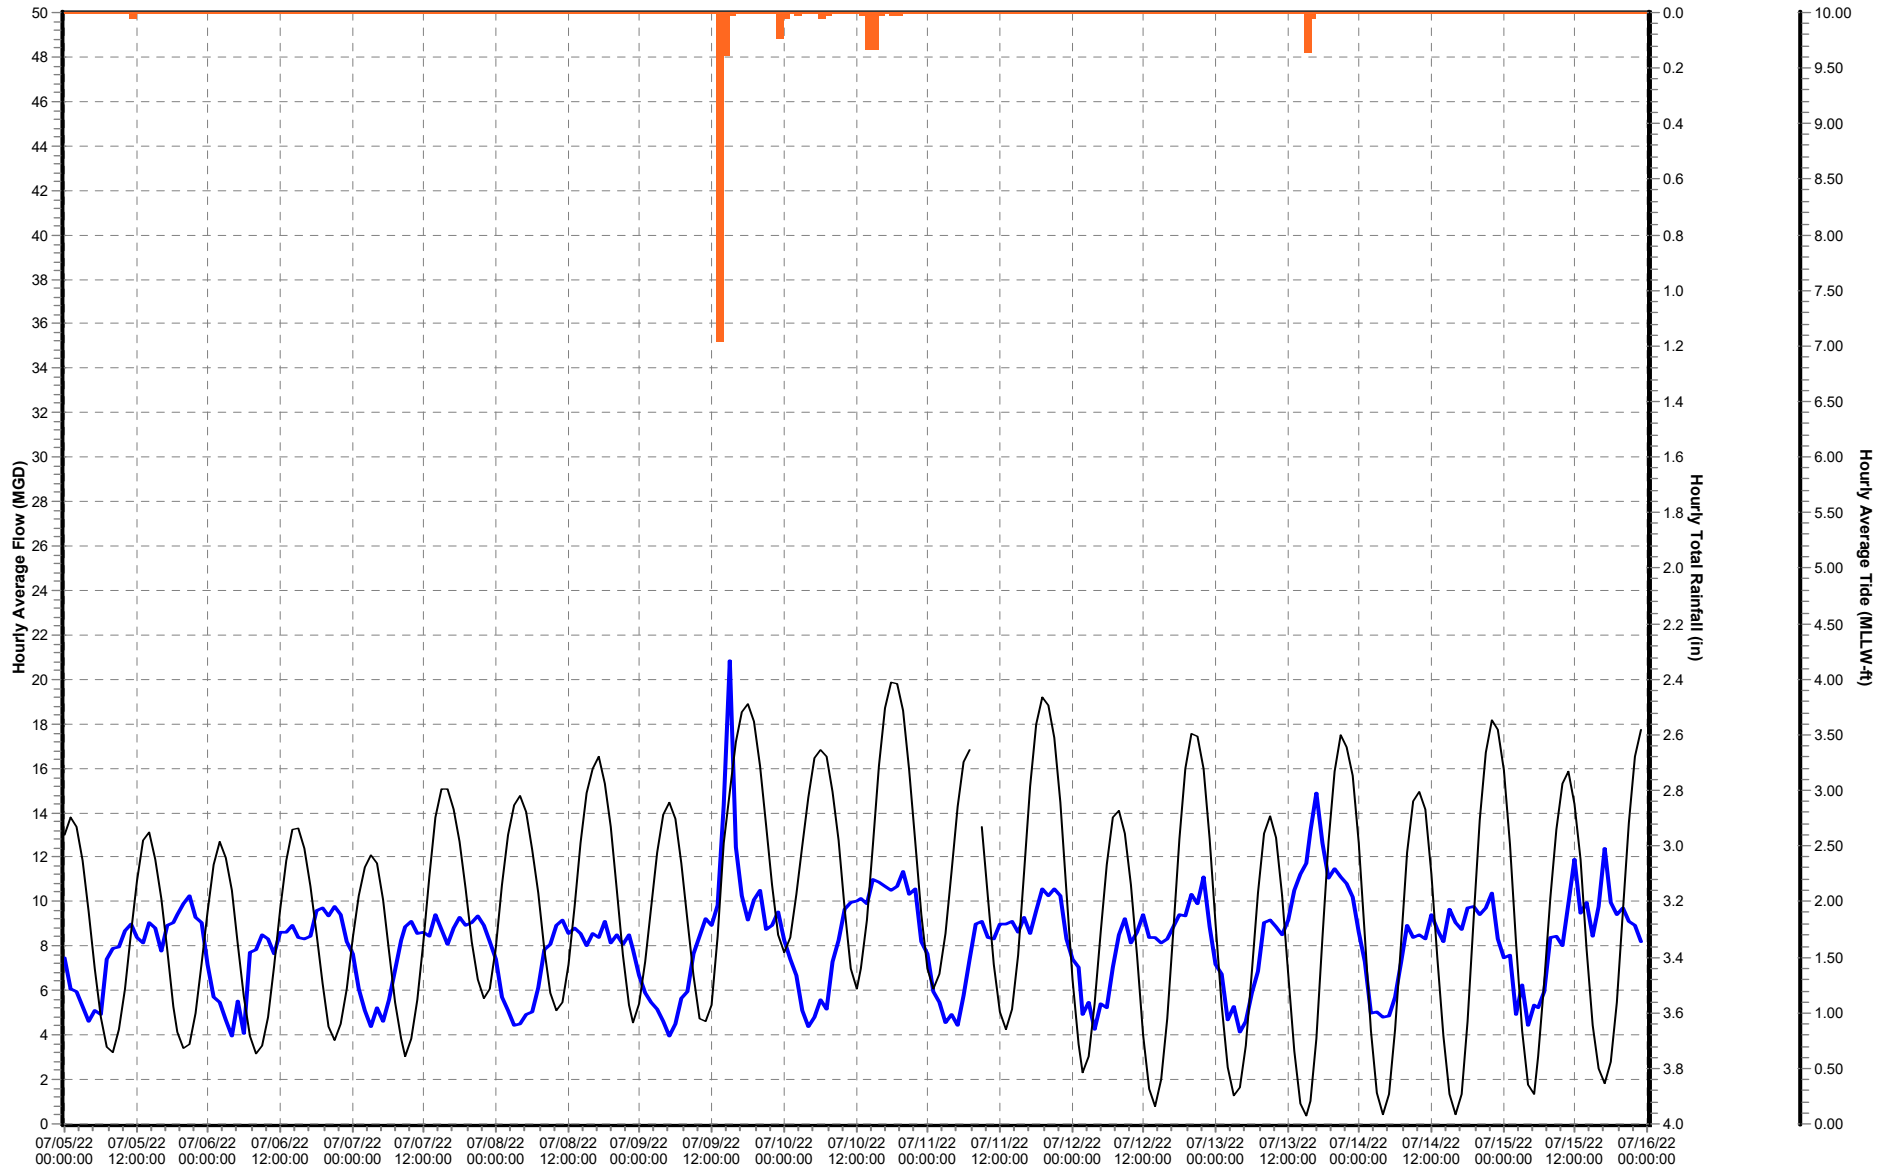
MMPS-035 (07/05/22 to 07/16/22)

MMPS-035.Flow_Effluent (MGD) MMPS-175: Taussig Blvd PS Rain Gauge SewellsPt Tide - MLLW Preliminary (ft)

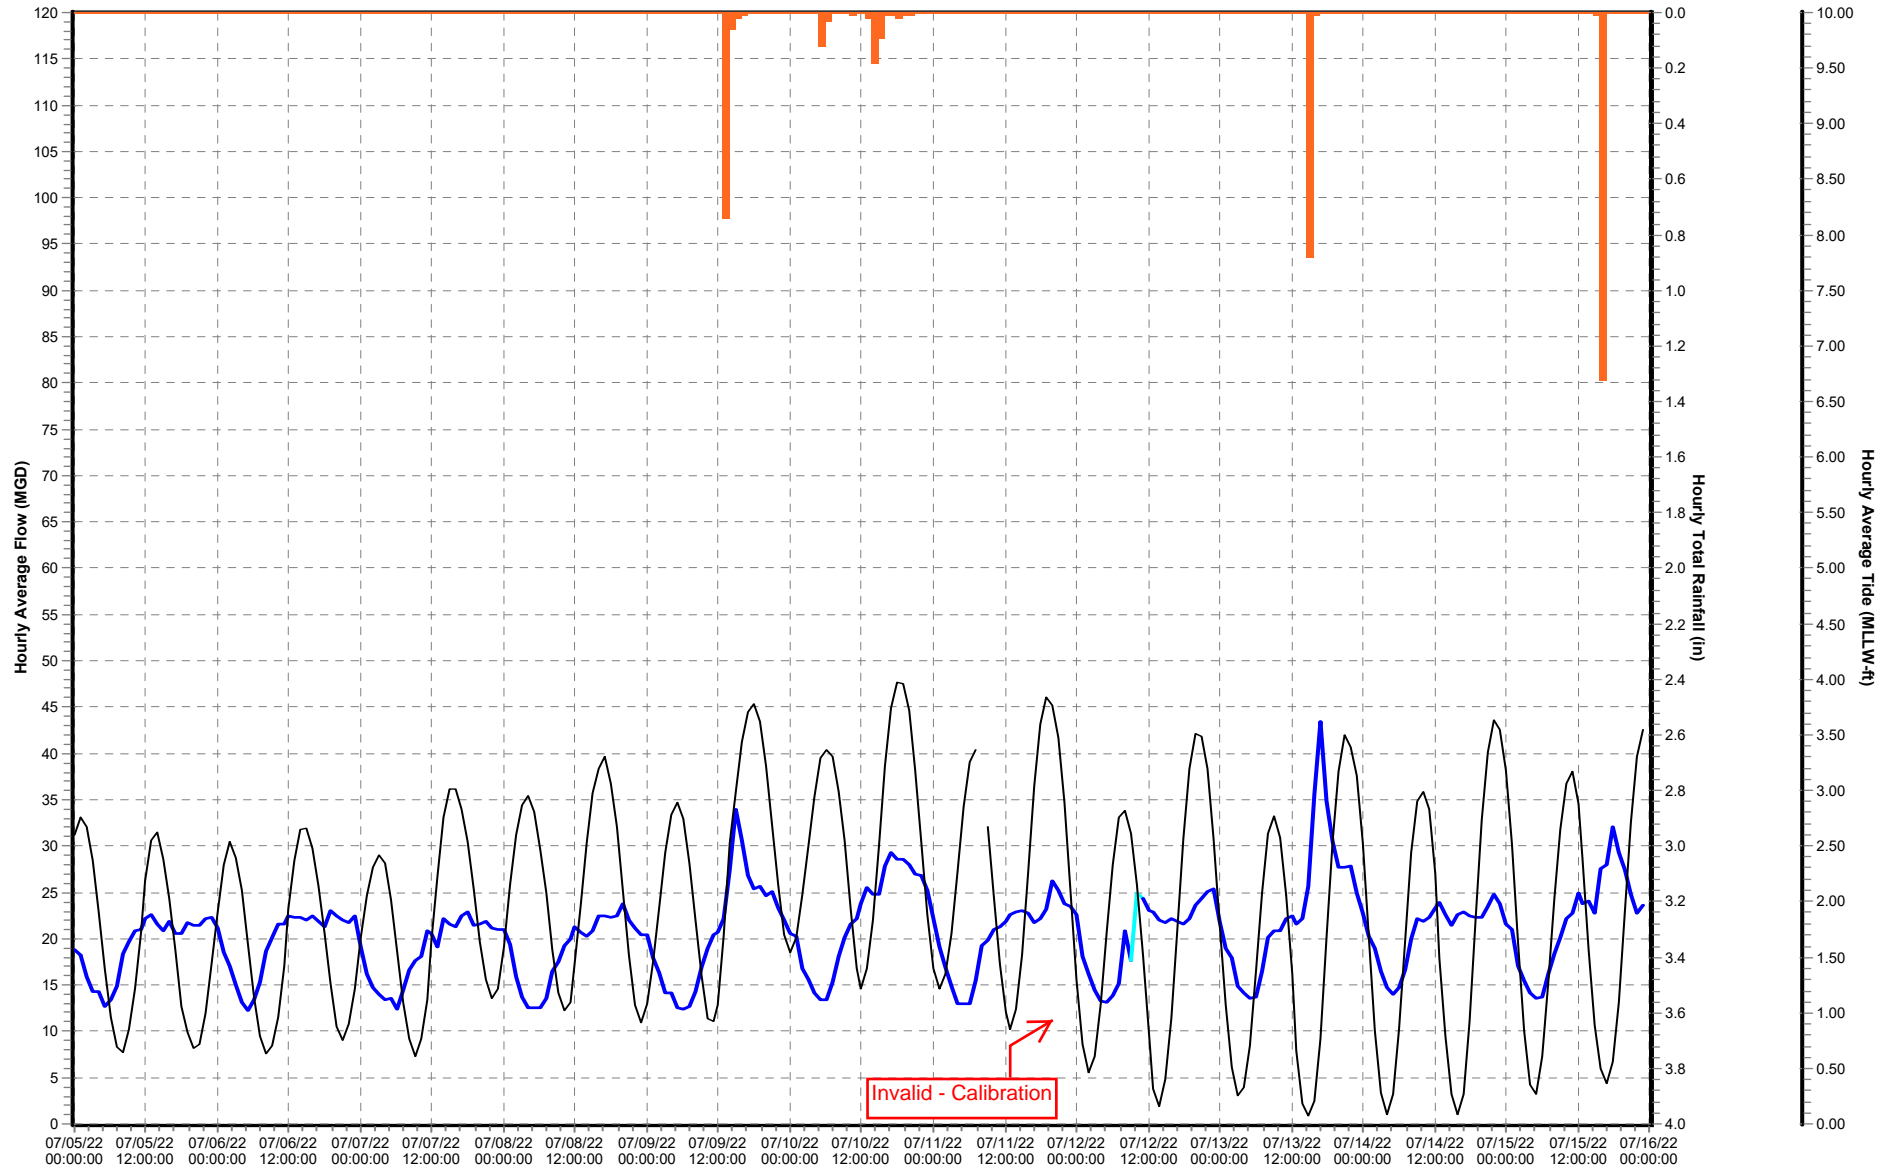
VIP Treatment Plant
MMPS-003 (07/05/22 to 07/16/22)

Flow_Effluent (MGD) MMPS-003: VIP Treatment Plant Rain Gauge SewellsPt Tide - MLLW Preliminary

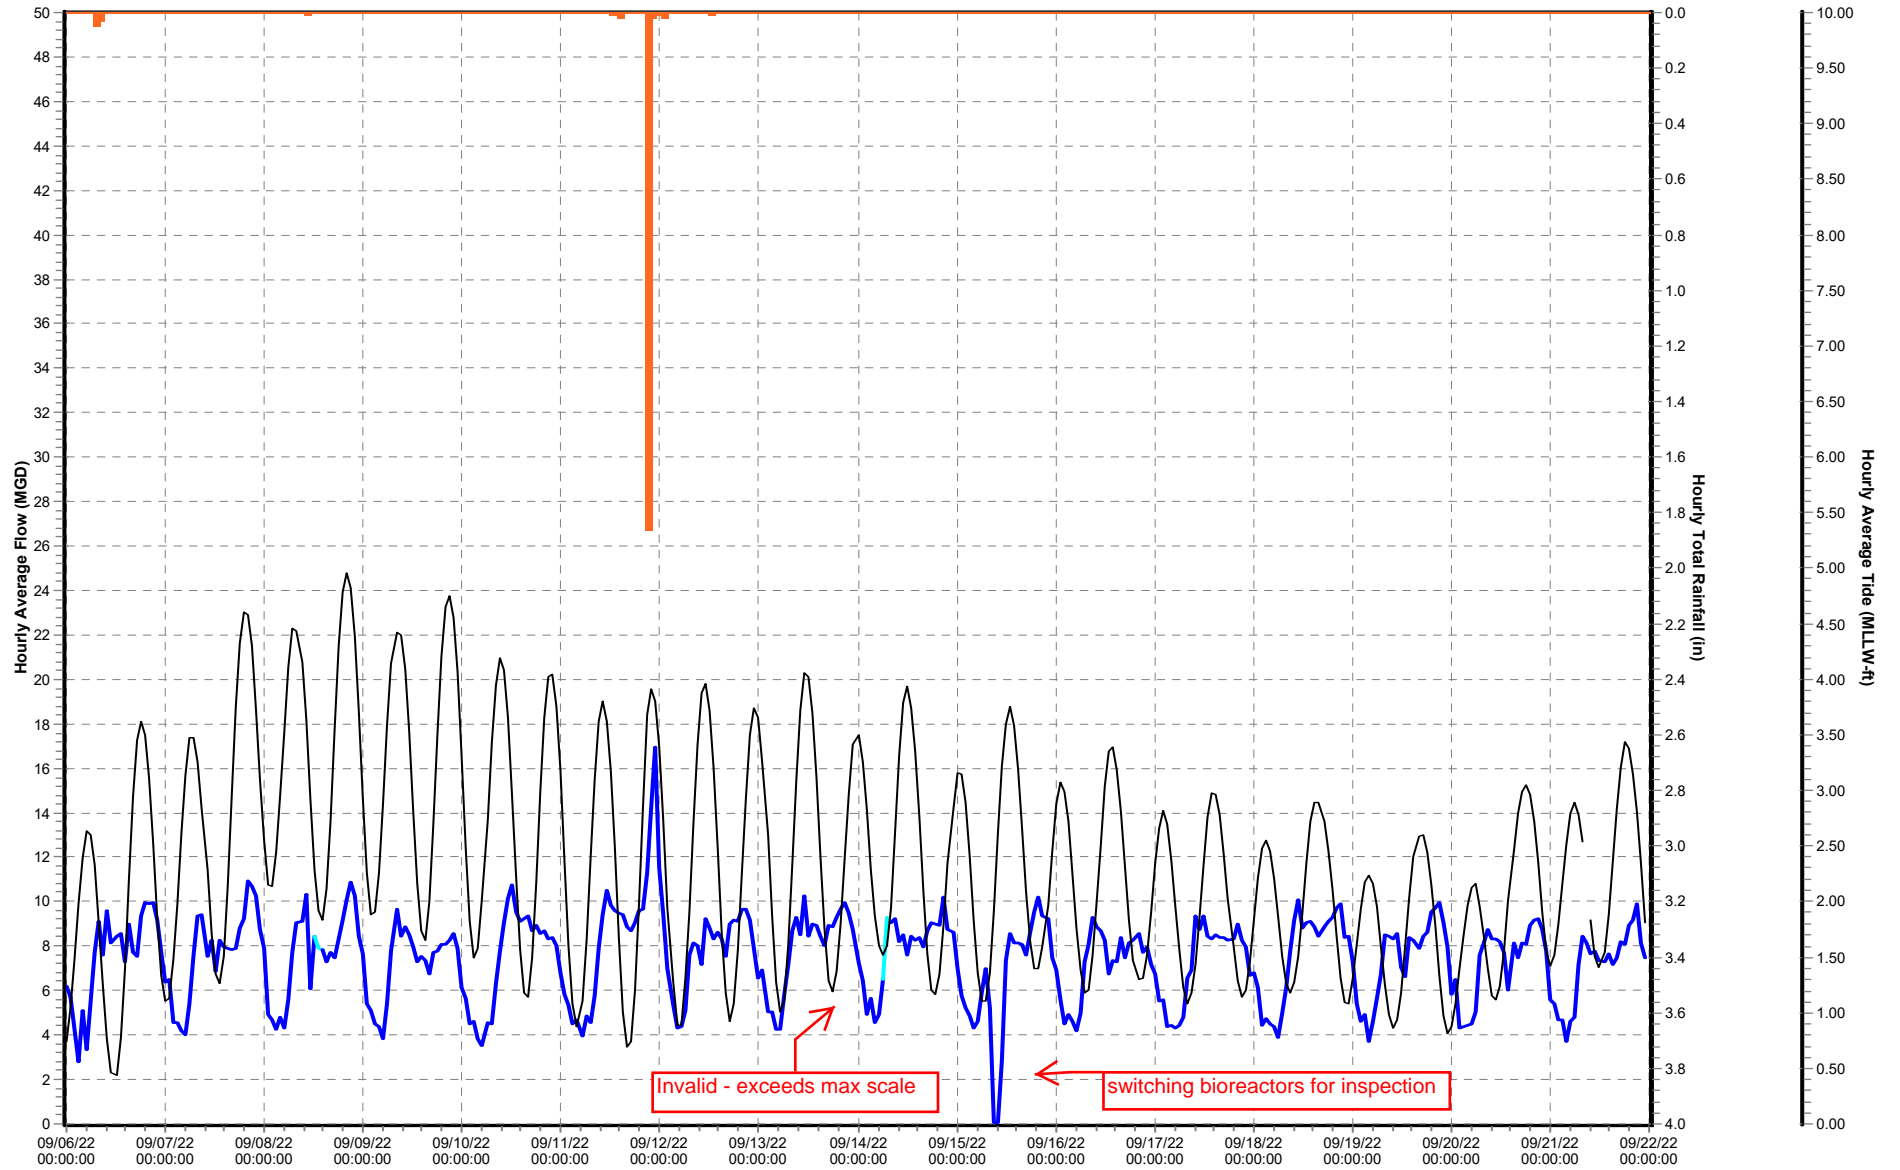
MMPS-035 (09/06/22 to 09/22/22)

MMPS-035.Flow_Effluent (MGD) MMPS-175: Taussig Blvd PS Rain Gauge SewellsPt Tide - MLLW Preliminary (ft)
