QUARTERLY REPORT
January 1 – March 31, 2026

Hampton Roads Sanitation District
1434 Air Rail Avenue
Virginia Beach, VA 23455

Post-Storm Report

February 22, 2026

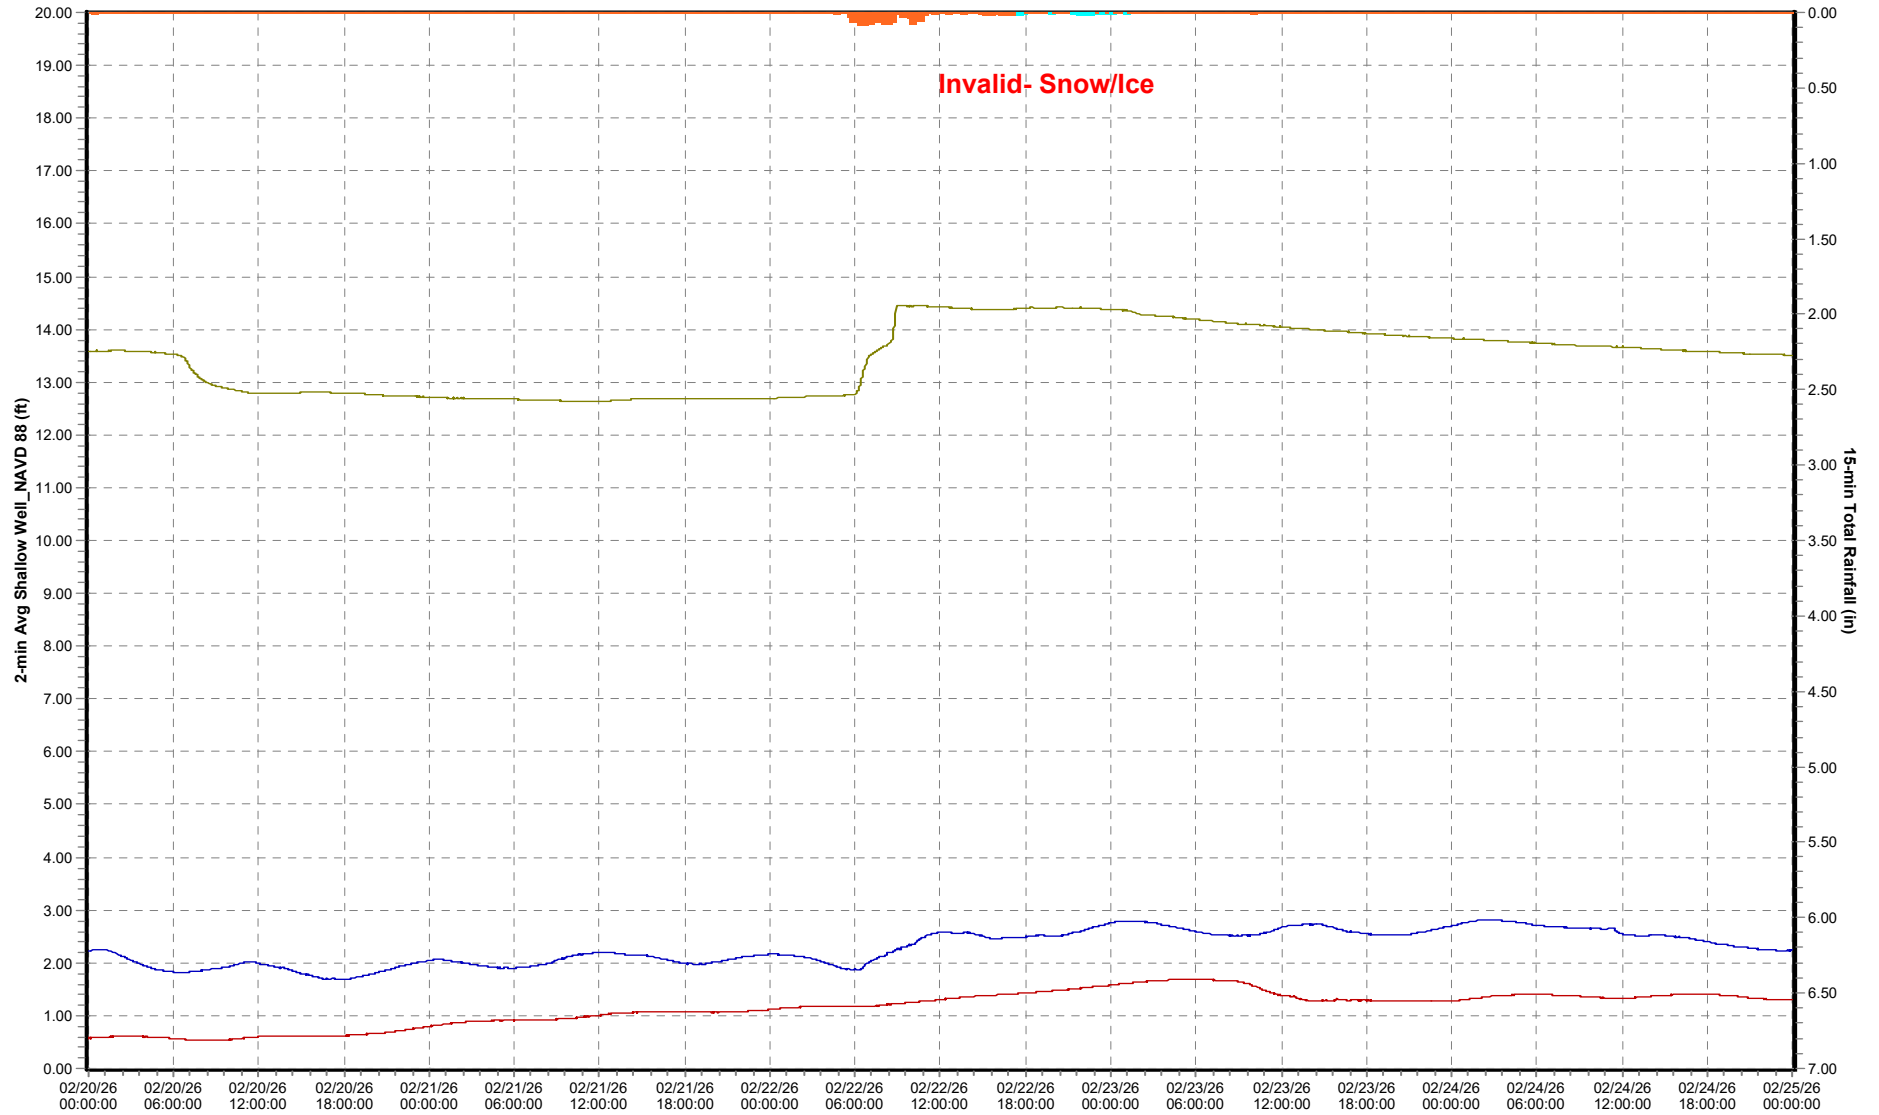
North Shore Shallow Well Graphs

Shallow wells are located at/or near HRSD Pump Stations to measure groundwater levels. The water column is measured using a pressure transducer located near the bottom of the well. The installed sensor measures gauge pressure in inches of water. The Shallow Well_NAVD88 measurement referenced in Appendix C refers to the elevation (referenced as NAVD 88) of the sensor plus the gauge measurement in feet.

02/20/26 to 02/25/26

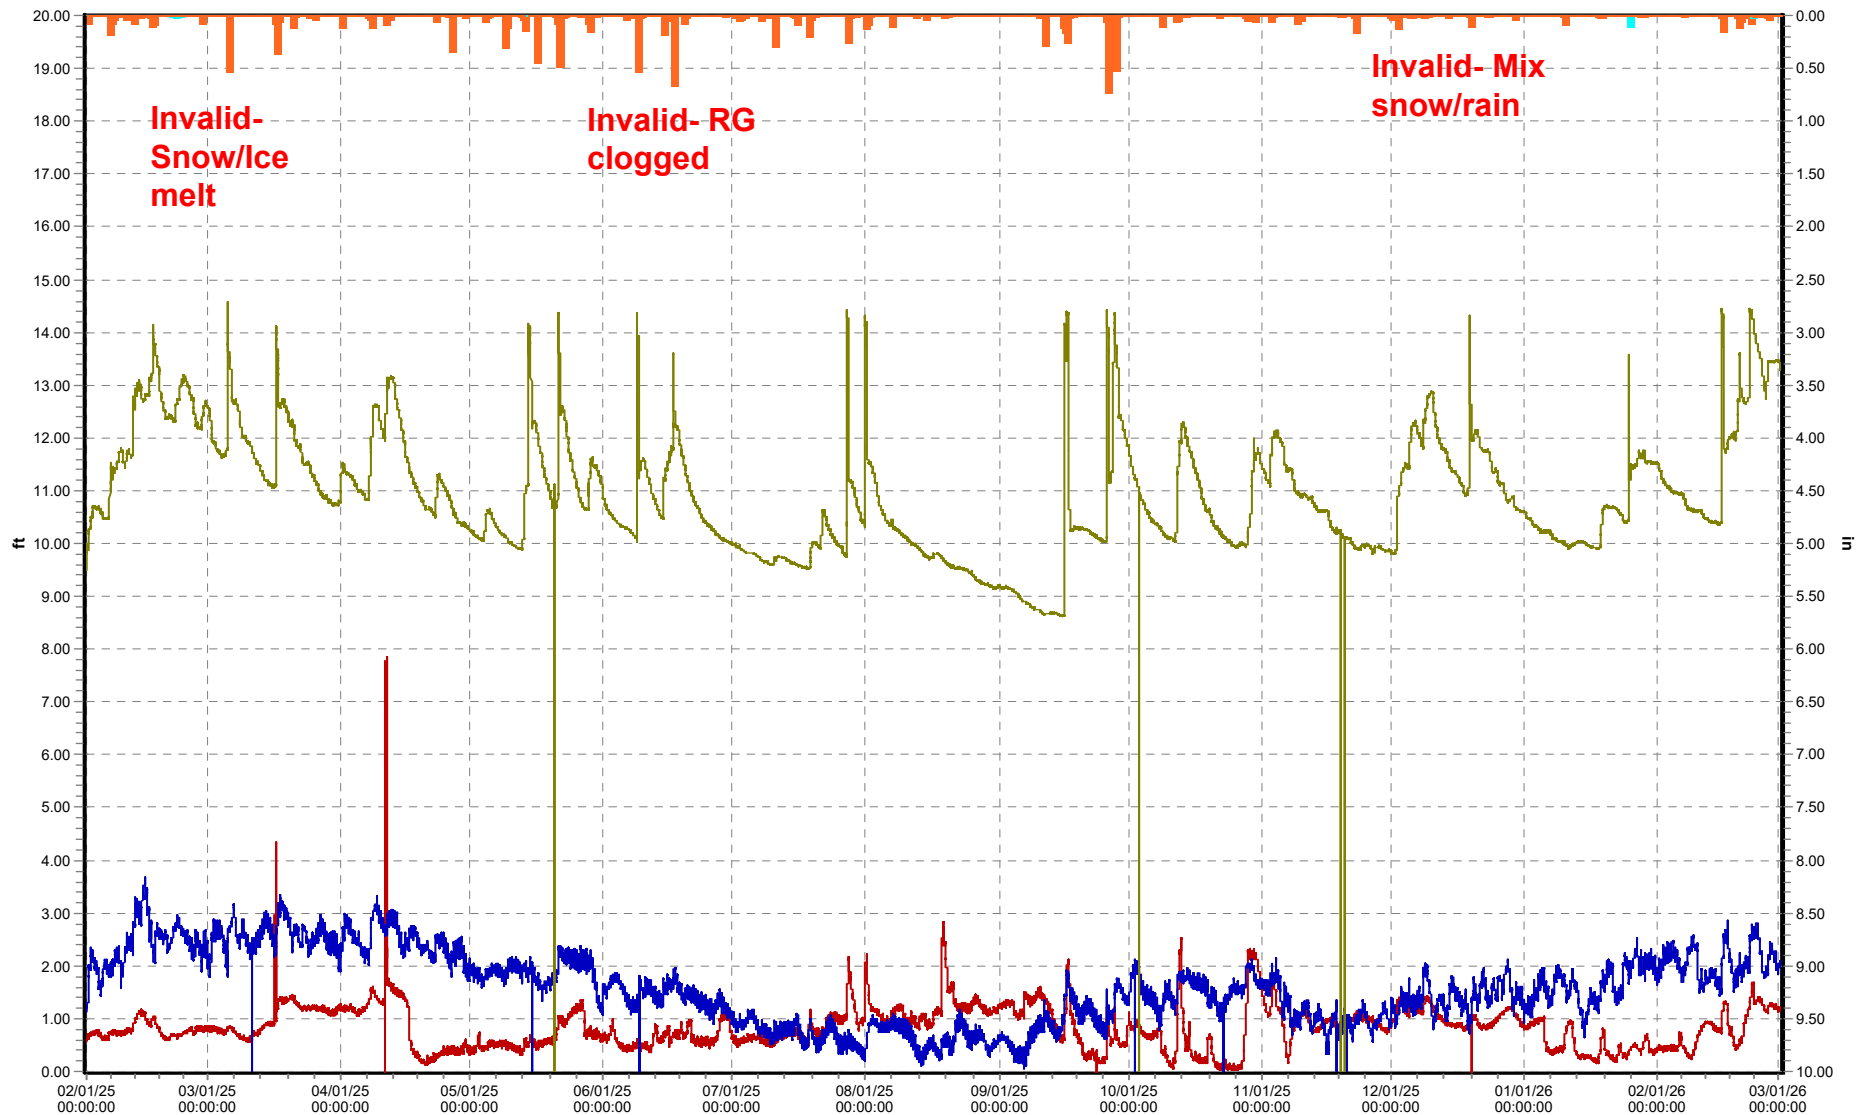
HRSD NP - Lucas Creek PS

MMPS-148 (02/01/25 to 03/01/26)
