Phase I Environmental Site Assessment Hartman Avenue Pump Station Onancock, Virginia 23417

Hampton Roads Sanitation District

Project number: 60669159

August 23, 2022

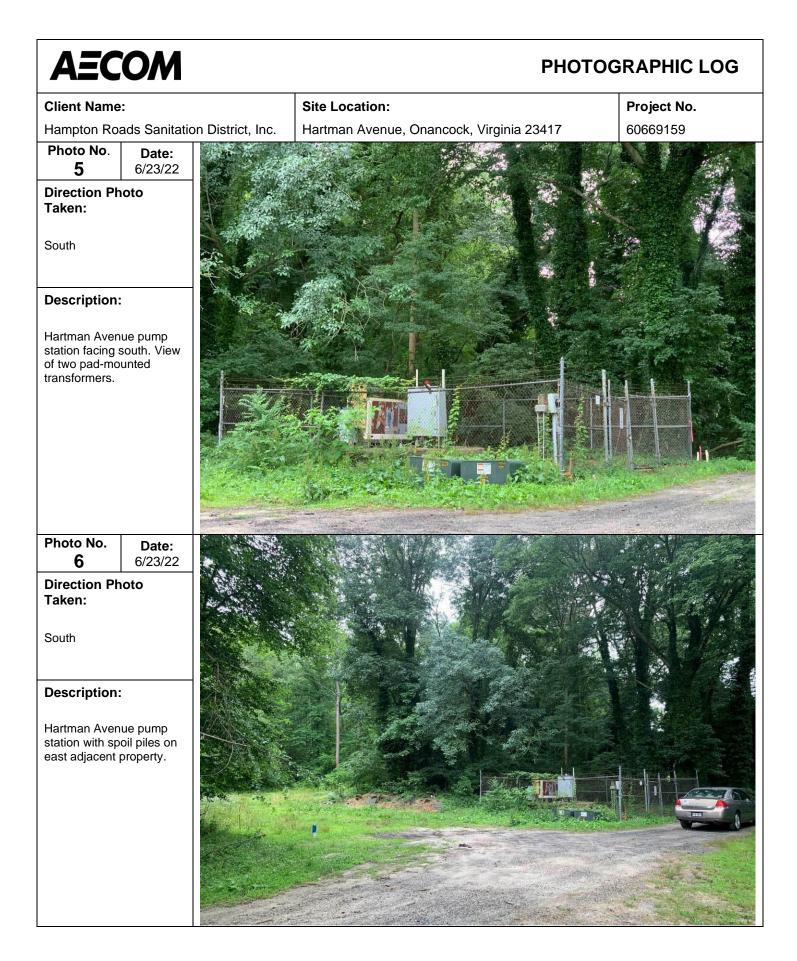
AEC	AECOM PHOTOGRAPHIC LOG					
Client Name	:		Site Location:	Project No.		
Hampton Ro	ads Sanitatic	on District, Inc.	Hartman Avenue, Onancock, Virginia 23417	60669159		
Photo No. 7	Date: 6/23/22	and the second				
Direction Ph Taken: South				· · · · ·		
Description	:					
Hartman avenue pump station with adjacent spoils and pad mounted transformer.						
Photo No.	Date: 6/23/22					
Direction Ph Taken: N/A						
Description	:	-				
Sewer conduit stockpile adjacent to the east of the subject property.

- Piles of soil, concrete, asphalt, and stored sewer pipe were observed adjacent to the east of the subject property. The presence of these materials is considered a *de minimis* condition in connection with the subject property

• Piles of soil, concrete, asphalt, and sewer pipe were observed stored adjacent to the east of the subject property. The dumping is considered a *de minimis* condition in connection with the subject property.
