# Appendix B: Pump Station Final Condition Assessment Report

This report is an Appendix to HRSD's Rehabilitation Action (Rehab) Plan to satisfy the requirements of the United State's Environmental Protection Agency (EPA) Consent Decree as well as the Virginia Department of Environmental Quality (DEQ) Special Order by Consent (SOC) for reporting on results of the Condition Assessment Program (CAP). This document summarizes condition assessment results related to HRSD's pumping facilities. Appendices A, C, D, and E satisfy the remaining reporting requirements of the CAP. Assets found at material risk of failure, as described further in this report, are addressed in the main document, the Rehab Plan. The primary purpose of the HRSD CAP was to find sanitary sewer assets presenting an actual material risk of failure. For the purposes of this document, "failure" means any condition resulting in a sanitary sewer overflow, pipe leakage, or interruption of service to HRSD's customers, due to a physical condition defect in the system.

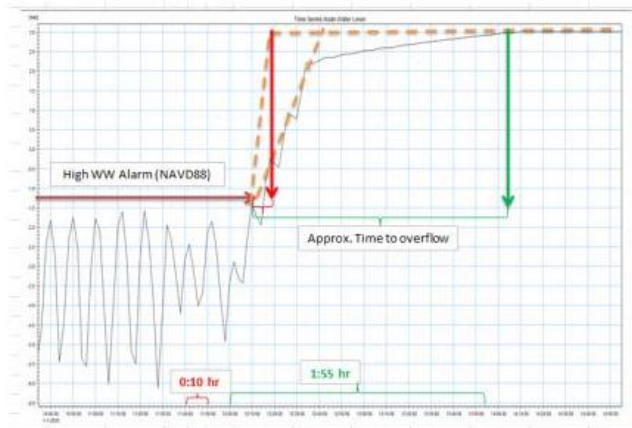
Critical Response Time, Sample Graph from RHM Analysis for HRSD PS #142 Jamestown Crescent

**CRT is approximately 10 minutes.**

In this case, the ART of 106 minutes exceeds the CRT of 10 minutes; therefore this station does not meet the requirement for crew response.

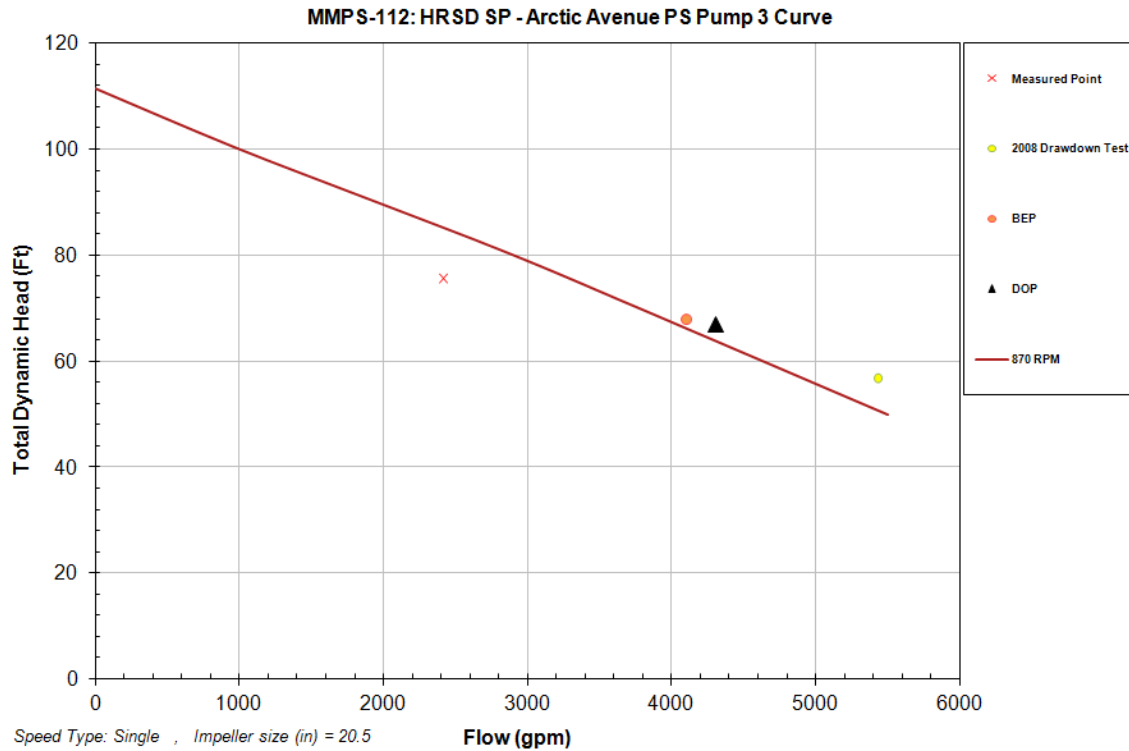
Arctic Ave PS uses variable speed Flomatcher pump controls which do not give a remote indication of pump shaft speed. The plotted curve is for the maximum pump shaft speed and, depending on available data; the measured point gives an indication of the pumps normal operating range rather than pumping capacity.

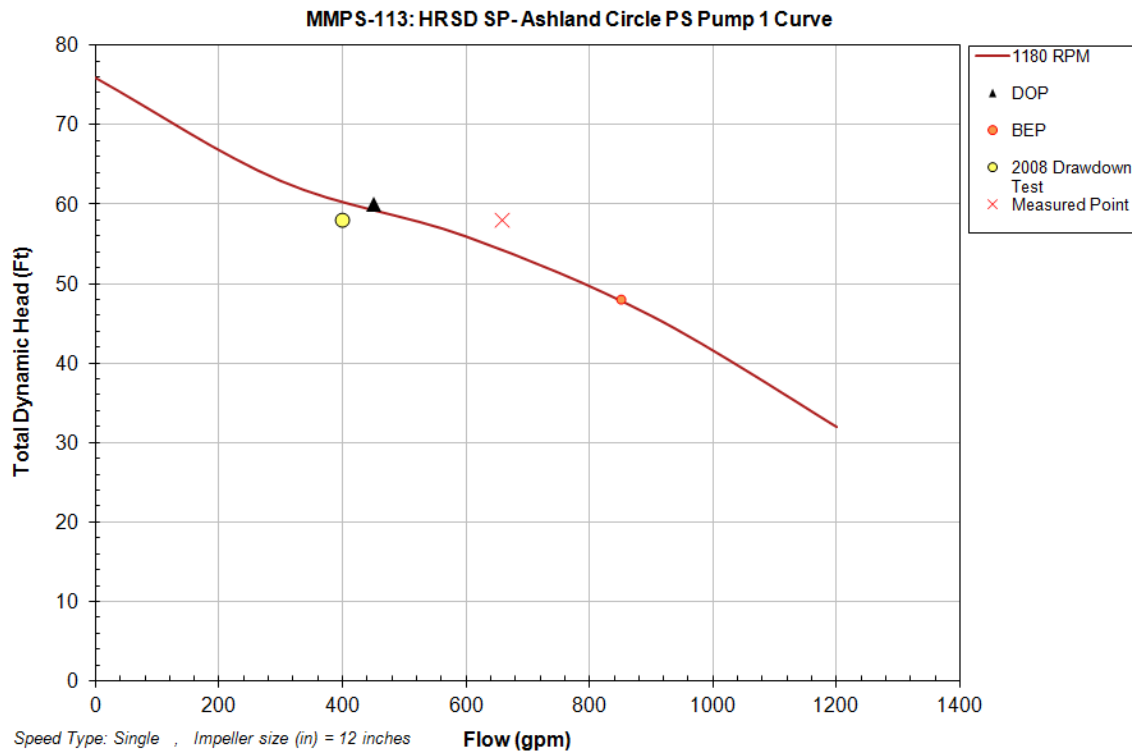
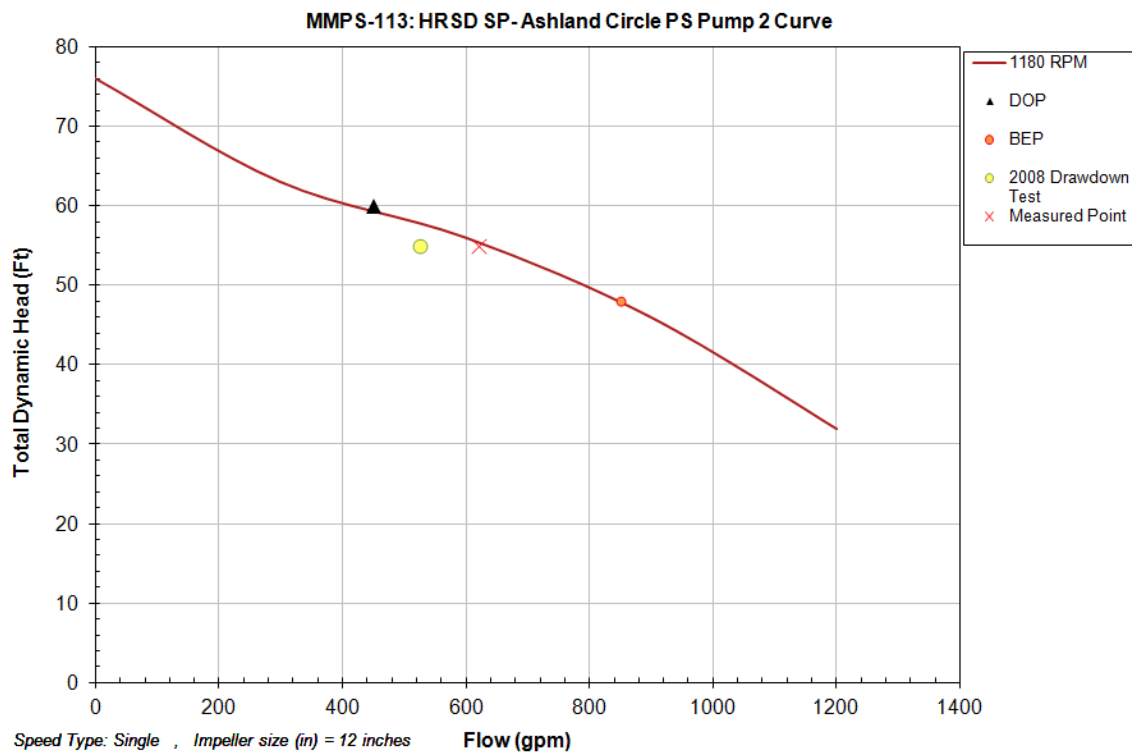
Ashland Circle PS does not have a discharge pressure sensor with remote indication. The station does not discharge to a manifolded force main so the TDH was assumed based on the results of the 2008 draw down test. The Flow is the average pumping rate.

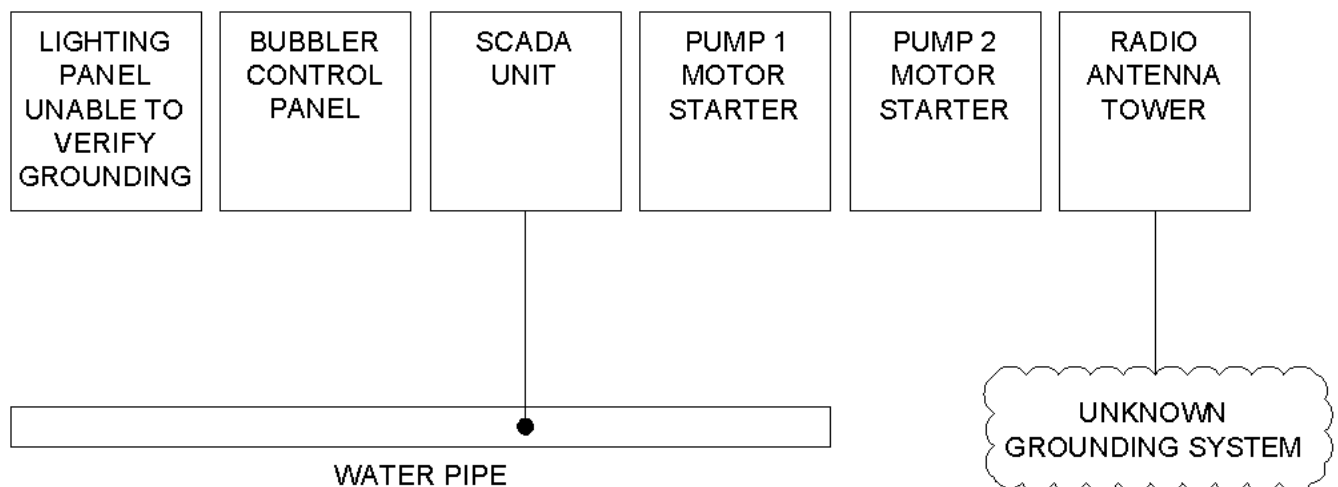
Figure 102-4. Ashland Circle Grounding System

- Service Entrance Surge Protection Device Installed
- Air Terminals Installed and Bonded to Ground System
- Ground Rod Test Wells Noticeable
- Ground Rods Noticeable
  - 0 Rod(s) Noticeable
- Indications of a Building Ground Ring
- No History of Lightning Strikes
- No History of Failures Resulting in SSO in Past 5 Years
- Equipment properly Surge Protected:
  - SCADA Unit has no surge suppression on coax between Antenna & radio
  - Bubbler control panel is not protected by a surge suppressor
- Equipment Properly Grounded:
  - Motor starters & bubbler control panel are not bonded to the station grounding system

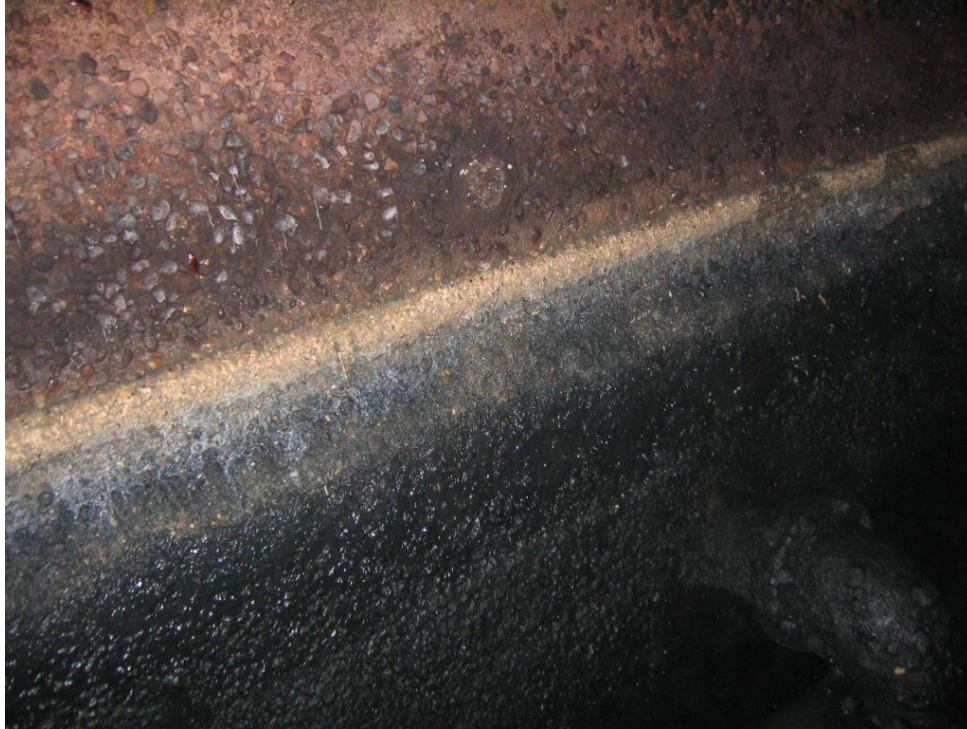
Figure 103-3. Bainbridge Blvd Wet Well

After the initial round of inspections, HRSD used a specialty contractor to revisit select stations for wet well structural inspections including concrete strength tests. Test results showed that the Bainbridge Blvd wet well is deteriorating.

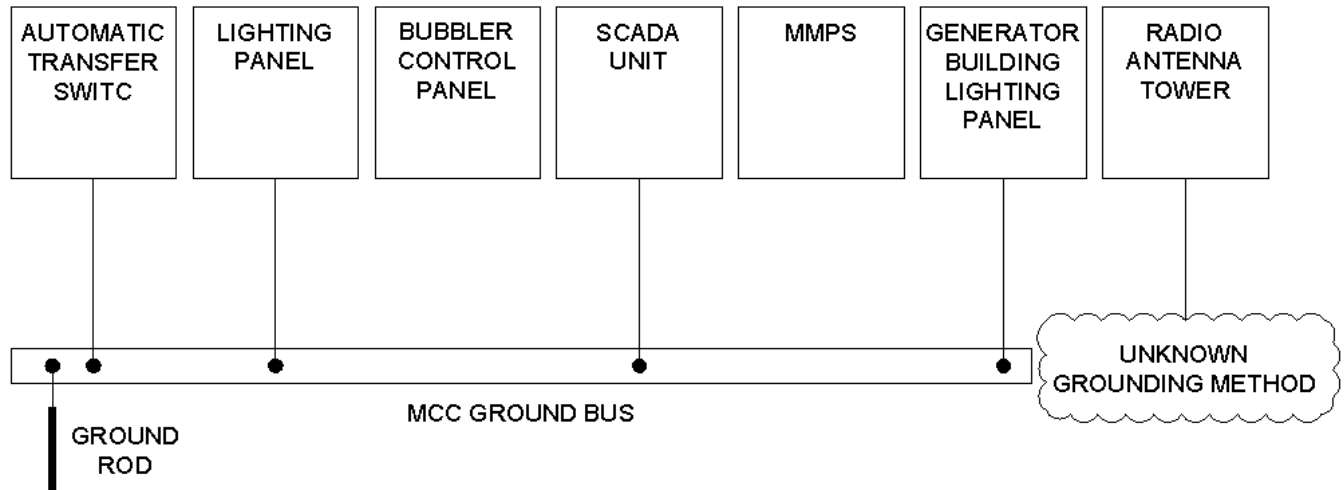
Figure 103-4. Bainbridge Blvd Grounding System

- Service Entrance Surge Protection Device Installed
- Air Terminals Installed and Bonded to Ground System
- Ground Rod Test Wells Noticeable
- Ground Rods Noticeable
  - 1 Rod(s) Noticeable
- Indications of a Building Ground Ring
- No History of Lightning Strikes
- No History of Failures Resulting in SSO in Past 5 Years
- Equipment properly Surge Protected:
  - SCADA Unit has no surge suppression on coax between Antenna & radio
  - Bubbler control panel is not protected by a surge suppressor
- Equipment Properly Grounded:
  - Bubbler control panel & MMPS are not bonded to the station grounding system

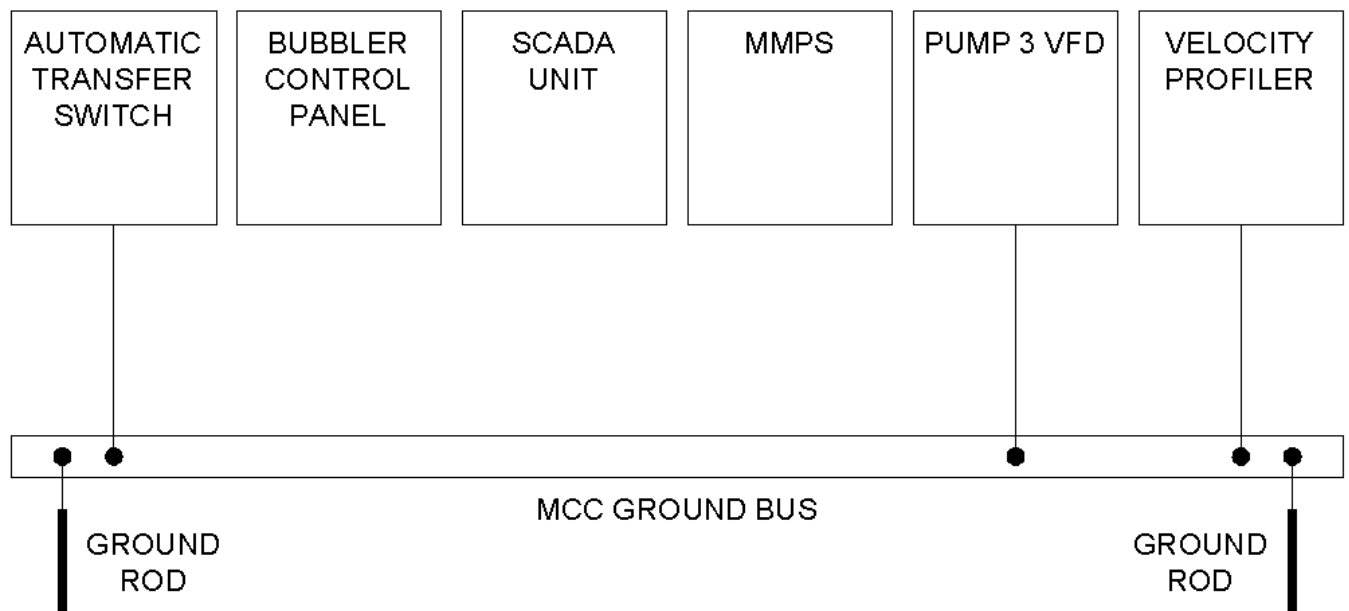
Figure 104-3. Cedar Lane Grounding System

- Service Entrance Surge Protection Device Installed
- Air Terminals Installed and Bonded to Ground System
- Ground Rod Test Wells Noticeable
- Ground Rods Noticeable
  - 2 Rod(s) Noticeable
- Indications of a Building Ground Ring
- No History of Lightning Strikes
- No History of Failures Resulting in SSO in Past 5 Years
- Equipment properly Surge Protected:
  - SCADA Unit has no surge suppression on coax between Antenna & radio
  - Bubbler control panel & velocity profiler are not protected by a surge suppressor
- Equipment Properly Grounded:
  - Bubbler control panel, velocity profiler, & MMPS are not bonded to the station grounding system

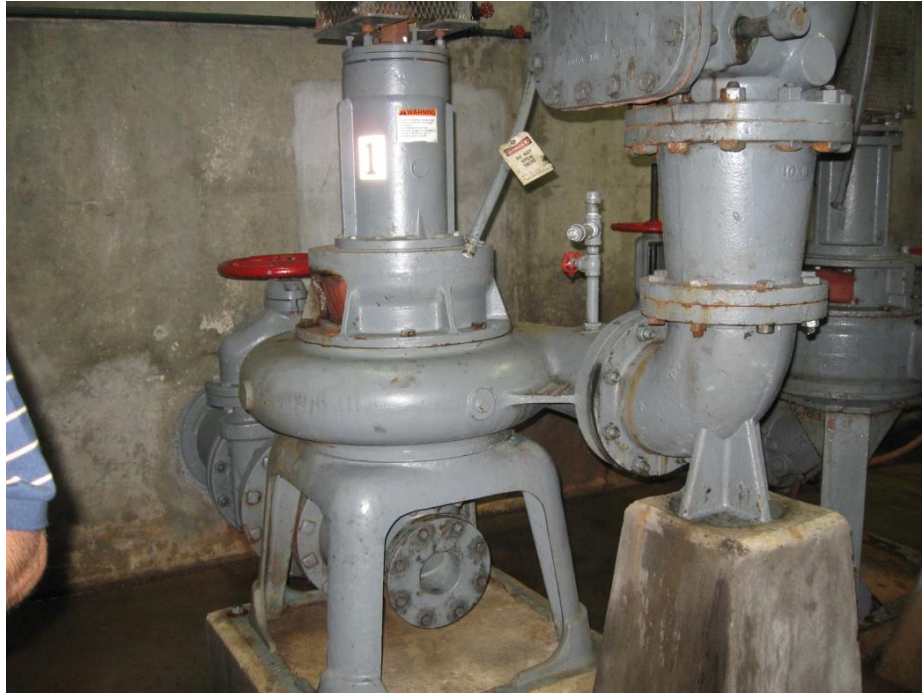
Figure 105-3. Chesapeake Blvd Pump No.1

The Chesapeake Blvd pumps were experiencing maintenance issues at the time of inspection.

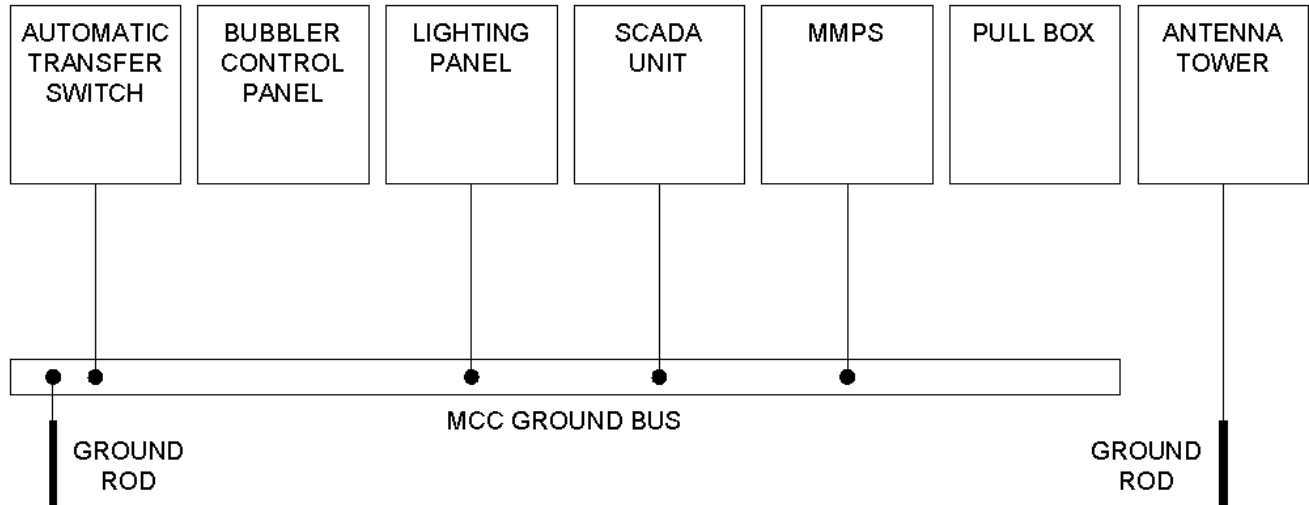
Figure 105-4. Chesapeake Blvd Grounding System

- Service Entrance Surge Protection Device Installed
- Air Terminals Installed and Bonded to Ground System
- Ground Rod Test Wells Noticeable
- Ground Rods Noticeable
  - 2 Rod(s) Noticeable
- Indications of a Building Ground Ring
- No History of Lightning Strikes
- No History of Failures Resulting in SSO in Past 5 Years
- Equipment properly Surge Protected:
  - SCADA Unit has no surge suppression on coax between Antenna & radio
  - Bubbler control panel is not protected by a surge suppressor
- Equipment Properly Grounded:
  - Bubbler control panel is not bonded to the station grounding system

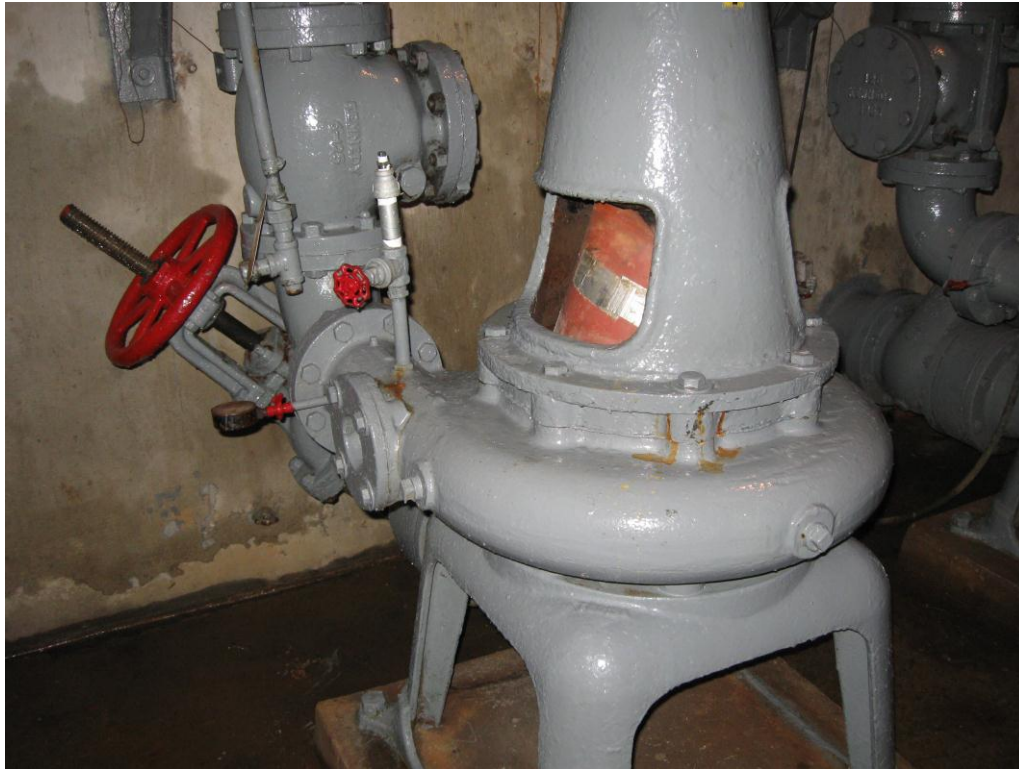
Figure 106-3. City Park Pump Room

The station pumps were experiencing maintenance issues at the time of inspection.

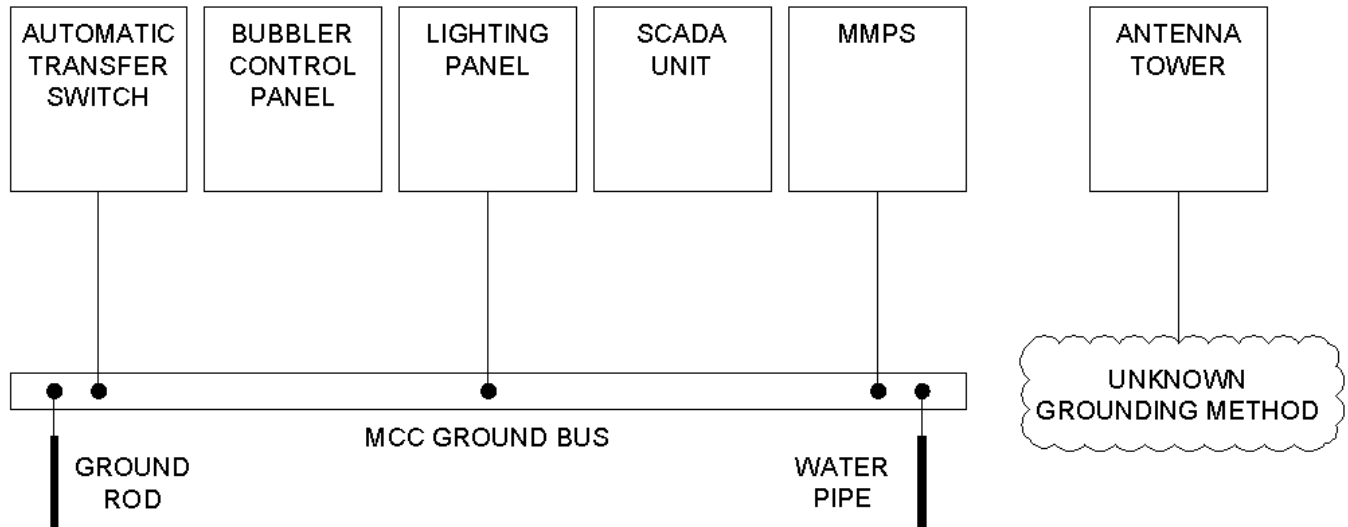
Figure 106-4. City Park Grounding System

- Service Entrance Surge Protection Device Installed
- Air Terminals Installed and Bonded to Ground System
- Ground Rod Test Wells Noticeable
- Ground Rods Noticeable
  - 1 Rod(s) Noticeable
- Indications of a Building Ground Ring
- No History of Lightning Strikes
- No History of Failures Resulting in SSO in Past 5 Years
- Equipment properly Surge Protected:
  - SCADA Unit has no surge suppression on coax between Antenna & radio
  - Bubbler control panel is not protected by a surge suppressor
- Equipment Properly Grounded:
  - Bubbler control panel & SCADA Unit are not bonded to the station grounding system

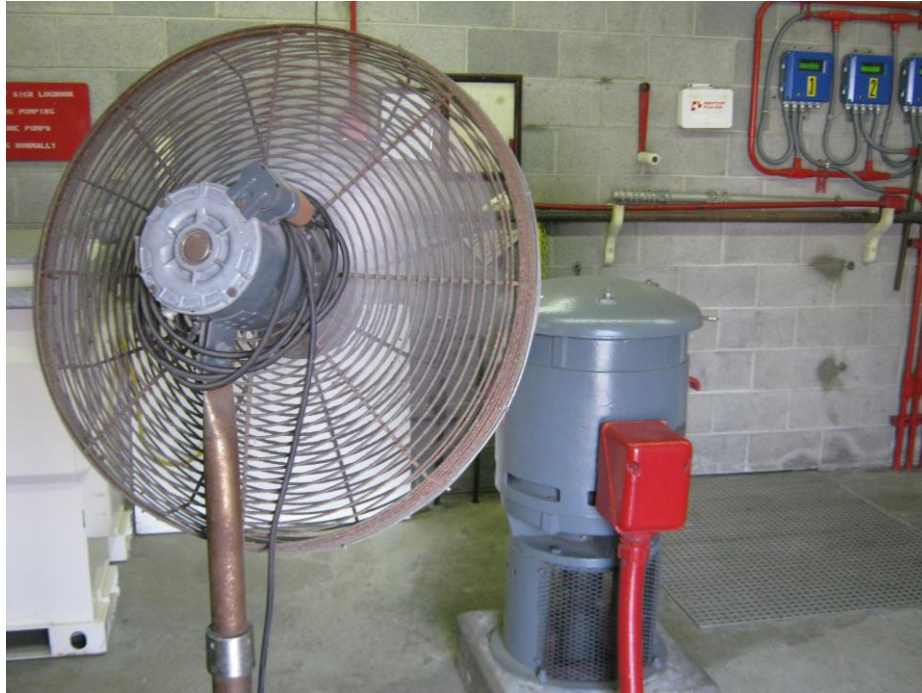
Figure 107-3. Motor No. 2 Cooling Fan

Motor No. 2 gets warm in operation. There is a fan on a pedestal providing cooling air.

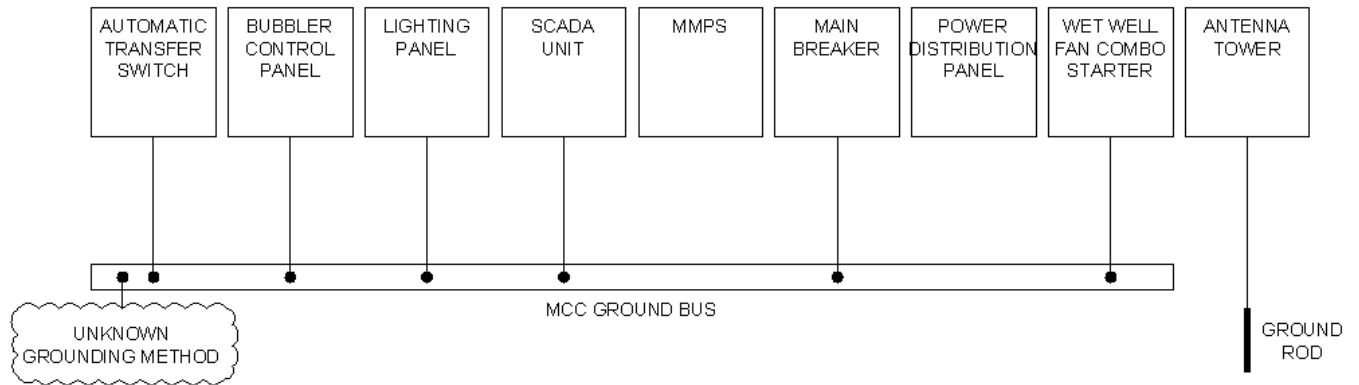
Figure 107-6. Colley Ave Grounding System

- Service Entrance Surge Protection Device Installed
- Air Terminals Installed and Bonded to Ground System
- Ground Rod Test Wells Noticeable
- Ground Rods Noticeable
  - 1 Rod(s) Noticeable
- Indications of a Building Ground Ring
- No History of Lightning Strikes
- No History of Failures Resulting in SSO in Past 5 Years
- Equipment properly Surge Protected:
  - SCADA Unit has no surge suppression on coax between Antenna & radio.
  - Bubbler control panel is not protected by a surge suppressor
- Equipment Properly Grounded:
  - Bubbler control panel & SCADA Unit are not bonded to the station grounding system

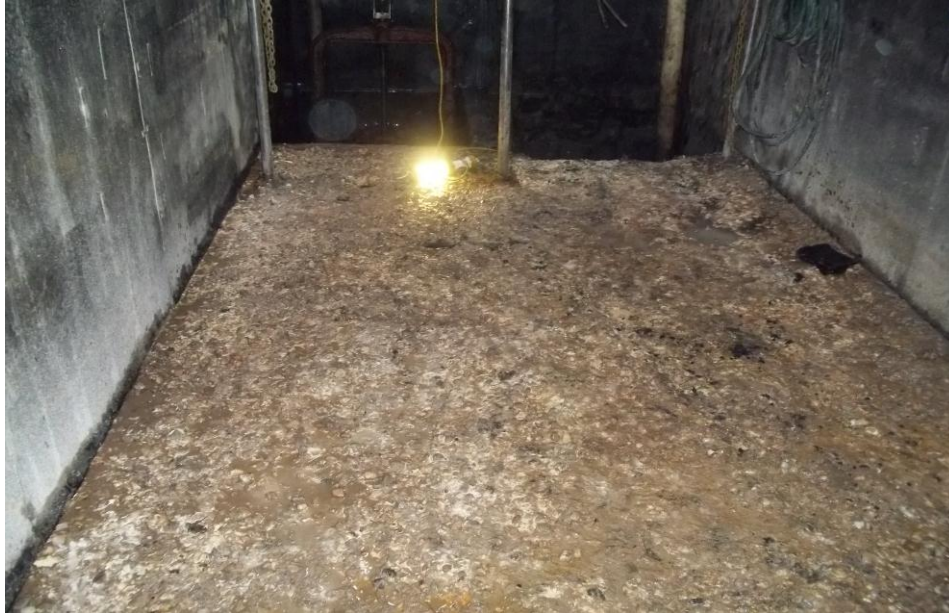
Figure 108-3. Dovercourt Wet Well Intermediate Slab

After the initial round of inspections, HRSD used a specialty contractor to revisit select stations for wet well structural inspections including concrete strength tests. Test results showed that the Dovercourt Rd wet well is deteriorating.

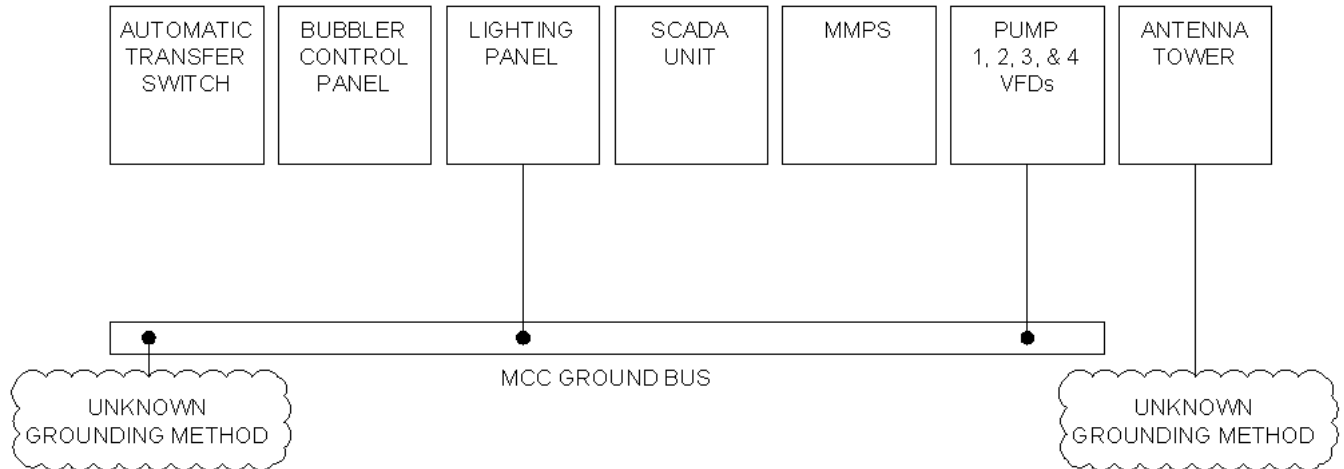
Figure 108-4. Dovercourt Rd Grounding System

- Service Entrance Surge Protection Device Installed
- Air Terminals Installed and Bonded to Ground System
- Ground Rod Test Wells Noticeable
- Ground Rods Noticeable
  - 0 Rod(s) Noticeable
- Indications of a Building Ground Ring
- No History of Lightning Strikes
- No History of Failures Resulting in SSO in Past 5 Years
- Equipment properly Surge Protected:
  - SCADA Unit has no surge suppression on coax between Antenna & radio
  - Bubbler control panel & velocity profiler are not protected by a surge suppressor
- Equipment Properly Grounded:
  - Bubbler control panel & MMPS are not bonded to the station grounding system

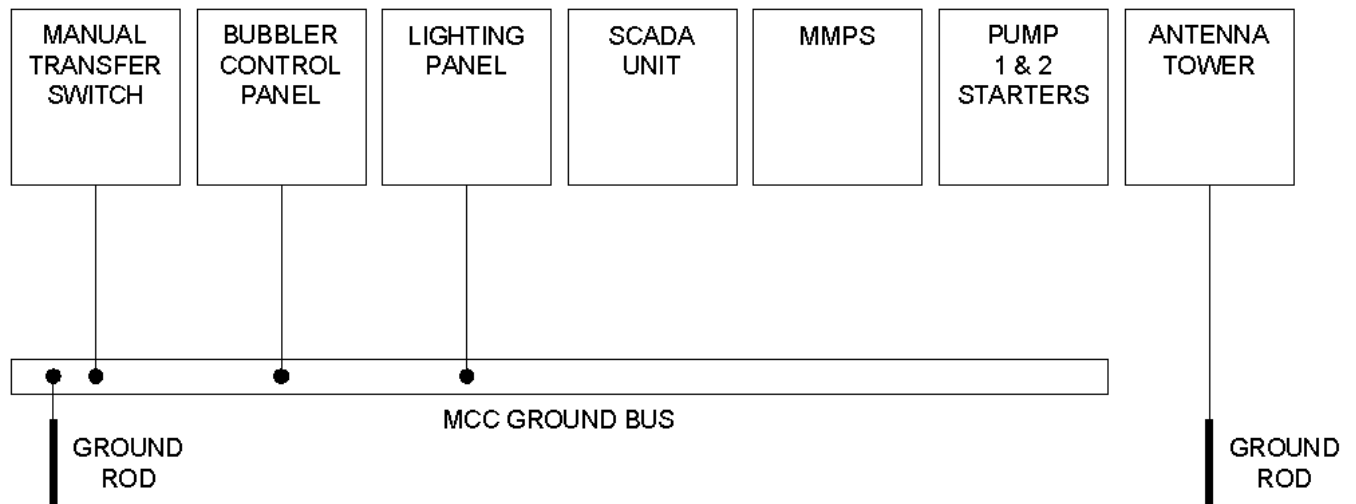
Figure 109-3. Dozier's Court Grounding System

- Service Entrance Surge Protection Device Installed
- Air Terminals Installed and Bonded to Ground System
- Ground Rod Test Wells Noticeable
- Ground Rods Noticeable
  - 2 Rod(s) Noticeable
- Indications of a Building Ground Ring
- No History of Lightning Strikes
- No History of Failures Resulting in SSO in Past 5 Years
- Equipment properly Surge Protected:
  - SCADA Unit has no surge suppression on coax between Antenna & radio
  - Bubbler control panel is not protected by a surge suppressor
- Equipment Properly Grounded:
  - Motor starters & MMPS are not bonded to the station grounding system

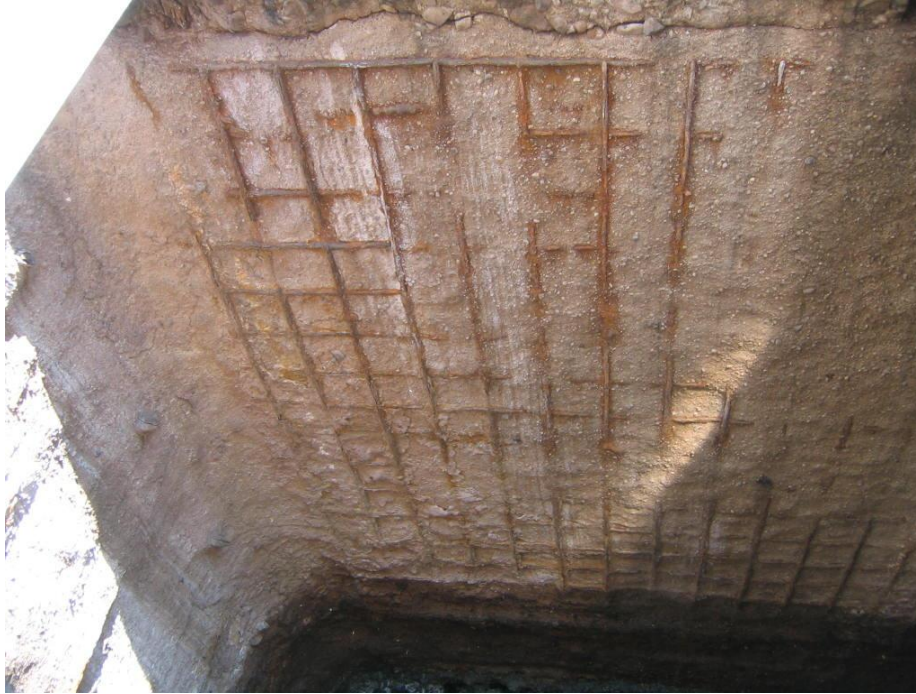
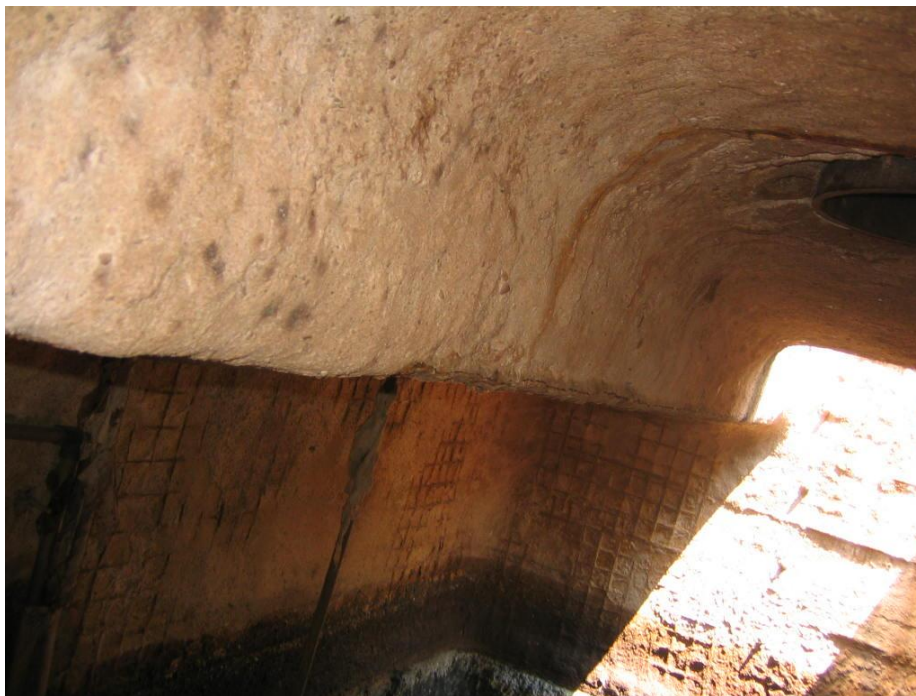
After the initial round of inspections, HRSD used a specialty contractor to revisit select stations for wet well structural inspections including concrete strength tests. Test results showed that the Ferebee Ave wet well is deteriorating.

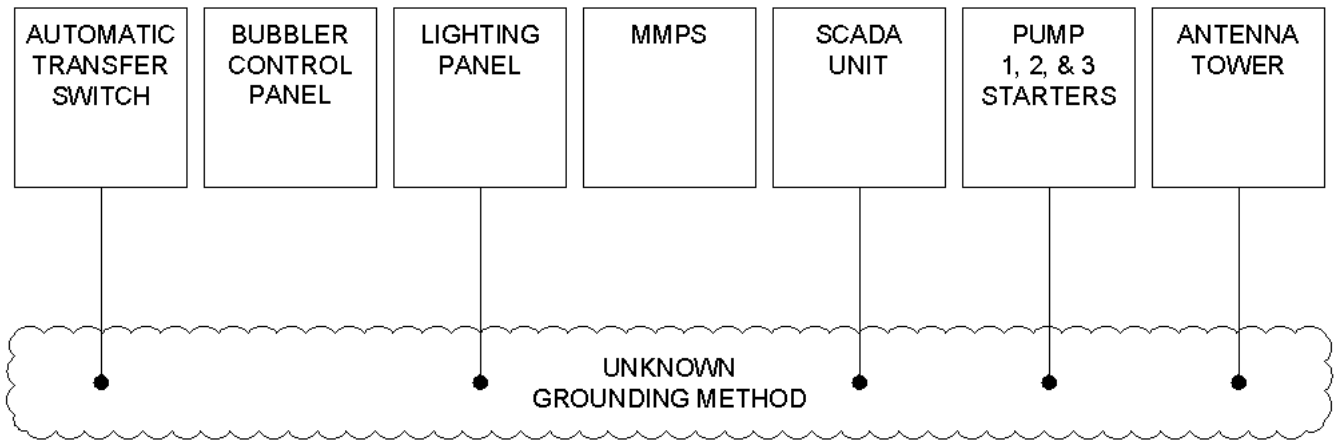
Figure 110-5. Ferebee Ave Grounding System

- Service Entrance Surge Protection Device Installed
- Air Terminals Installed and Bonded to Ground System
- Ground Rod Test Wells Noticeable
- Ground Rods Noticeable
  - 0 Rod(s) Noticeable
- Indications of a Building Ground Ring
- No History of Lightning Strikes
- No History of Failures Resulting in SSO in Past 5 Years
- Equipment properly Surge Protected:
  - Bubbler control panel is not protected with surge suppression
  - SCADA Unit has no surge suppression on coax between Antenna & radio
- Equipment Properly Grounded:
  - Motor starters & MMPS are not properly bonded to the station grounding system

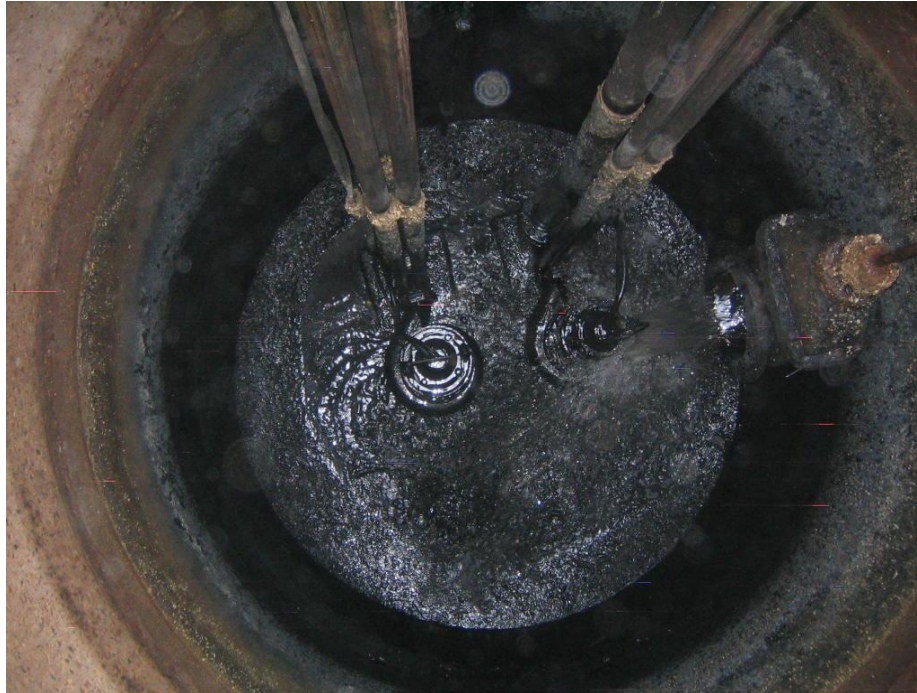
Figure 111-3. Granby St Wet Well

The Granby Street wet well has some exposed aggregate.

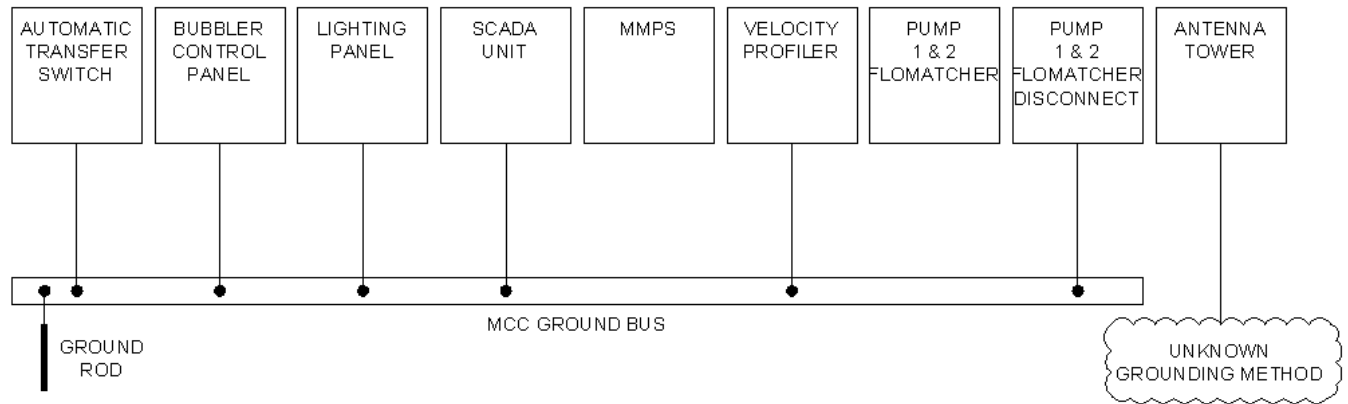
Figure 112-4. Independence Blvd Grounding System

- Service Entrance Surge Protection Device Installed
- Air Terminals Installed and Bonded to Ground System
- Ground Rod Test Wells Noticeable
- Ground Rods Noticeable
  - 1 Rod(s) Noticeable
- Indications of a Building Ground Ring
- No History of Lightning Strikes
- No History of Failures Resulting in SSO in Past 5 Years
- Equipment properly Surge Protected:
  - Control panel & velocity profiler are not protected with surge suppression
  - SCADA Unit has no surge suppression on coax between Antenna & radio
- Equipment Properly Grounded:
  - MMPS is not properly bonded to the station grounding system

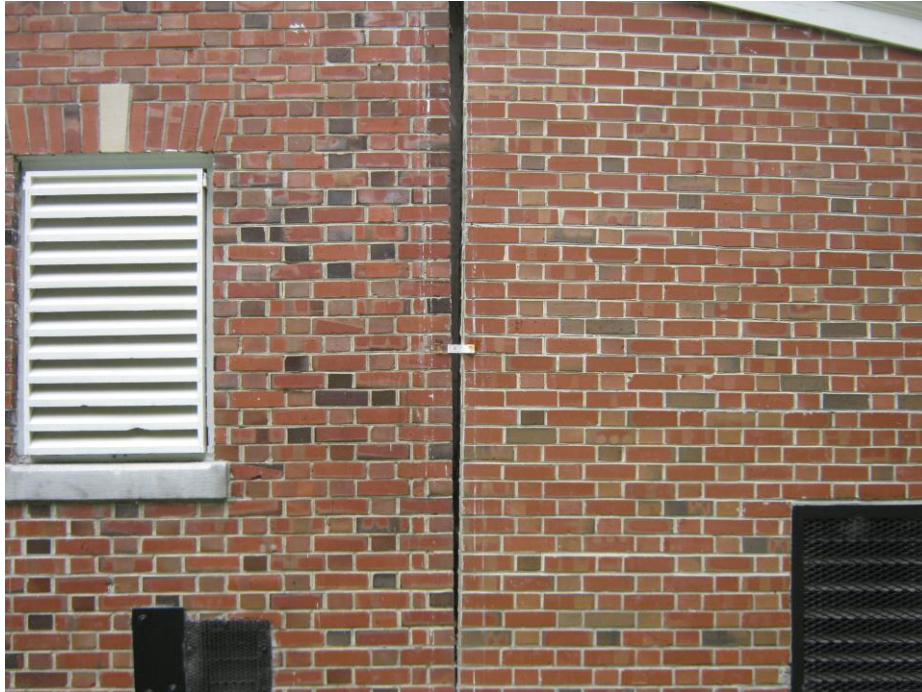
Figure 113-3. Luxembourg Ave Building

The Luxembourg Ave building appears to be experiencing differential settlement. After the initial round of inspections, HRSD used a specialty contractor to revisit select stations for wet well structural inspections including concrete strength tests. Test results showed that the Luxembourg Ave wet well is deteriorating.

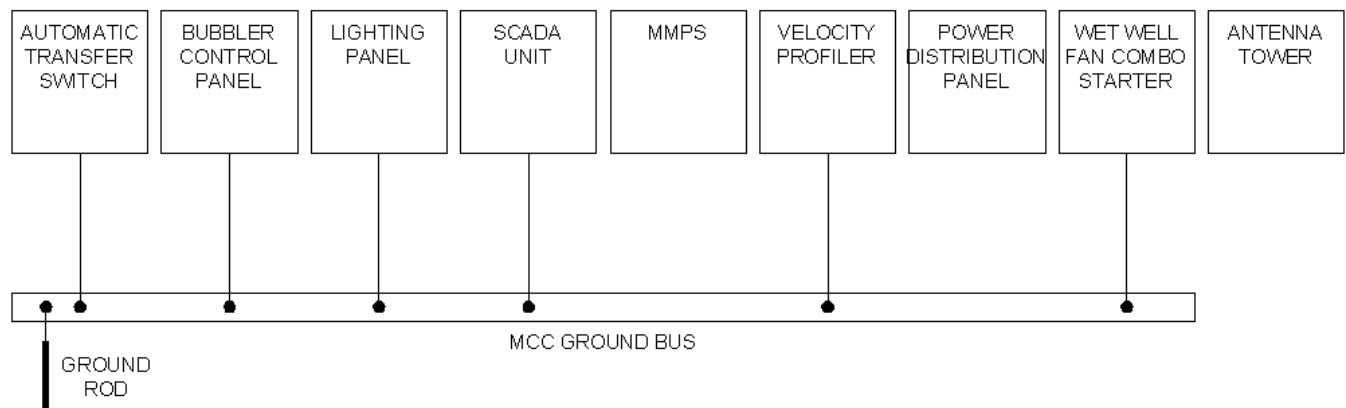
Figure 113-5. Luxembour Ave Grounding System

- Ground Rod Test Wells Noticeable
- Ground Rods Noticeable
  - 1 Rod(s) Noticeable
- Indications of a Building Ground Ring
- No History of Lightning Strikes
- No History of Failures Resulting in SSO in Past 5 Years
- Equipment properly Surge Protected:
  - SCADA Unit has no surge suppression on coax between Antenna & radio.
  - Bubbler control panel & velocity profiler are not protected by a surge suppressor.
- Equipment Properly Grounded:
  - MMPS is not bonded to the station grounding system.

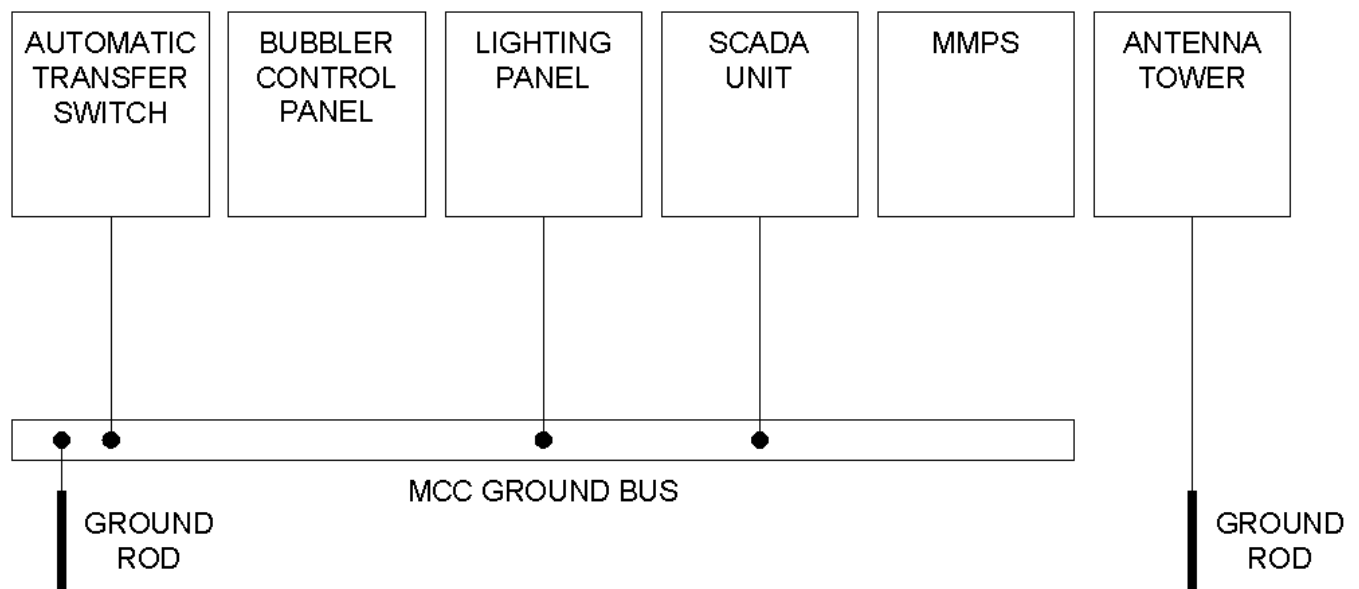
Figure 114-3. Monroe Place Grounding System

- Service Entrance Surge Protection Device Installed
- Air Terminals Installed and Bonded to Ground System
- Ground Rod Test Wells Noticeable
- Ground Rods Noticeable
  - 2 Rod(s) Noticeable
- Indications of a Building Ground Ring
- No History of Lightning Strikes
- No History of Failures Resulting in SSO in Past 5 Years
- Equipment properly Surge Protected:
  - SCADA Unit has no surge suppression on coax between Antenna & radio.
  - Bubbler control panel is not protected by a surge suppressor.
- Equipment Properly Grounded:
  - Bubbler control panel & MMPS are not bonded to the station grounding system.

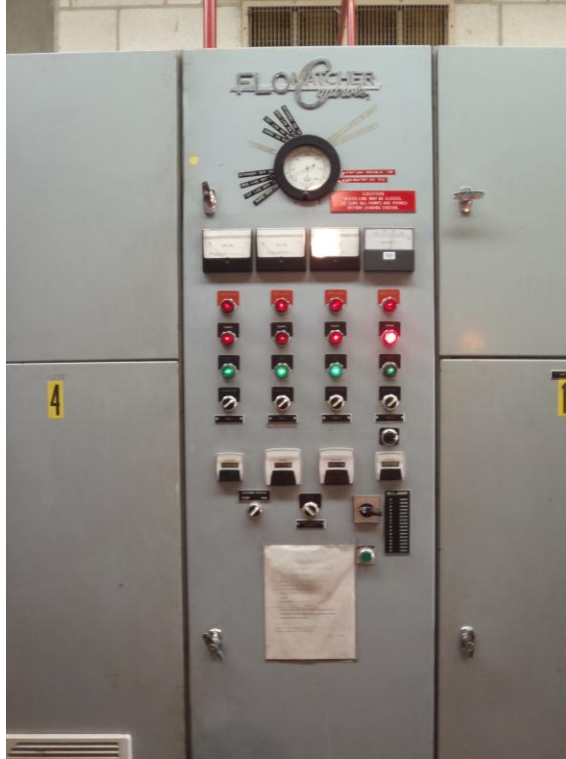
Figure 115-3. Newtown Rd Flomatcher

115	Newtown Road	FLOmatcher	FLOmatcher	3	2	None to Report	Continue Scheduled Maintenance Activities	Equipment is well maintained but is old and should be considered for replacement.	2

Newtown Rd PS uses Flomatcher pump controllers. After the initial round of inspections, HRSD used a specialty contractor to revisit select stations for wet well structural inspections including concrete strength tests. Test results showed that the Newtown Rd wet well is deteriorating.

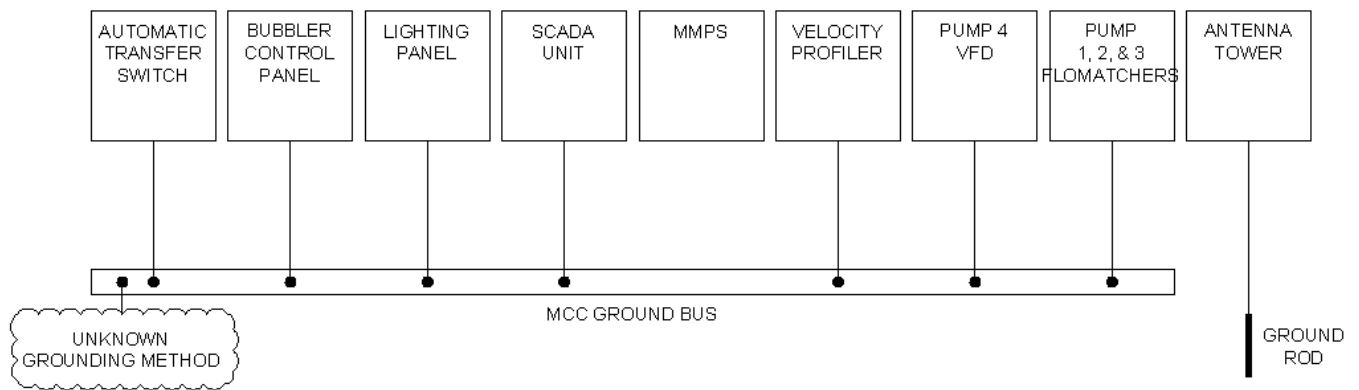
Figure 115-5. Newtown Rd Grounding System

- Service Entrance Surge Protection Device Installed
- Air Terminals Installed and Bonded to Ground System
- Ground Rod Test Wells Noticeable
- Ground Rods Noticeable
  - 1 Rod(s) Noticeable
- Indications of a Building Ground Ring
- No History of Lightning Strikes
- No History of Failures Resulting in SSO in Past 5 Years
- Equipment properly Surge Protected:
  - SCADA Unit has no surge suppression on coax between Antenna & radio.
  - Bubbler control panel & velocity profiler are not protected by a surge suppressor.
- Equipment Properly Grounded:
  - MMPS is not bonded to the station grounding system.

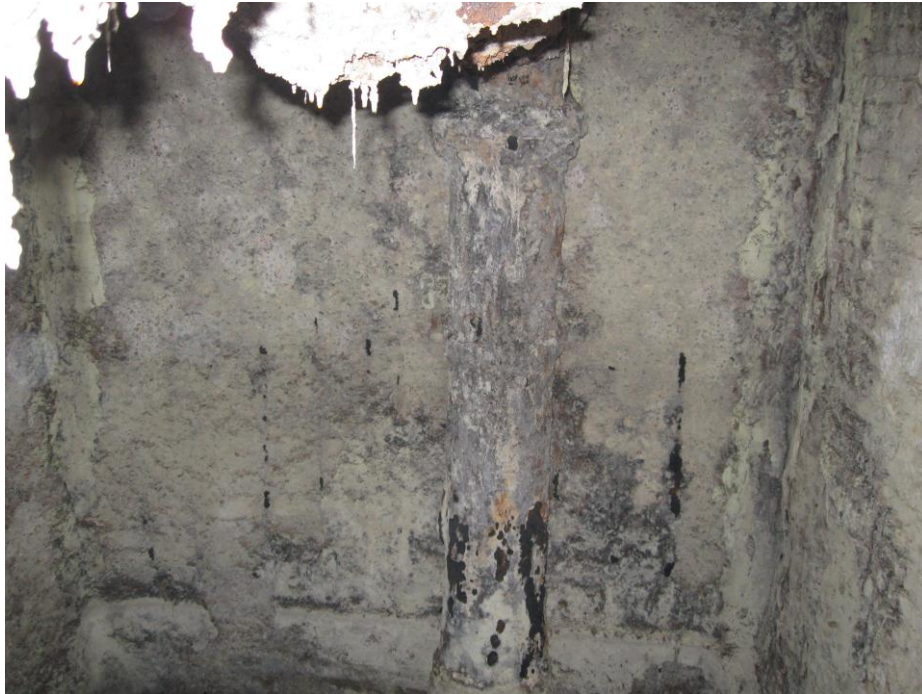
Figure 116-3. Norchester St Wet well

The Norchester St wet well is corroding.

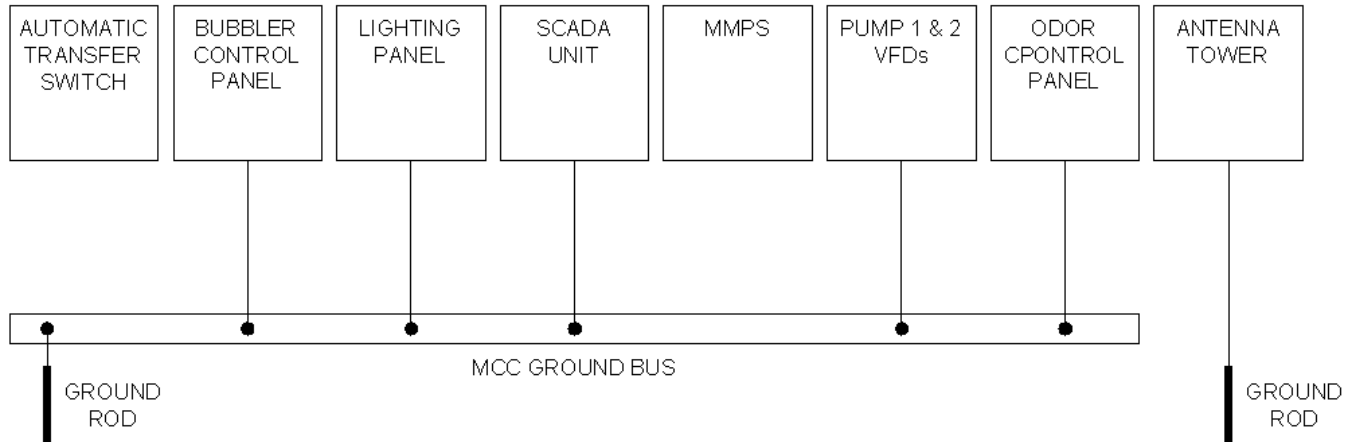
Figure 116-4. Norchester St Grounding System

- Service Entrance Surge Protection Device Installed
- Air Terminals Installed and Bonded to Ground System
- Ground Rod Test Wells Noticeable
- Ground Rods Noticeable
  - 2 Rod(s) Noticeable
- Indications of a Building Ground Ring
- No History of Lightning Strikes
- No History of Failures Resulting in SSO in Past 5 Years
- Equipment properly Surge Protected:
  - SCADA Unit has no surge suppression on coax between Antenna & radio
  - Odor control panel is not protected by a surge suppressor
- Equipment Properly Grounded:
  - MMPS is not bonded to the station grounding system
