# Appendix B: Pump Station Final Condition Assessment Report

This report is an Appendix to HRSD's Rehabilitation Action (Rehab) Plan to satisfy the requirements of the United State's Environmental Protection Agency (EPA) Consent Decree as well as the Virginia Department of Environmental Quality (DEQ) Special Order by Consent (SOC) for reporting on results of the Condition Assessment Program (CAP). This document summarizes condition assessment results related to HRSD's pumping facilities. Appendices A, C, D, and E satisfy the remaining reporting requirements of the CAP. Assets found at material risk of failure, as described further in this report, are addressed in the main document, the Rehab Plan. The primary purpose of the HRSD CAP was to find sanitary sewer assets presenting an actual material risk of failure. For the purposes of this document, "failure" means any condition resulting in a sanitary sewer overflow, pipe leakage, or interruption of service to HRSD's customers, due to a physical condition defect in the system.

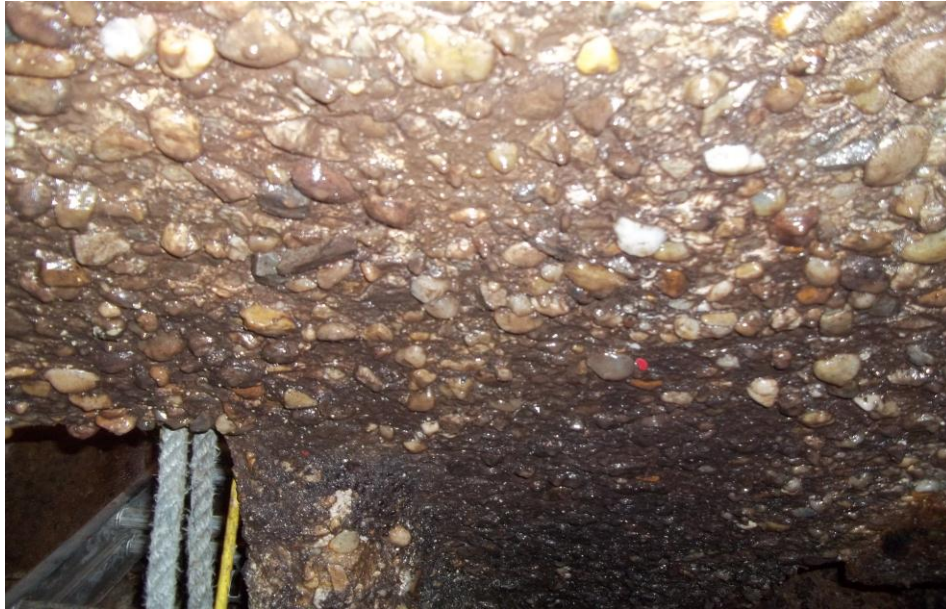
Figure 117-3. North Shore Rd Wet Well Ceiling

After the initial round of inspections, HRSD used a specialty contractor to revisit select stations for wet well structural inspections including concrete strength tests. Test results showed that the North Shore Rd wet well is deteriorating.

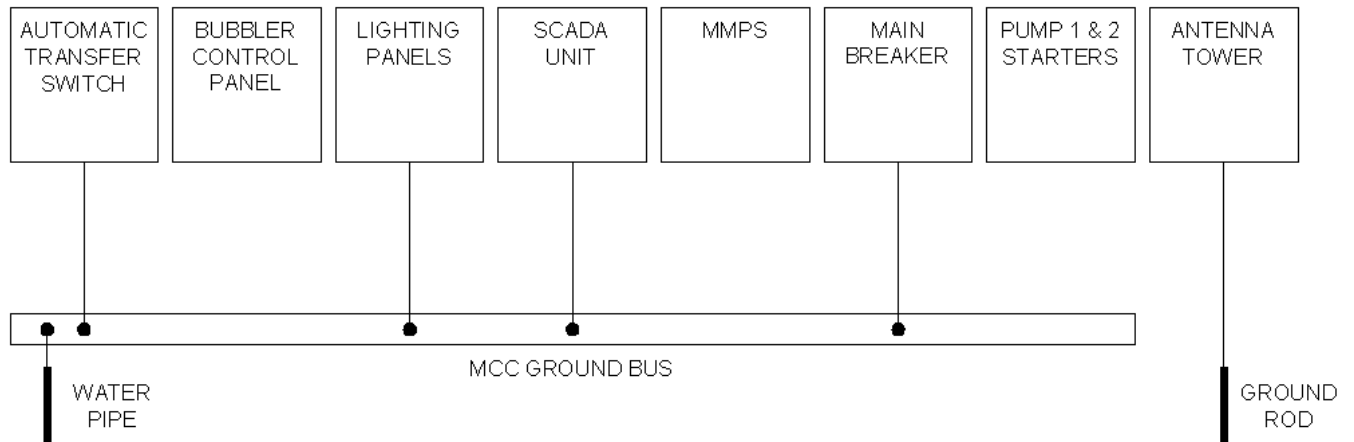
Figure 117-4. North Shore Rd Grounding System

- Service Entrance Surge Protection Device Installed
- Air Terminals Installed and Bonded to Ground System
- Ground Rod Test Wells Noticeable
- Ground Rods Noticeable
  - 1 Rod(s) Noticeable
- Indications of a Building Ground Ring
- No History of Lightning Strikes
- No History of Failures Resulting in SSO in Past 5 Years
- Equipment properly Surge Protected:
  - SCADA Unit has no surge suppression on coax between Antenna & radio
  - Bubbler control panel is not protected by a surge suppressor
- Equipment Properly Grounded:
  - MMPS, motor starters, ATS, & bubbler control panel are not bonded to the station grounding system

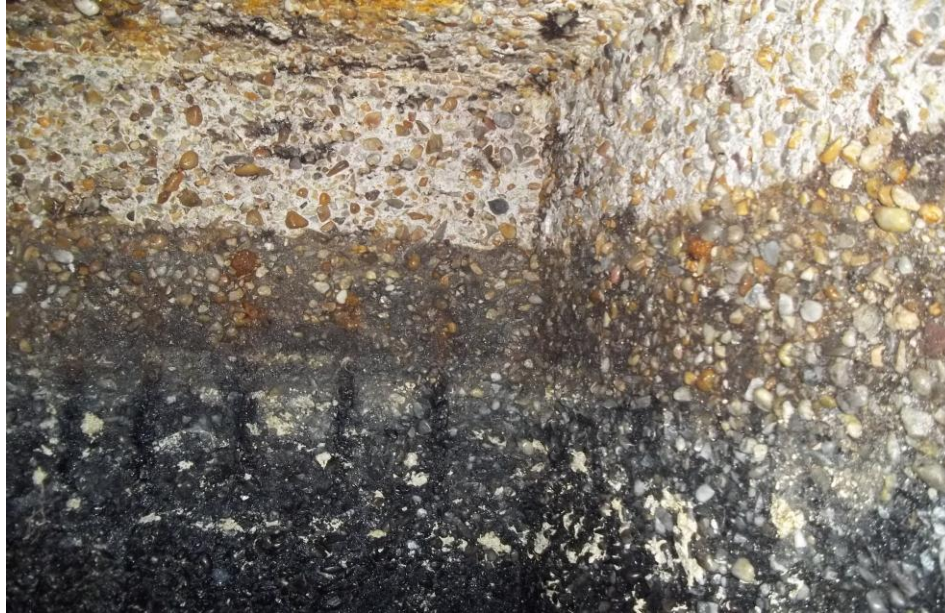
Figure 118-3. Typical Norview Ave Wet Well Concrete.

After the initial round of inspections, HRSD used a specialty contractor to revisit select stations for wet well structural inspections including concrete strength tests. Test results showed that the Norview Ave wet well is deteriorating.

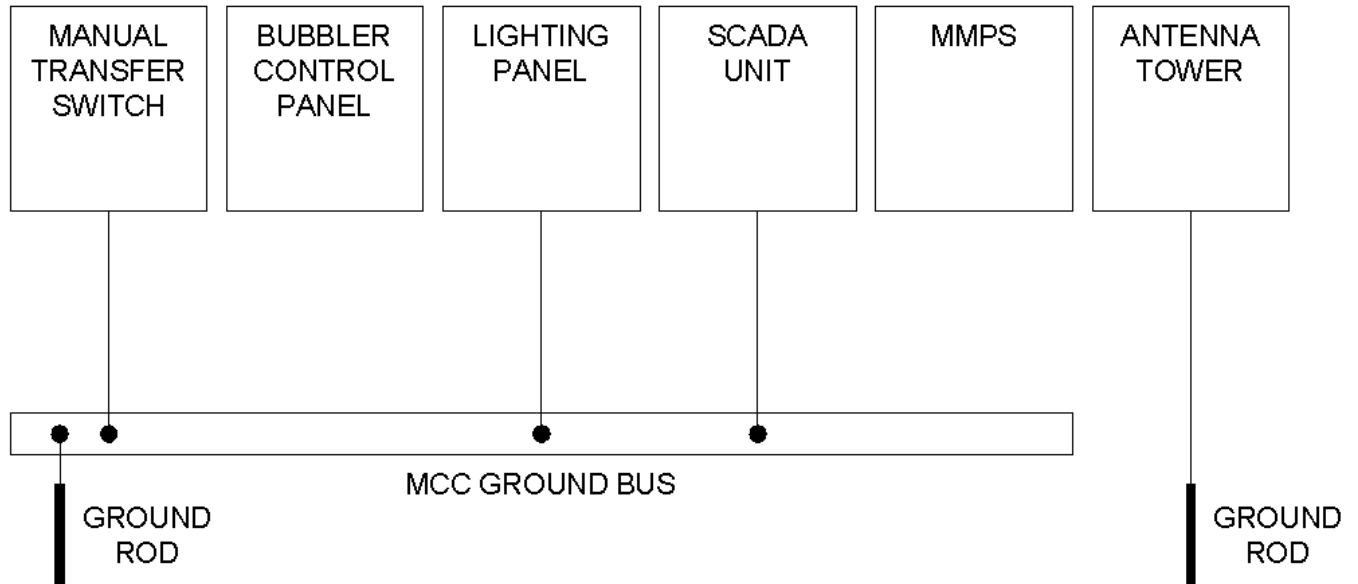
Figure 118-4. Norview Ave Grounding System

- Service Entrance Surge Protection Device Installed
- Air Terminals Installed and Bonded to Ground System
- Ground Rod Test Wells Noticeable
- Ground Rods Noticeable
  - 2 Rod(s) Noticeable
- Indications of a Building Ground Ring
- No History of Lightning Strikes
- No History of Failures Resulting in SSO in Past 5 Years
- Equipment properly Surge Protected:
  - SCADA Unit has no surge suppression on coax between Antenna & radio
  - Bubbler control panel is not protected by a surge suppressor
- Equipment Properly Grounded:
  - Bubbler control panel & MMPS are not bonded to the station grounding system

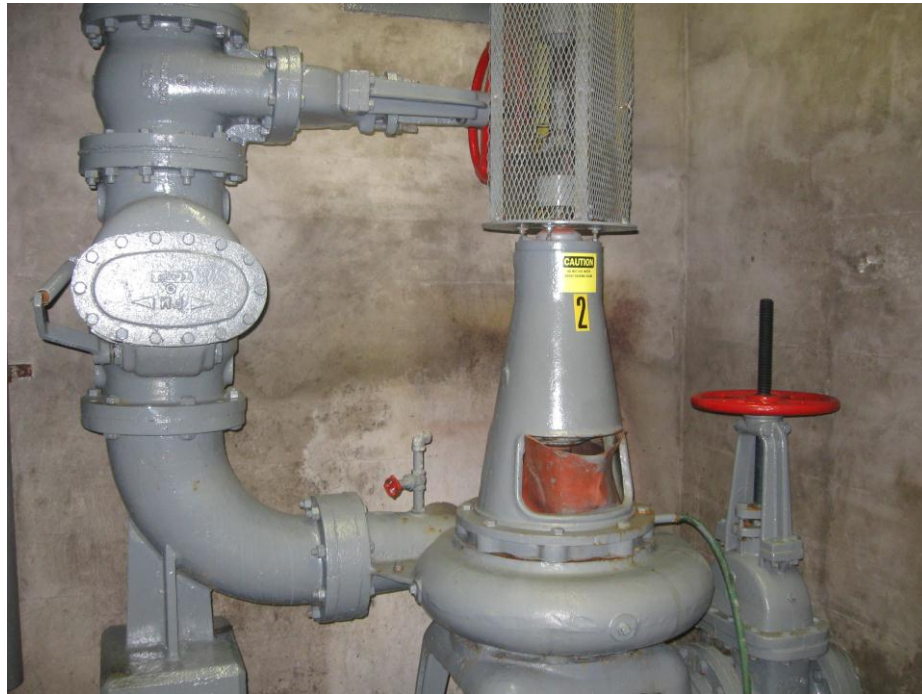
Figure 119-3. Pump No. 2

Pump #2 lost prime during normal operations as observed during inspection. Operations personnel reported reliability issues at the station.

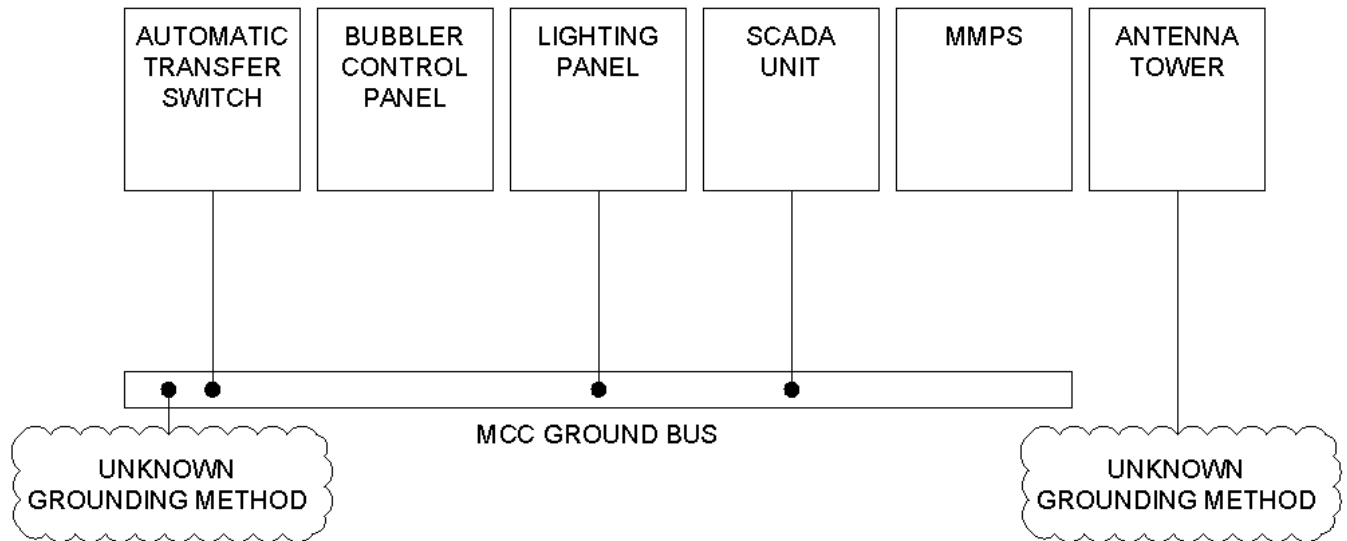
Figure 119-4. Park Ave Grounding System

- Service Entrance Surge Protection Device Installed
- Air Terminals Installed and Bonded to Ground System
- Ground Rod Test Wells Noticeable
- Ground Rods Noticeable
  - 0 Rod(s) Noticeable
- Indications of a Building Ground Ring
- No History of Lightning Strikes
- No History of Failures Resulting in SSO in Past 5 Years
- Equipment properly Surge Protected:
  - Bubbler control panel is not protected with surge suppression
  - SCADA Unit has no surge suppression on coax between Antenna & radio
- Equipment Properly Grounded:
  - Bubbler control panel & MMPS are not properly bonded to the station grounding system

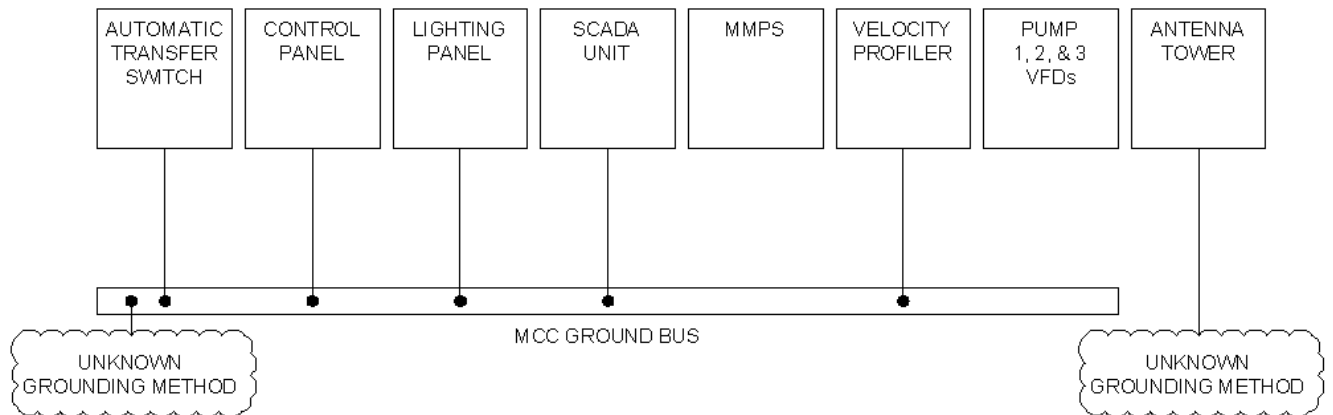
Figure 120-3. Pine Tree Grounding System

- Service Entrance Surge Protection Device Installed
- Air Terminals Installed and Bonded to Ground System
- Ground Rod Test Wells Noticeable
- Ground Rods Noticeable
  - 0 Rod(s) Noticeable
- Indications of a Building Ground Ring
- No History of Lightning Strikes
- No History of Failures Resulting in SSO in Past 5 Years
- Equipment properly Surge Protected:
  - SCADA Unit has no surge suppression on coax between Antenna & radio
  - Control panel & velocity profiler are not protected by a surge suppressor
- Equipment Properly Grounded:
  - MMPS is not bonded to the station grounding system

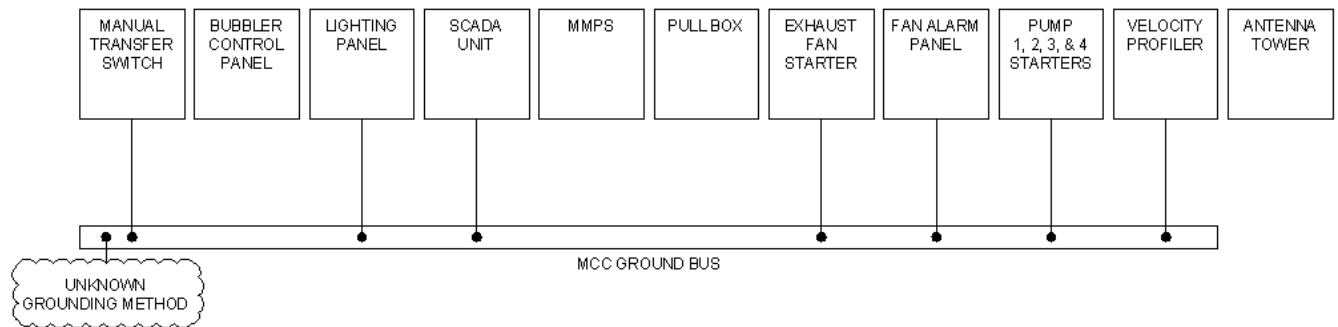
Figure 121-3. Plume St Grounding System

- Service Entrance Surge Protection Device Installed
- Air Terminals Installed and Bonded to Ground System
- Ground Rod Test Wells Noticeable
- Ground Rods Noticeable
  - 0 Rod(s) Noticeable
- Indications of a Building Ground Ring
- No History of Lightning Strikes
- No History of Failures Resulting in SSO in Past 5 Years
- Equipment properly Surge Protected:
  - SCADA Unit has no surge suppression on coax between Antenna & radio
  - Bubbler control panel are not protected by a surge suppressor
- Equipment Properly Grounded:
  - MMPS, SCADA Unit, & bubbler control panel are not bonded to the station grounding system

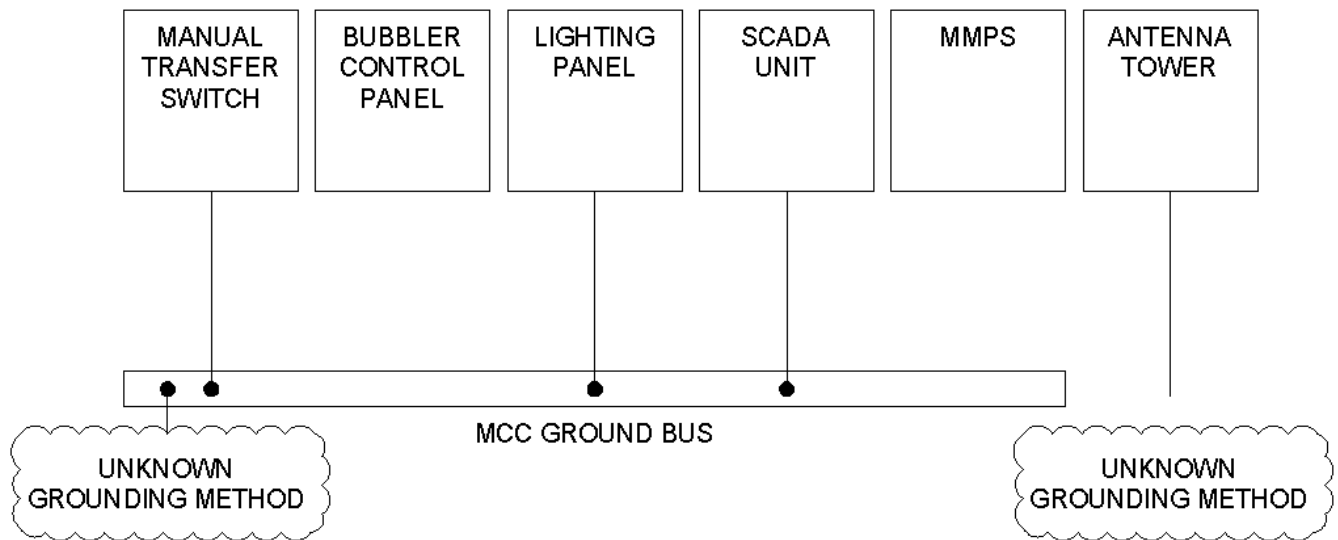
Figure 122-4. Powhatan Ave Grounding System

- Service Entrance Surge Protection Device Installed
- Air Terminals Installed and Bonded to Ground System
- Ground Rod Test Wells Noticeable
- Ground Rods Noticeable
  - 0 Rod(s) Noticeable
- Indications of a Building Ground Ring
- No History of Lightning Strikes
- No History of Failures Resulting in SSO in Past 5 Years
- Equipment properly Surge Protected:
  - SCADA Unit has no surge suppression on coax between Antenna & radio.
  - Bubbler control panel is not protected by a surge suppressor.
- Equipment Properly Grounded:
  - Bubbler control panel & MMPS are not bonded to the station grounding system.
  - Broken antenna ground wire outside of pump station.

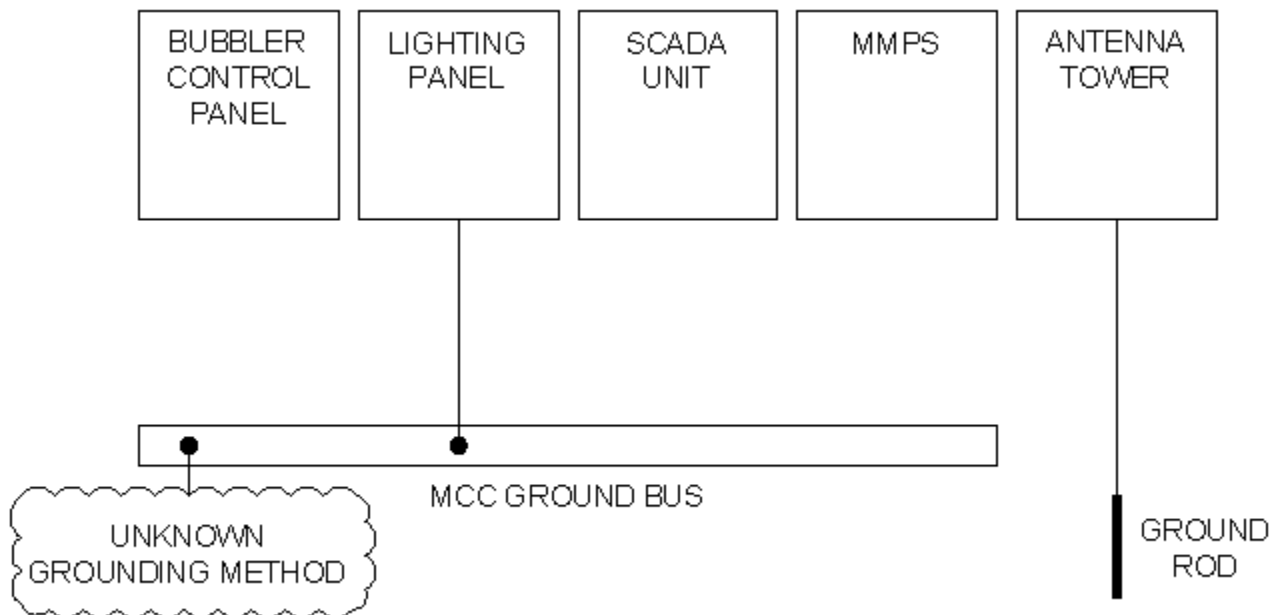
Figure 123-3. Quail Ave PS Grounding System

- Service Entrance Surge Protection Device Installed
- Air Terminals Installed and Bonded to Ground System
- Ground Rod Test Wells Noticeable
- Ground Rods Noticeable
  - 1 Rod(s) Noticeable
- Indications of a Building Ground Ring
- No History of Lightning Strikes
- No History of Failures Resulting in SSO in Past 5 Years
- Equipment properly Surge Protected:
  - SCADA Unit has no surge suppression on coax between Antenna & radio
  - Bubbler control panel is not protected by a surge suppressor
- Equipment Properly Grounded:
  - MMPS, SCADA unit, & bubbler control panel are not bonded to the station grounding system

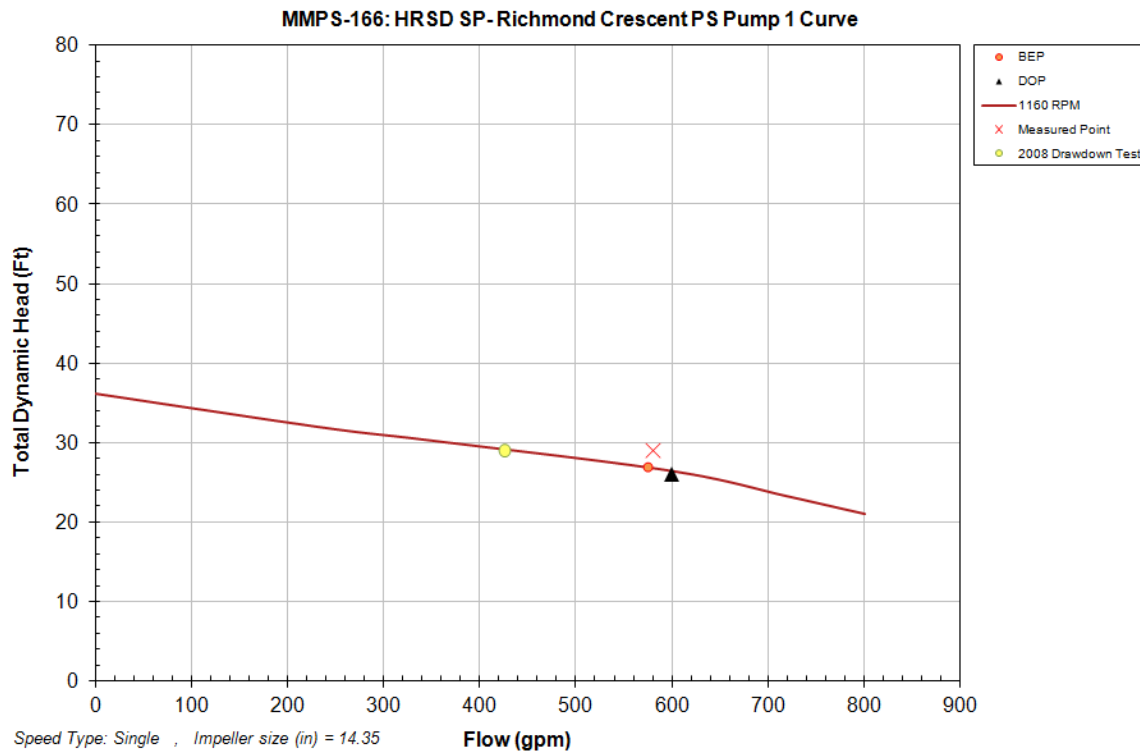
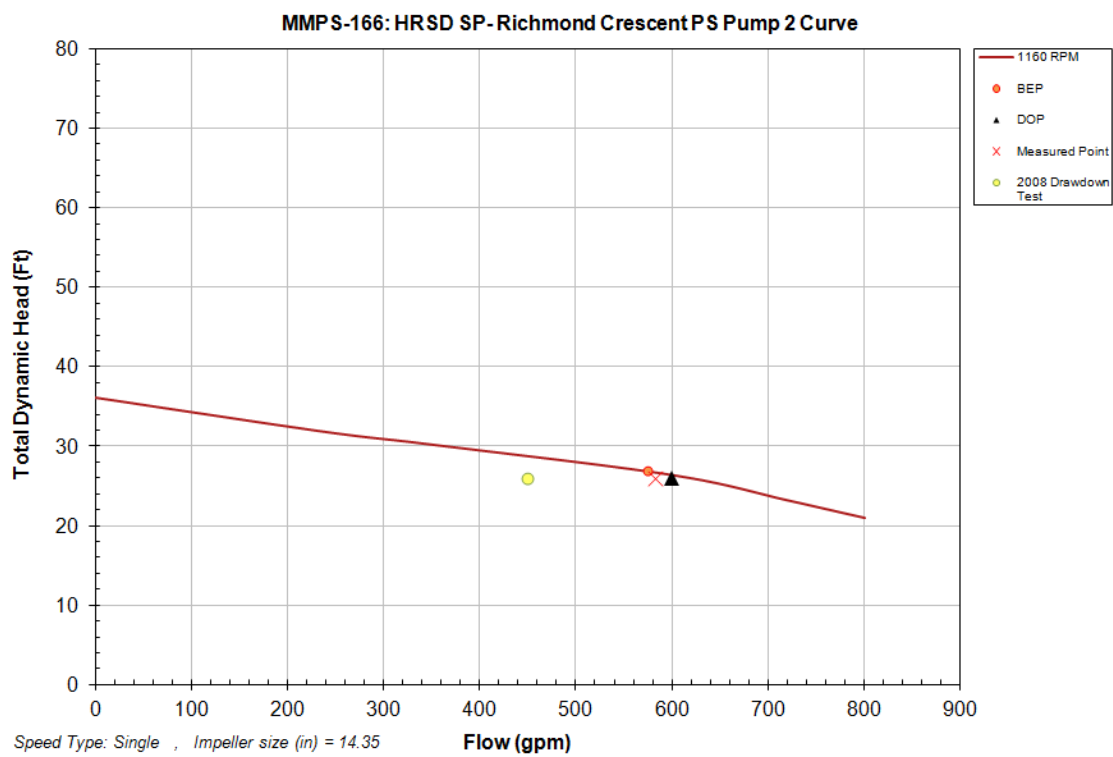
Richmond Crescent PS does not have a discharge pressure sensor with remote indication. The station does not discharge to a manifolded force main so the TDH was assumed based on the results of the 2008 draw down test. The Flow is the average pumping rate.

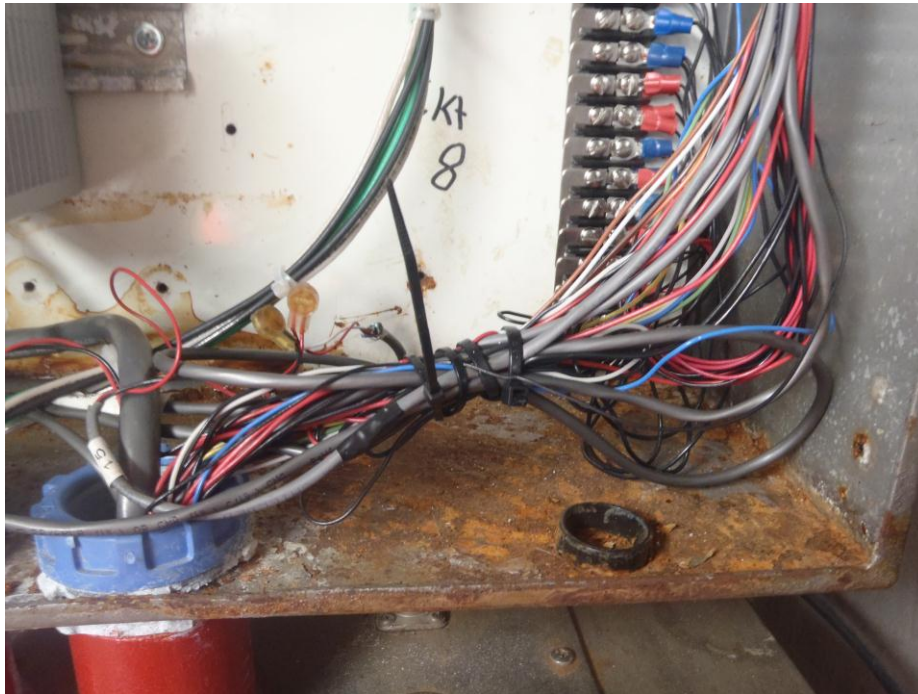
Figure 124-3. SCADA Panel

The SCADA panel is a C&P Region 3 asset because of corrosion.

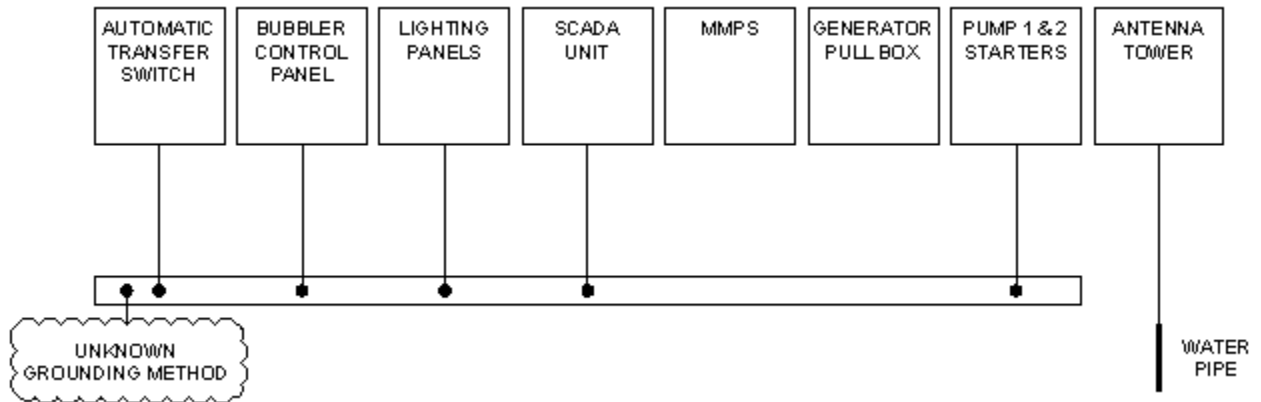
Figure 124-4. Richmond Crescent Grounding System

- Service Entrance Surge Protection Device Installed
- Air Terminals Installed and Bonded to Ground System
- Ground Rod Test Wells Noticeable
- Ground Rods Noticeable
  - 0 Rod(s) Noticeable
- Indications of a Building Ground Ring
- No History of Lightning Strikes
- No History of Failures Resulting in SSO in Past 5 Years
- Equipment properly Surge Protected:
  - SCADA Unit has no surge suppression on coax between Antenna & radio
- Equipment Properly Grounded:
  - Generator pull box & MMPS are not bonded to the station grounding system.

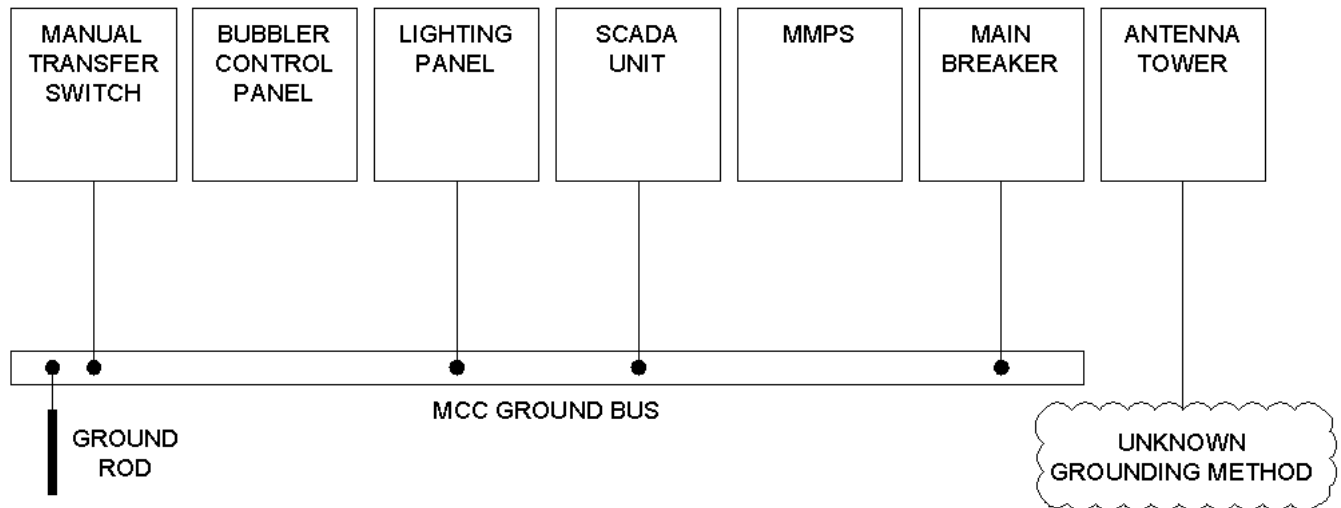
Figure 125-3. Seay Ave Grounding System

- Service Entrance Surge Protection Device Installed
- Air Terminals Installed and Bonded to Ground System
- Ground Rod Test Wells Noticeable
- Ground Rods Noticeable
  - 1 Rod(s) Noticeable
- Indications of a Building Ground Ring
- No History of Lightning Strikes
- No History of Failures Resulting in SSO in Past 5 Years
- Equipment properly Surge Protected:
  - Bubbler control panel is not protected by a surge suppressor.
- Equipment Properly Grounded:
  - Bubbler control panel is not bonded to the station grounding system.

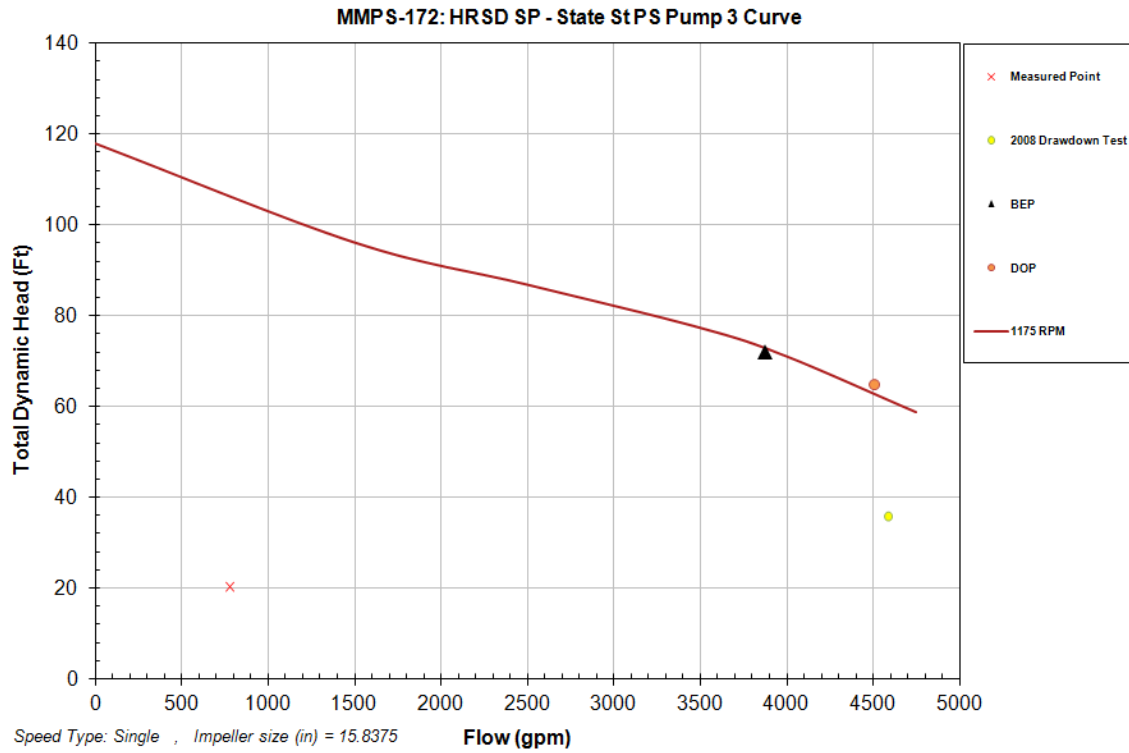
State Street PS uses variable speed Flomatcher pump controls which do not give a remote indication of pump shaft speed. The plotted curve is for the maximum pump shaft speed and the measured point gives an indication of the pumps normal operating range rather than pumping capacity.

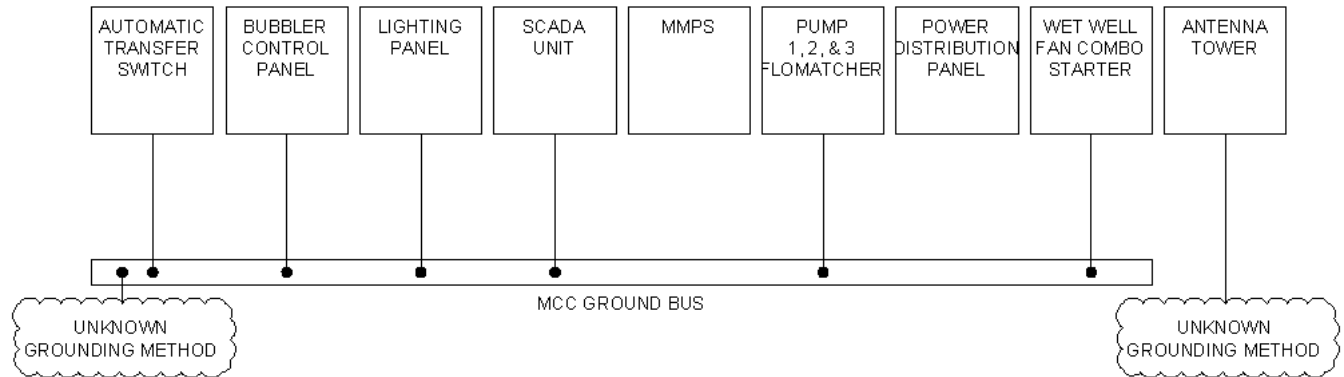
Figure 127-4. State St Grounding System

- Service Entrance Surge Protection Device Installed
- Air Terminals Installed and Bonded to Ground System
- Ground Rod Test Wells Noticeable
- Ground Rods Noticeable
  - 0 Rod(s) Noticeable
- Indications of a Building Ground Ring
- No History of Lightning Strikes
- No History of Failures Resulting in SSO in Past 5 Years
- Equipment properly Surge Protected:
  - SCADA Unit has no surge suppression on coax between Antenna & radio
  - Bubbler control panel & MMPS are not protected by a surge suppressor
- Equipment Properly Grounded:
  - MMPS is not bonded to the station grounding system

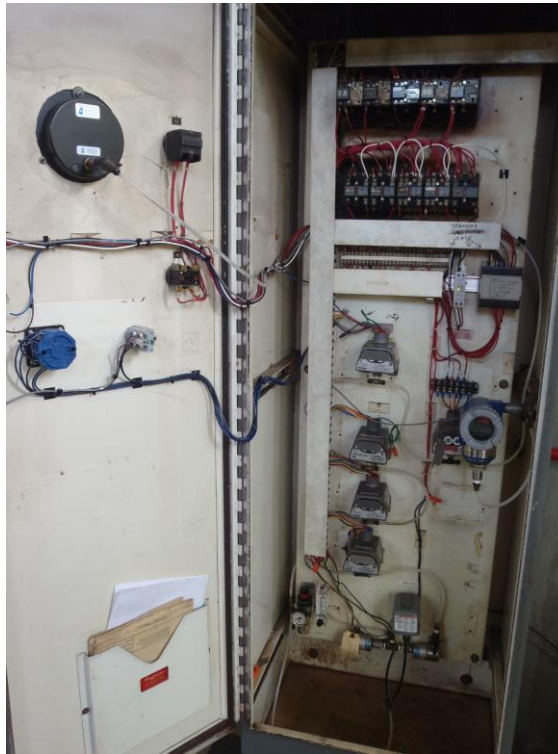
Figure 129-3. Taussig Blvd Bubbler Panel

The wet well fan is scheduled for replacement (CMMS WO # 902524). The bubbler panel shown below is deteriorating and shows evidence of previous fire damage.

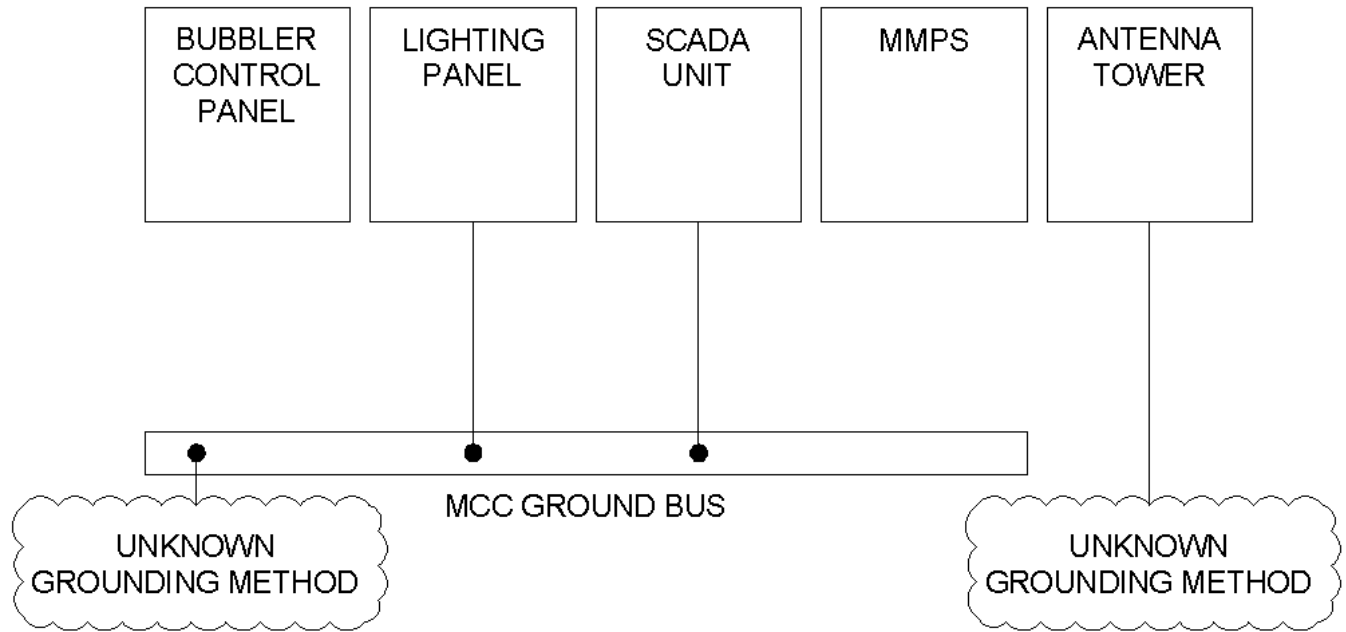
Figure 129-4. Taussig Blvd Grounding System

- Service Entrance Surge Protection Device Installed
- Air Terminals Installed and Bonded to Ground System
- Ground Rod Test Wells Noticeable
- Ground Rods Noticeable
  - 0 Rod(s) Noticeable
- Indications of a Building Ground Ring
- No History of Lightning Strikes
- No History of Failures Resulting in SSO in Past 5 Years
- Equipment properly Surge Protected:
  - SCADA Unit has no surge suppression on coax between Antenna & radio
  - Bubbler control panel is not protected by a surge suppressor
- Equipment Properly Grounded:
  - Bubbler control panel & MMPS are not bonded to the station grounding system

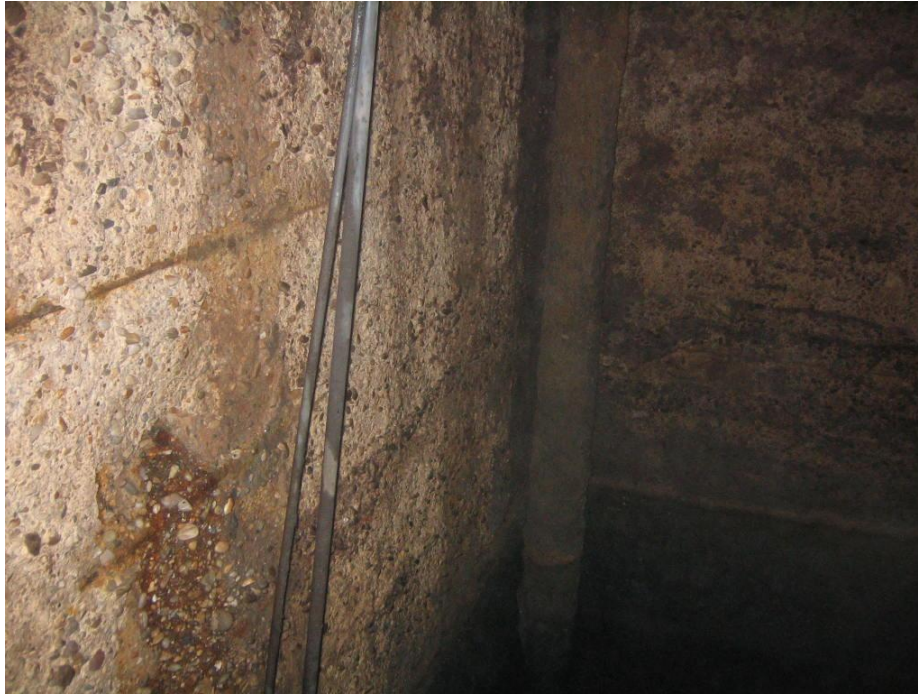
Figure 130-3. Virginia Beach Blvd Wet well

After the initial round of inspections, HRSD used a specialty contractor to revisit select stations for wet well structural inspections including concrete strength tests. Test results showed that the Virginia Beach Blvd wet well is deteriorating.

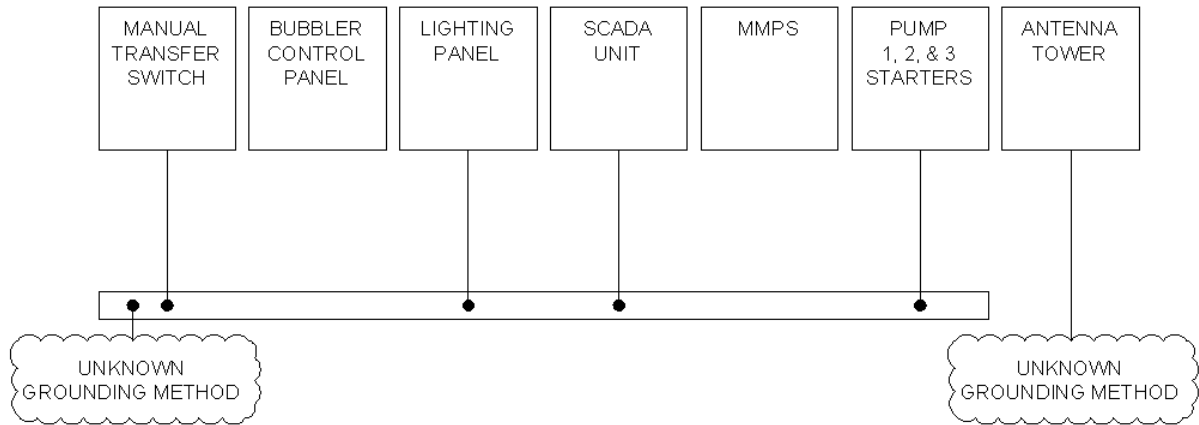
Figure 130-4. Virginia Beach Blvd Grounding System

- Service Entrance Surge Protection Device Installed
- Air Terminals Installed and Bonded to Ground System
- Ground Rod Test Wells Noticeable
- Ground Rods Noticeable
  - 0 Rod(s) Noticeable
- Indications of a Building Ground Ring
- No History of Lightning Strikes
- No History of Failures Resulting in SSO in Past 5 Years
- Equipment properly Surge Protected:
  - SCADA Unit has no surge suppression on coax between Antenna & radio
  - Bubbler control panel is not protected by a surge suppressor
- Equipment Properly Grounded:
  - Bubbler control panel & MMPS are not bonded to the station grounding system

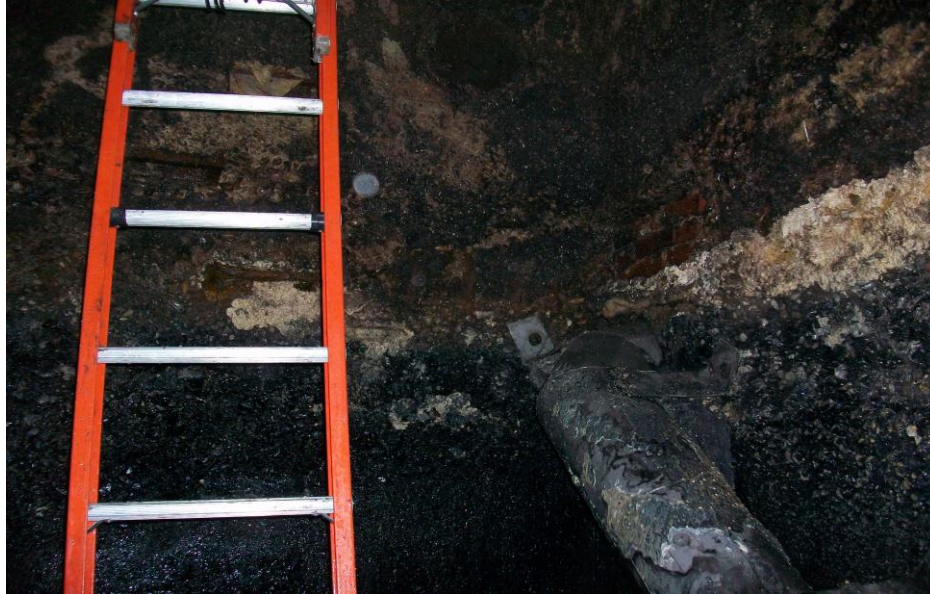
Figure 131-3. Washington District Wet Well

After the initial round of inspections, HRSD used a specialty contractor to revisit select stations for wet well structural inspections including concrete strength tests. Test results showed that the Washington District wet well is deteriorating.

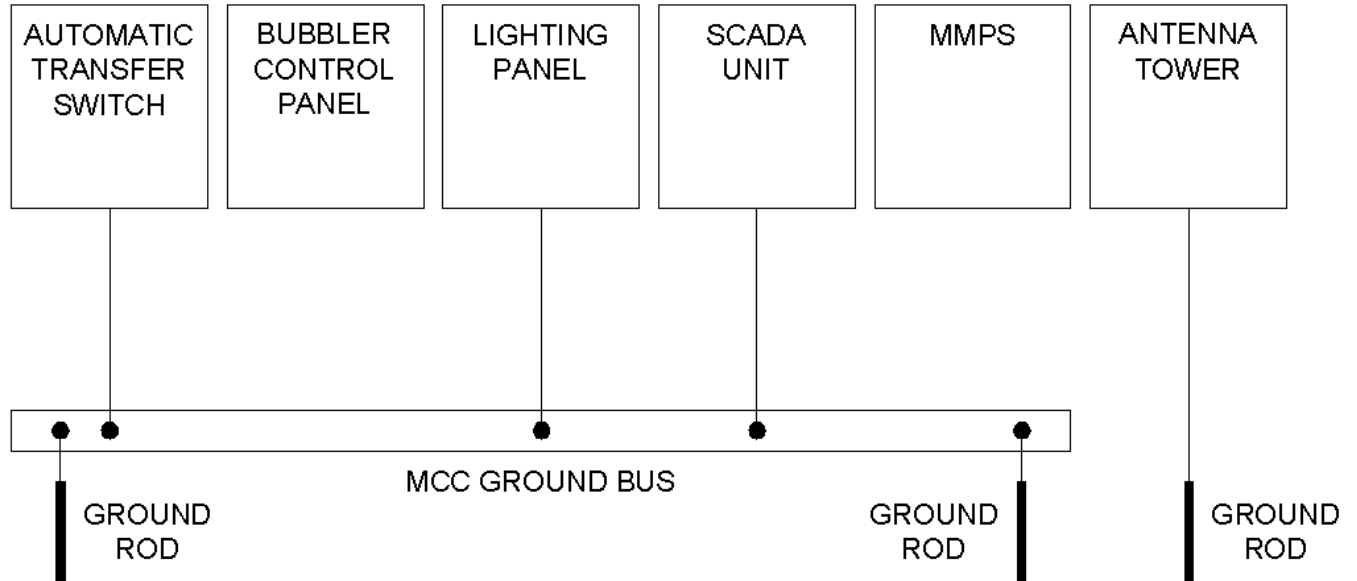
Figure 131-4. Washington District Grounding System

- Service Entrance Surge Protection Device Installed
- Air Terminals Installed and Bonded to Ground System
- Ground Rod Test Wells Noticeable
- Ground Rods Noticeable
  - 4 Rod(s) Noticeable
- Indications of a Building Ground Ring
- No History of Lightning Strikes
- No History of Failures Resulting in SSO in Past 5 Years
- Equipment properly Surge Protected:
  - SCADA Unit has no surge suppression on coax between Antenna & radio
  - Bubbler control panel & MMPS are not protected by a surge suppressor
- Equipment Properly Grounded:
  - Bubbler control panel & MMPS are not bonded to the station grounding system

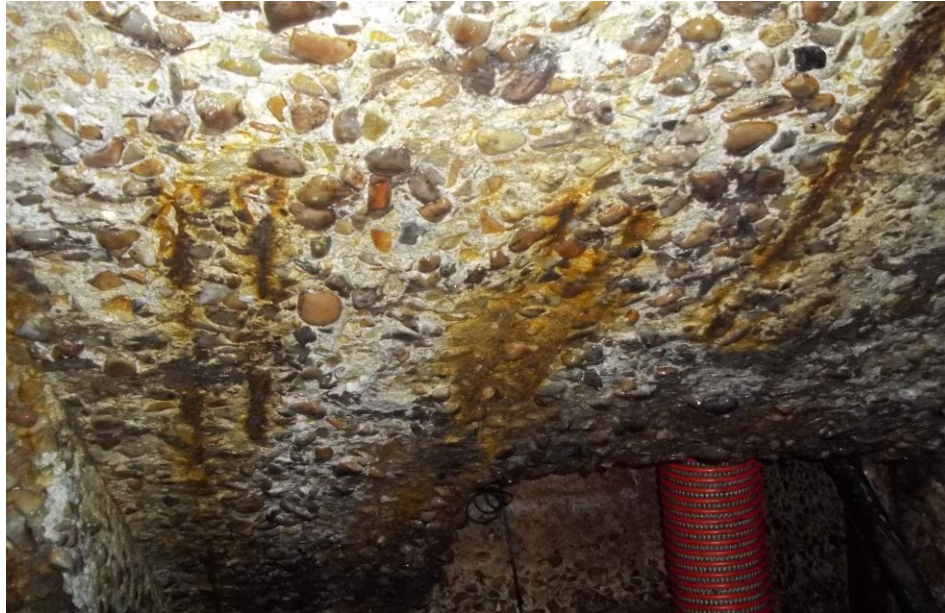
Figure 132-3. Willoughby Ave Wet well

After the initial round of inspections, HRSD used a specialty contractor to revisit select stations for wet well structural inspections including concrete strength tests. Test results showed that the Willoughby Ave wet well is deteriorating.

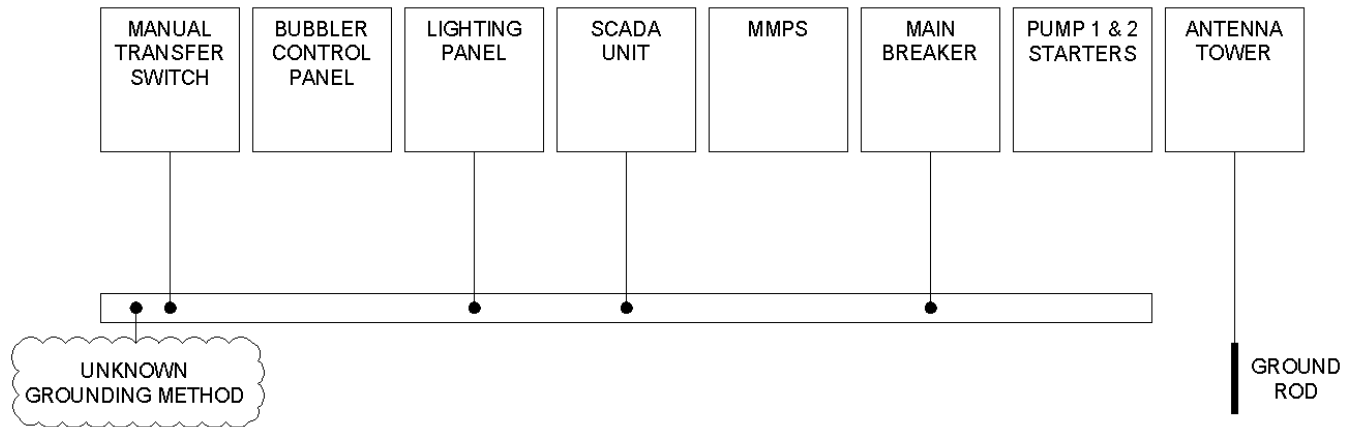
Figure 132-4. Willoughby Ave Grounding System

- Service Entrance Surge Protection Device Installed
- Air Terminals Installed and Bonded to Ground System
- Ground Rod Test Wells Noticeable
- Ground Rods Noticeable
  - 1 Rod(s) Noticeable
- Indications of a Building Ground Ring
- No History of Lightning Strikes
- No History of Failures Resulting in SSO in Past 5 Years
- Equipment properly Surge Protected:
  - SCADA Unit has no surge suppression on coax between Antenna & radio
  - Bubbler control panel is not protected by a surge suppressor
- Equipment Properly Grounded:
  - Bubbler control panel, motor starters, & MMPS are not bonded to the station grounding system

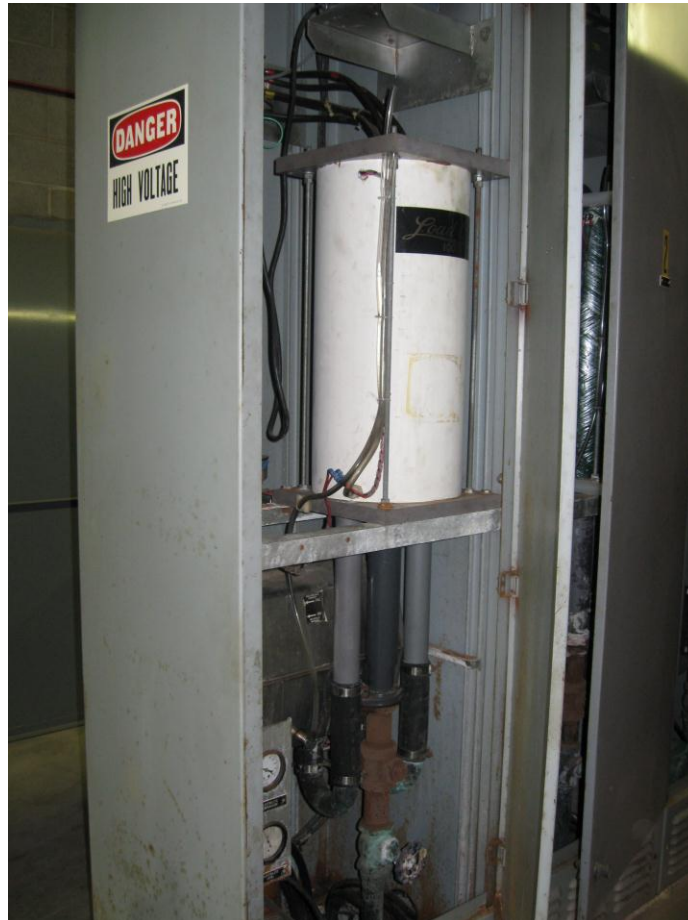
Figure 133-3. Providence Rd Flomatcher

The station uses Flomatcher pump controllers. This station is scheduled for improvements and / or replacement in the Interim System Improvements.

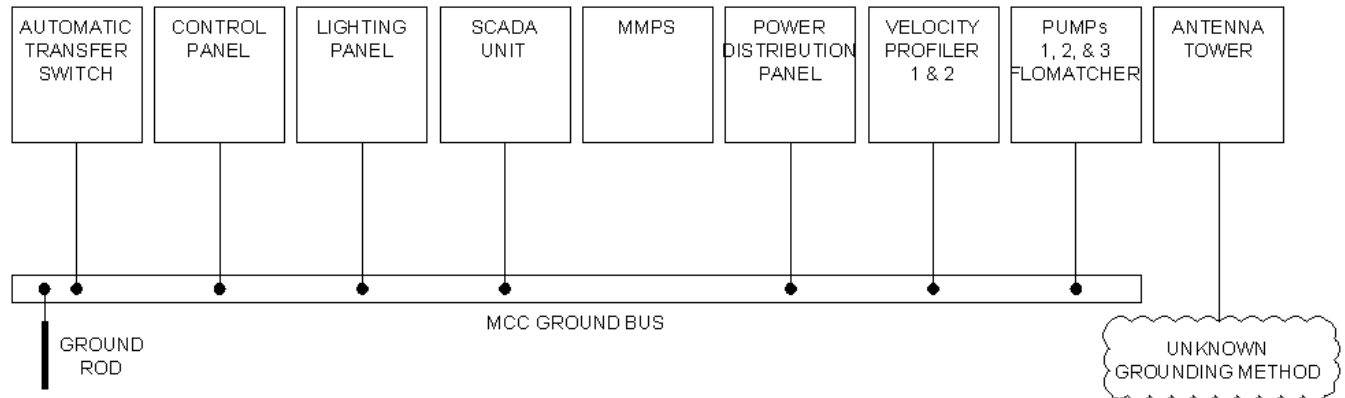
Figure 133-4. Providence Rd Grounding System

- Service Entrance Surge Protection Device Installed
- Air Terminals Installed and Bonded to Ground System
- Ground Rod Test Wells Noticeable
- Ground Rods Noticeable
  - 1 Rod(s) Noticeable
- Indications of a Building Ground Ring
- No History of Lightning Strikes
- No History of Failures Resulting in SSO in Past 5 Years
- Equipment properly Surge Protected:
  - SCADA Unit has no surge suppression on coax between Antenna & radio
  - Control panel & velocity profilers are not protected by a surge suppressor

- Equipment Properly Grounded:
  - MMPS is not bonded to the station grounding system

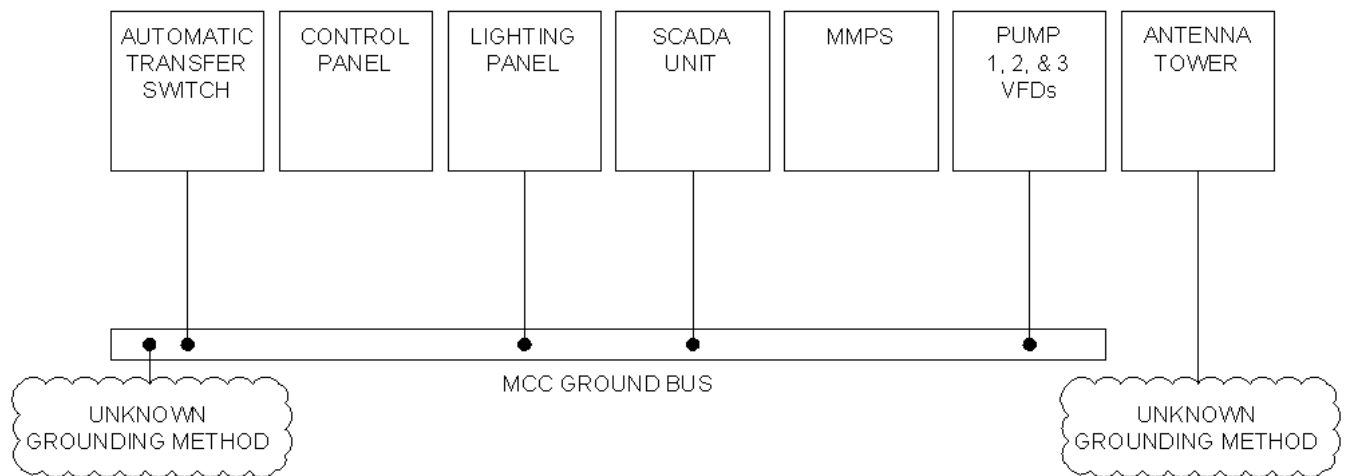
Figure 134-3. Pughsville Grounding System

- Service Entrance Surge Protection Device Installed
- Air Terminals Installed and Bonded to Ground System
- Ground Rod Test Wells Noticeable
- Ground Rods Noticeable
  - 0 Rod(s) Noticeable
- Indications of a Building Ground Ring
- No History of Lightning Strikes
- No History of Failures Resulting in SSO in Past 5 Years
- Equipment properly Surge Protected:
  - SCADA Unit has no surge suppression on coax between Antenna & radio
- Equipment Properly Grounded:
  - Control panel & MMPS are not bonded to the station grounding system

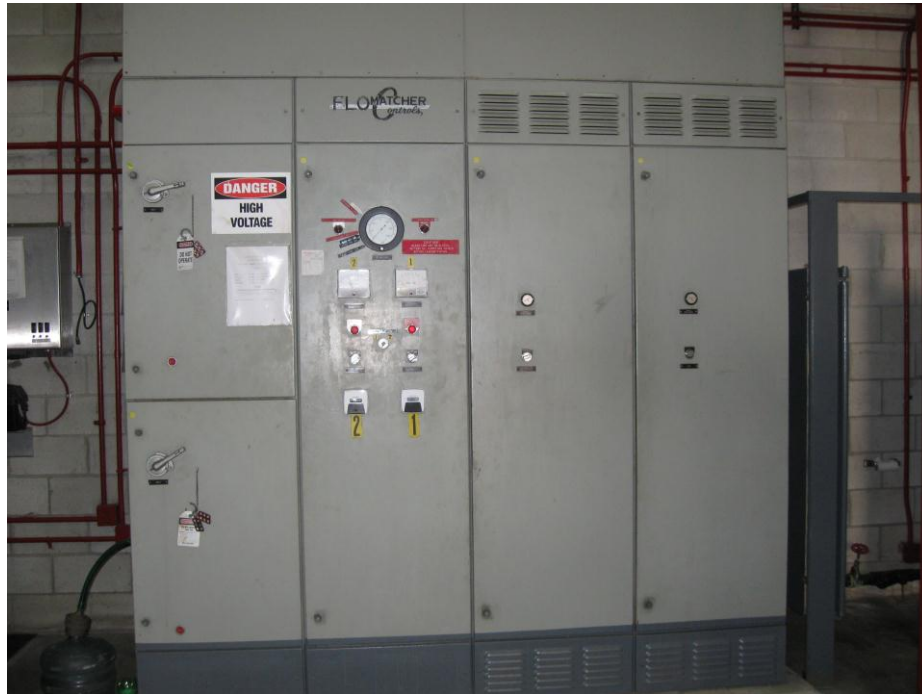
Figure 135-3. Suffolk PS Flomatcher

The station uses Flomatcher pump controllers. This station is scheduled for improvements and / or replacement in the Interim System Improvements.
