# Appendix B: Pump Station Final Condition Assessment Report

This report is an Appendix to HRSD's Rehabilitation Action (Rehab) Plan to satisfy the requirements of the United State's Environmental Protection Agency (EPA) Consent Decree as well as the Virginia Department of Environmental Quality (DEQ) Special Order by Consent (SOC) for reporting on results of the Condition Assessment Program (CAP). This document summarizes condition assessment results related to HRSD's pumping facilities. Appendices A, C, D, and E satisfy the remaining reporting requirements of the CAP. Assets found at material risk of failure, as described further in this report, are addressed in the main document, the Rehab Plan. The primary purpose of the HRSD CAP was to find sanitary sewer assets presenting an actual material risk of failure. For the purposes of this document, "failure" means any condition resulting in a sanitary sewer overflow, pipe leakage, or interruption of service to HRSD's customers, due to a physical condition defect in the system.

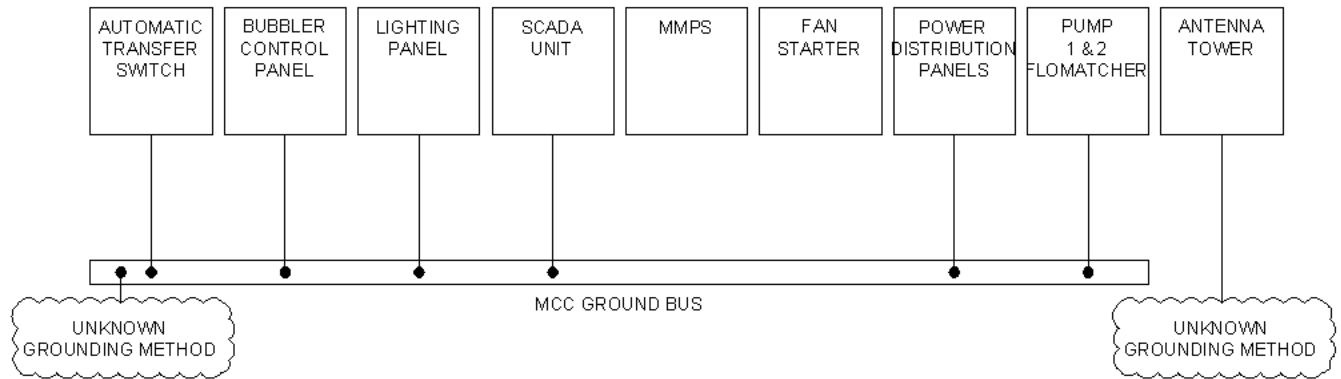
Figure 135-4. Suffolk Grounding System

- Service Entrance Surge Protection Device Installed
- Air Terminals Installed and Bonded to Ground System
- Ground Rod Test Wells Noticeable
- Ground Rods Noticeable
  - 0 Rod(s) Noticeable
- Indications of a Building Ground Ring
- No History of Lightning Strikes
- No History of Failures Resulting in SSO in Past 5 Years
- Equipment properly Surge Protected:
  - SCADA Unit has no surge suppression on coax between Antenna & radio
  - Bubbler control panel is not protected by a surge suppressor
- Equipment Properly Grounded:
  - MMPS & motor starters are not bonded to the station grounding system

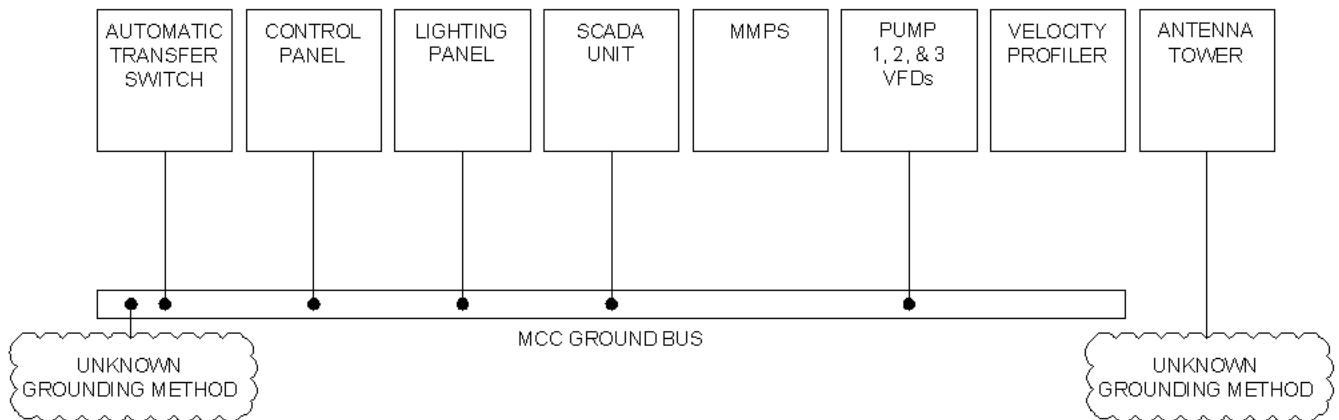
Figure 137-3. Bowers Hill Grounding System

- Service Entrance Surge Protection Device Installed
- Air Terminals Installed and Bonded to Ground System
- Ground Rod Test Wells Noticeable
- Ground Rods Noticeable
  - 0 Rod(s) Noticeable
- Indications of a Building Ground Ring
- No History of Lightning Strikes
- No History of Failures Resulting in SSO in Past 5 Years
- Equipment properly Surge Protected:
  - SCADA Unit has no surge suppression on coax between Antenna & radio
  - Velocity profiler is not protected by a surge suppressor
- Equipment Properly Grounded:
  - MMPS is not bonded to the station grounding system

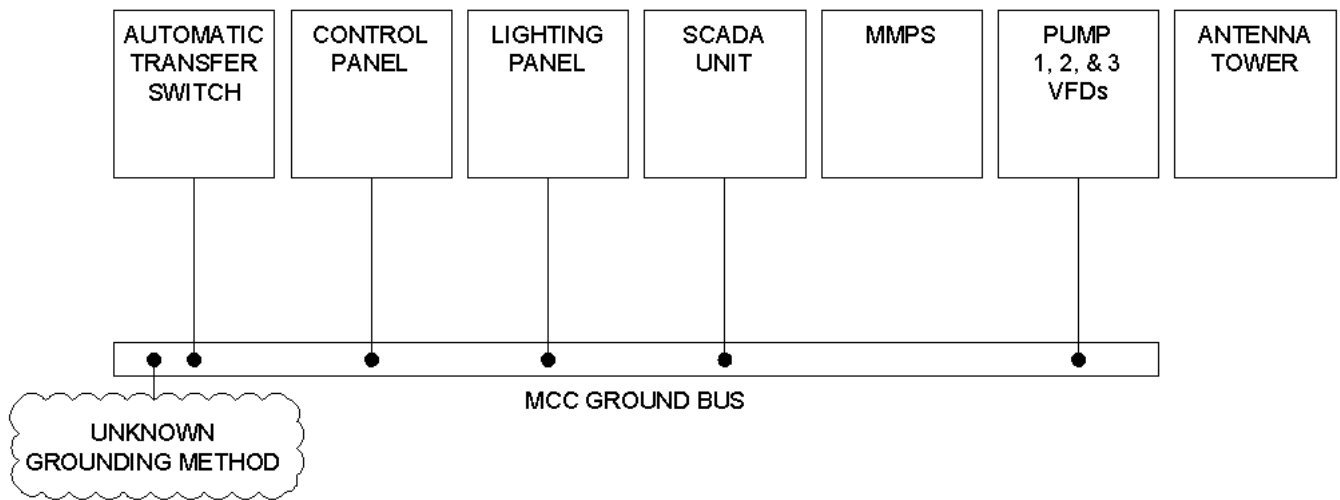
Figure 138-3. Deep Creek Grounding System

- Service Entrance Surge Protection Device Installed
- Air Terminals Installed and Bonded to Ground System
- Ground Rod Test Wells Noticeable
- Ground Rods Noticeable
  - 0 Rod(s) Noticeable
- Indications of a Building Ground Ring
- No History of Lightning Strikes
- No History of Failures Resulting in SSO in Past 5 Years
- Equipment properly Surge Protected:
  - SCADA Unit has no surge suppression on coax between Antenna & radio
- Equipment Properly Grounded:
  - MMPS is not bonded to the station grounding system

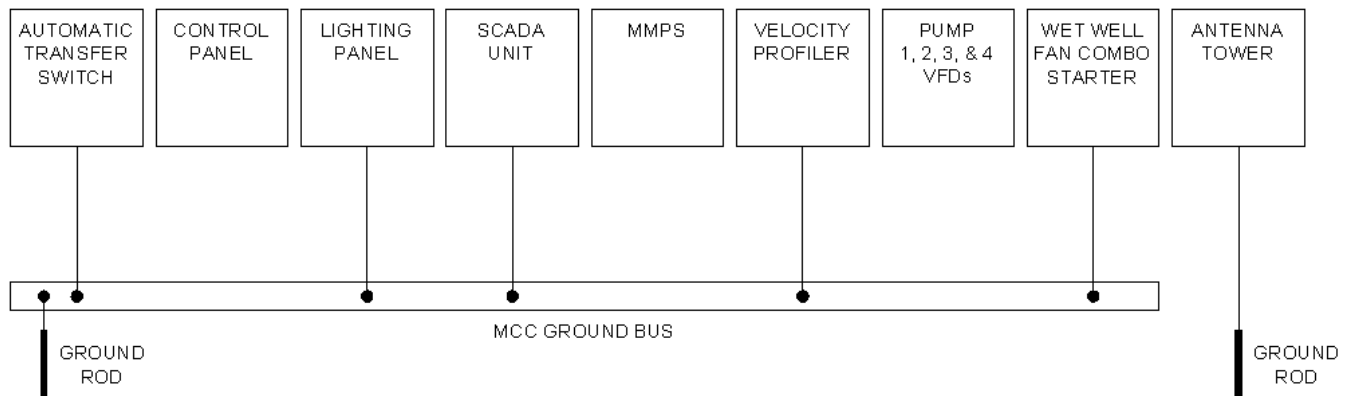
Figure 139-3. Quail Ave PRS Grounding System

- Service Entrance Surge Protection Device Installed
- Air Terminals Installed and Bonded to Ground System
- Ground Rod Test Wells Noticeable
- Ground Rods Noticeable
  - 1 Rod(s) Noticeable
- Indications of a Building Ground Ring
- No History of Lightning Strikes
- No History of Failures Resulting in SSO in Past 5 Years
- Equipment properly Surge Protected:
  - SCADA Unit has no surge suppression on coax between Antenna & radio
  - Velocity profiler is not protected by a surge suppressor
- Equipment Properly Grounded:
  - MMPS & control panel are not bonded to the station grounding system

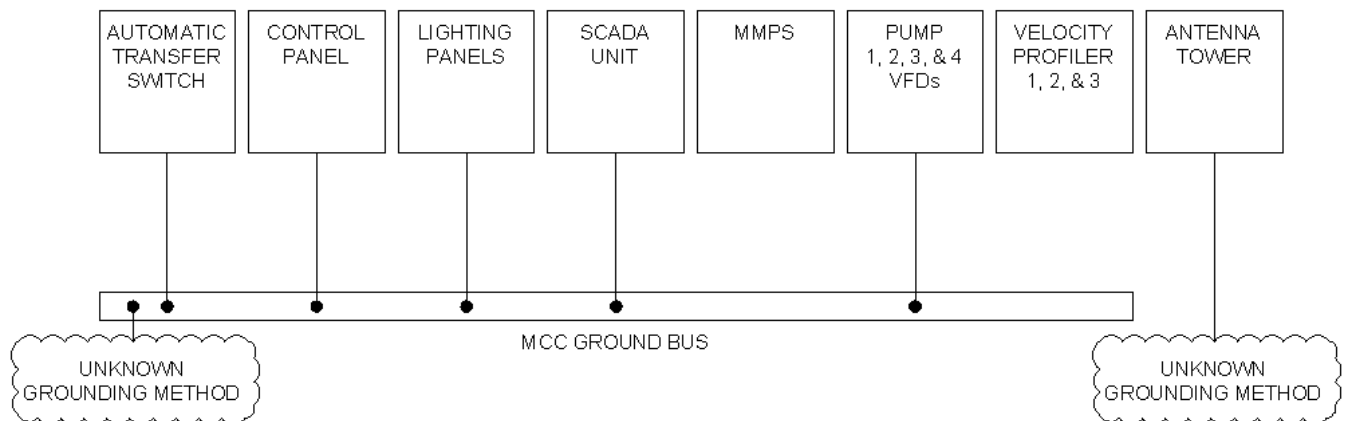
Figure 140-3. Atlantic Ave Grounding System

- Service Entrance Surge Protection Device Installed
- Air Terminals Installed and Bonded to Ground System
- Ground Rod Test Wells Noticeable
- Ground Rods Noticeable
  - 0 Rod(s) Noticeable
- Indications of a Building Ground Ring
- No History of Lightning Strikes
- No History of Failures Resulting in SSO in Past 5 Years
- Equipment properly Surge Protected:
  - SCADA Unit has no surge suppression on coax between Antenna & radio
  - Velocity profiler & control panel are not protected by a surge suppressor
- Equipment Properly Grounded:
  - MMPS is not bonded to the station grounding system

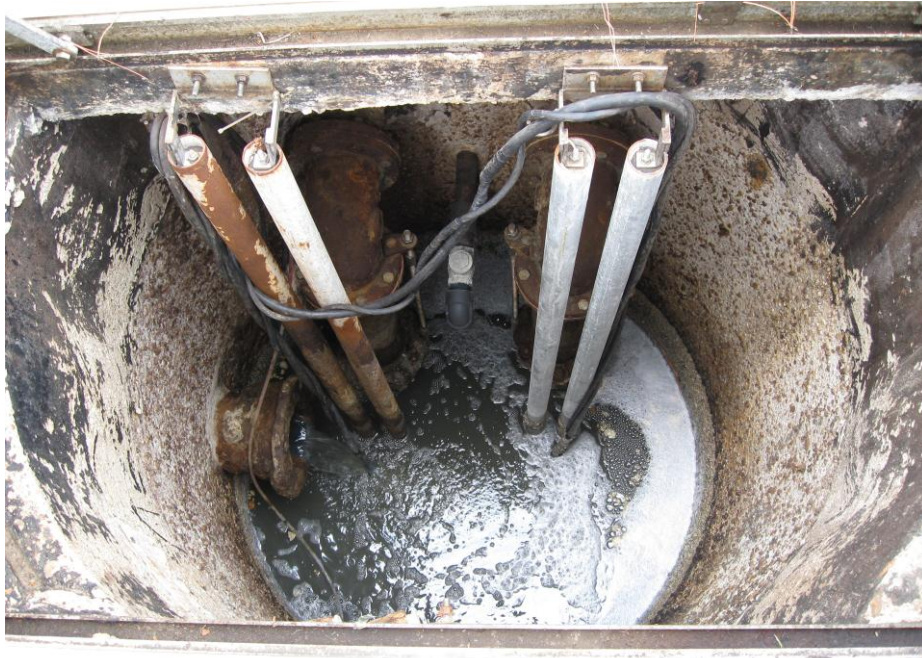
Figure 141-3. Hanover Ave Wet Well

PS	PS Name	Asset Type	Asset Description	Condition Rating	Performance Rating	Field Observations	Recommendation	Comments	Region
141	Hanover Avenue	Wet well	Wet well	4	1	Concrete Spalling	Schedule Corrective Action	Pump 2 rails corroded badly compared to pump 1. Influent has a high drop next to pump 2 rails. Wet well has no ventilation lines. 5/2012: HRSD PM inspection on 01/26/2012 indicates no major changes from the 2008 wet well data.	3
141	Hanover Avenue	Motor 1	Wastewater Pump Motor and Controller	2	1	Good	No Immediate Action Required	No Comment	1
141	Hanover Avenue	Motor 2	Wastewater Pump Motor and Controller	2	1	Good	No Immediate Action Required	No Comment	1
141	Hanover Avenue	Pump 1	Pump	2	1	Good	No Immediate Action Required	No Comment	1
141	Hanover Avenue	Pump 2	Pump	2	1	Good	No Immediate Action Required	No Comment	1
141	Hanover Avenue	Valves System	All Station Valves	2	1	Good	No Immediate Action Required	6/11: HRSD inspections indicate no problems with isolation valve operation.	1

The wet well is deteriorating.

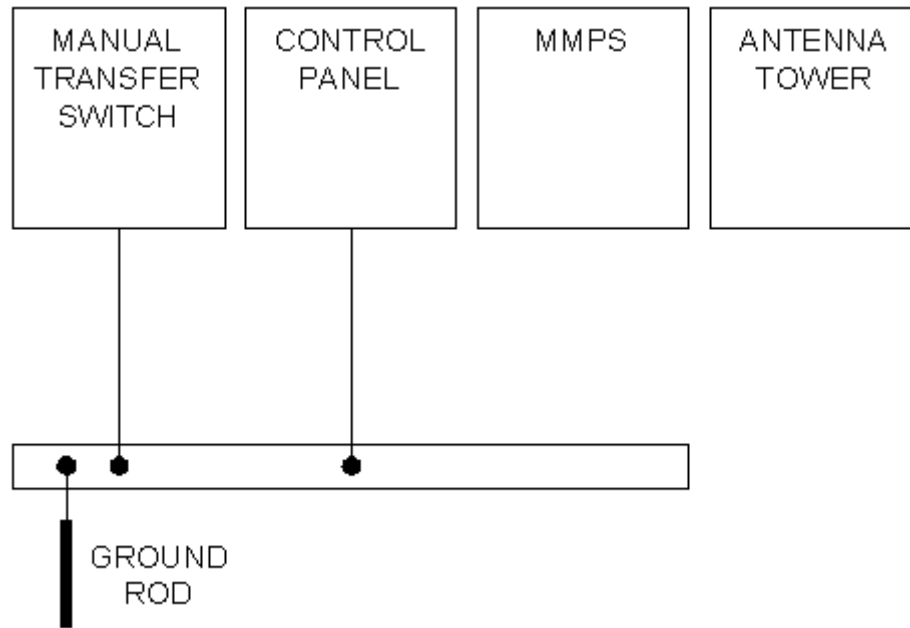
Figure 141-4. Hanover Ave Grounding System

- Service Entrance Surge Protection Device Installed
- Air Terminals Installed and Bonded to Ground System
- Ground Rod Test Wells Noticeable
- Ground Rods Noticeable
  - 1 Rod(s) Noticeable
- Indications of a Building Ground Ring
- No History of Lightning Strikes
- No History of Failures Resulting in SSO in Past 5 Years
- Equipment properly Surge Protected:
  - SCADA Unit has no surge suppression on coax between Antenna & radio
  - MMPS is not protected by a surge suppressor
- Equipment properly Grounded:
  - MMPS is not bonded to the station grounding system

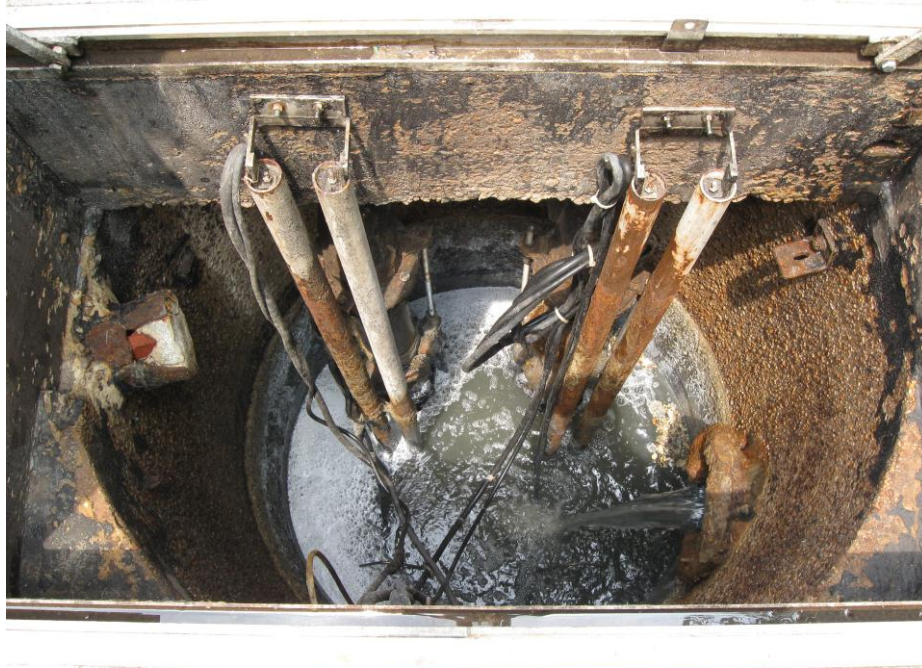
Figure 142-3. Jamestown Crescent Wet Well

PS	PS Name	Asset Type	Asset Description	Condition Rating	Performance Rating	Field Observations	Recommendation	Comments	Region
142	Jamestown Crescent	Wet well	Wet well	4	1	None	Schedule Corrective Action	New guide rails were installed 01/20/2012. 5/2012: HRSD PM inspection on 01/26/2012 no major changes since 2008 wet well data.	3
142	Jamestown Crescent	Motor 1	Wastewater Pump Motor and Controller	2	1	Good	No Immediate Action Required	No Comment	1
142	Jamestown Crescent	Motor 2	Wastewater Pump Motor and Controller	2	1	Good	No Immediate Action Required	No Comment	1
142	Jamestown Crescent	Pump 1	Pump	2	1	Good	No Immediate Action Required	Pump mounting rails corroded. (Replaced 01/20/2012)	1
142	Jamestown Crescent	Pump 2	Pump	2	1	Good	No Immediate Action Required	Pump mounting rails corroded. (Replaced 01/20/2012)	1
142	Jamestown Crescent	Valves System	All Station Valves	2	1	Good	No Immediate Action Required	6/11: HRSD inspections indicate no problems with isolation valve operation.	1

The wet well is deteriorating.

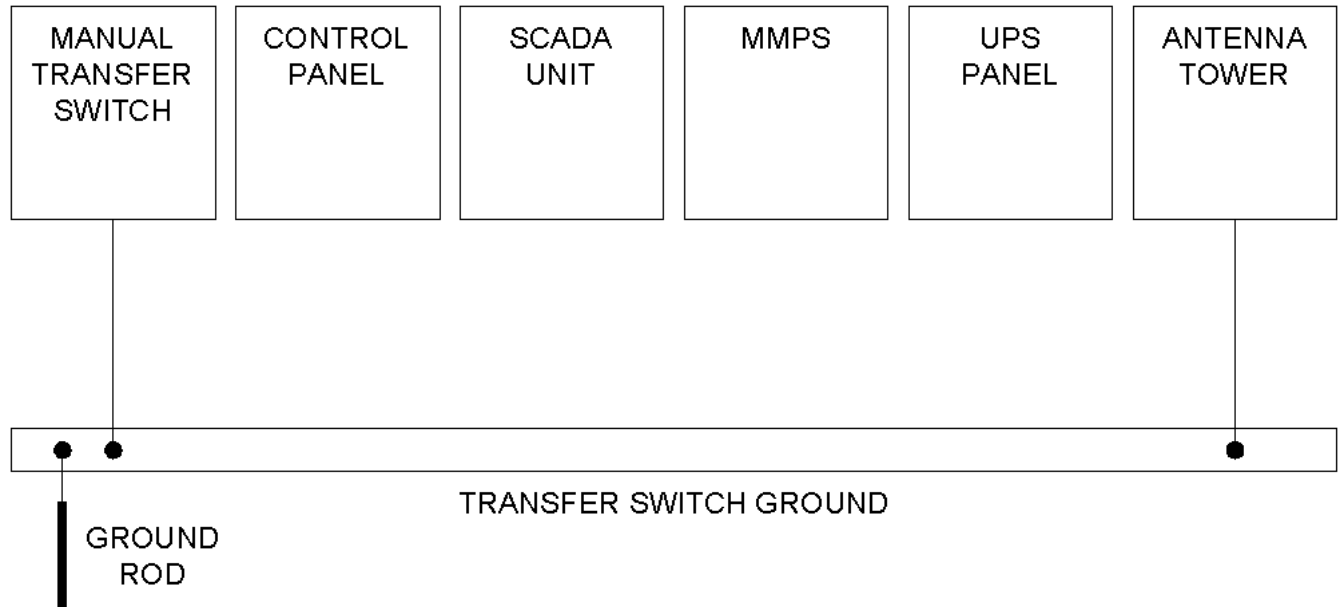
Figure 142-4. Jamestown Crescent Grounding System

- Service Entrance Surge Protection Device Installed
- Air Terminals Installed and Bonded to Ground System
- Ground Rod Test Wells Noticeable
- Ground Rods Noticeable
  - 1 Rod(s) Noticeable
- Indications of a Building Ground Ring
- No History of Lightning Strikes
- No History of Failures Resulting in SSO in Past 5 Years
- Equipment properly Surge Protected:
  - SCADA Unit has no surge suppression on coax between Antenna & radio
- Equipment properly Grounded:
  - MMPS, SCADA Unit, starter Panel, & UPS panel are not bonded to the station grounding system

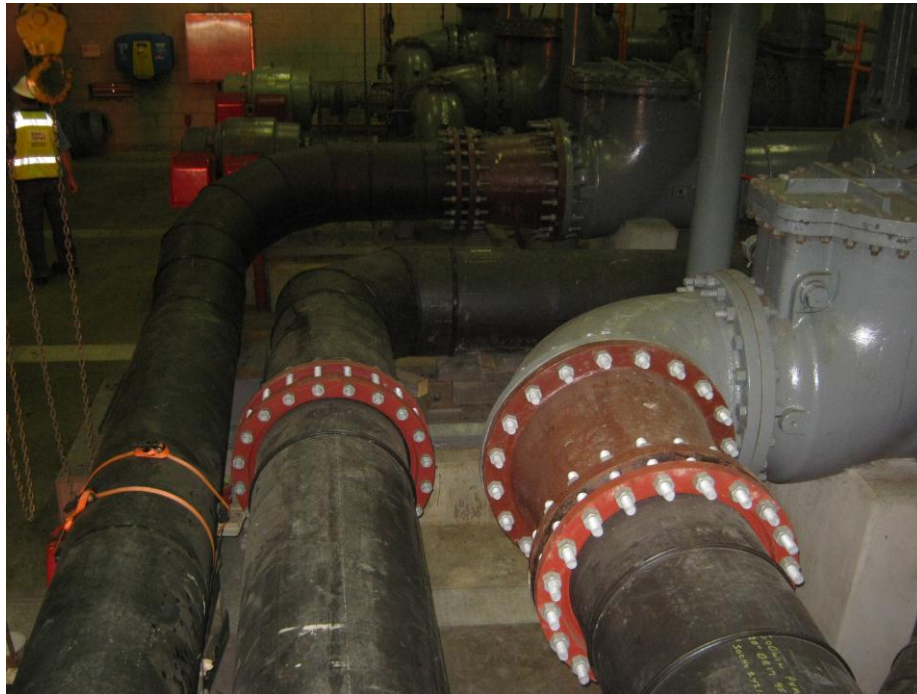
There are three diesel-driven pumps onsite that are hard piped into the two spots where station pumps #1 and #2 were removed. The station uses flomatcher pump controllers.

Figure 143-3. Shipp's Corner HDPE Diesel-Driven Pump Piping

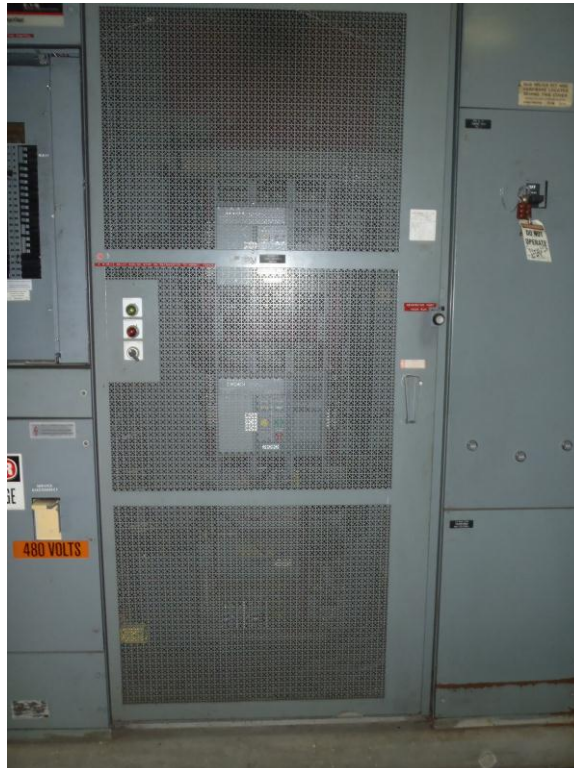
**Figure 143-5. Transfer Switch**

143	Shippo Corner	Transfer Switch	Transfer Switch	2	2	Good	No Immediate Action Required	Panel door should be considered for replacement.	1
143	Shippo Corner	Engine	Generator Drive Engine	2	1	Good	No Immediate Action Required	No Comment	1

The door panel to the automatic transfer switch requires action.

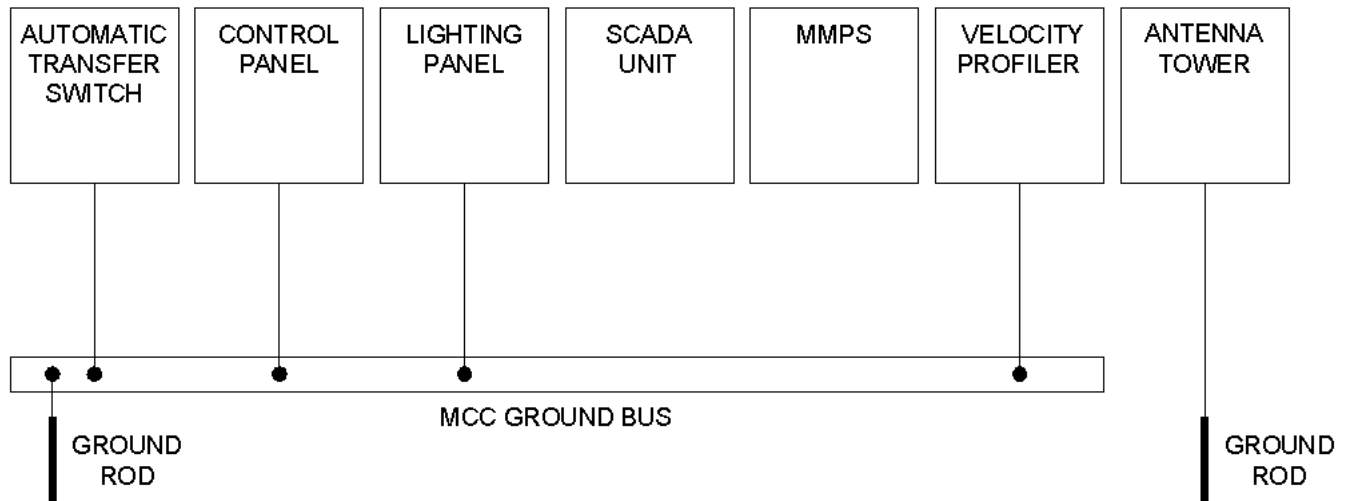
Figure 143-6. Shippo Corner Grounding System

- Service Entrance Surge Protection Device Installed
- Air Terminals Installed and Bonded to Ground System
- Ground Rod Test Wells Noticeable
- Ground Rods Noticeable
  - 1 Rod(s) Noticeable
- Indications of a Building Ground Ring
- No History of Lightning Strikes
- No History of Failures Resulting in SSO in Past 5 Years
- Equipment properly Surge Protected:
  - SCADA Unit has no surge suppression on coax between Antenna & radio
  - Velocity profiler & control panel are not protected by a surge suppressor
- Equipment properly Grounded:
  - MMPS & SCADA Unit are not bonded to the station grounding system
  - Replace MCC ground wire, it is corroded

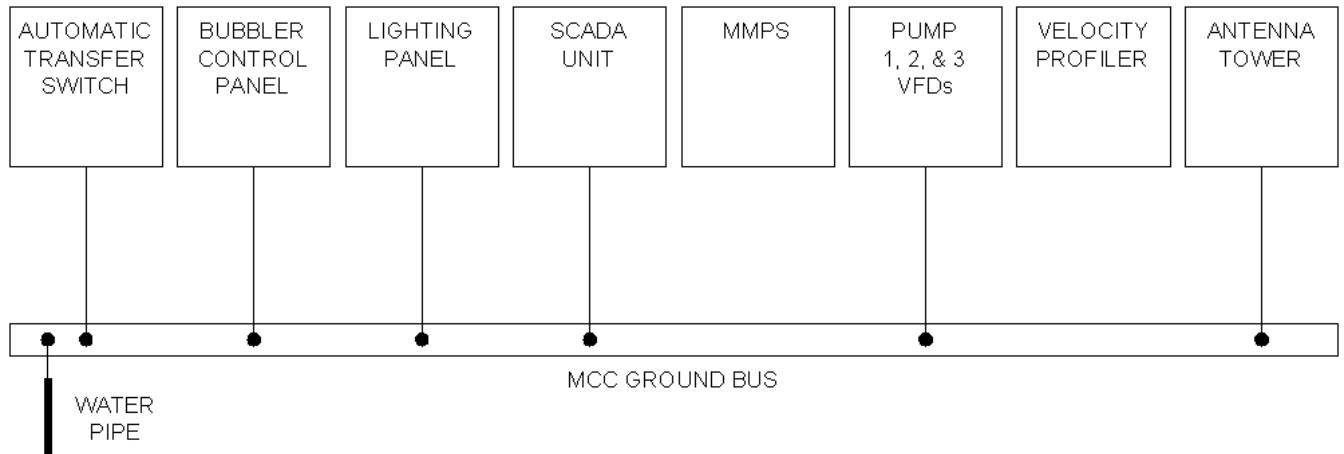
Figure 144-3. Elmhurst Ln Grounding System

- Service Entrance Surge Protection Device Installed
- Air Terminals Installed and Bonded to Ground System
- Ground Rod Test Wells Noticeable
- Ground Rods Noticeable
  - 0 Rod(s) Noticeable
- Indications of a Building Ground Ring
- No History of Lightning Strikes
- No History of Failures Resulting in SSO in Past 5 Years
- Equipment properly Surge Protected:
  - SCADA Unit has no surge suppression on coax between Antenna & radio
  - Velocity profiler is not protected by a surge suppressor
- Equipment properly Grounded:
  - MMPS & velocity profiler are not bonded to the station grounding system

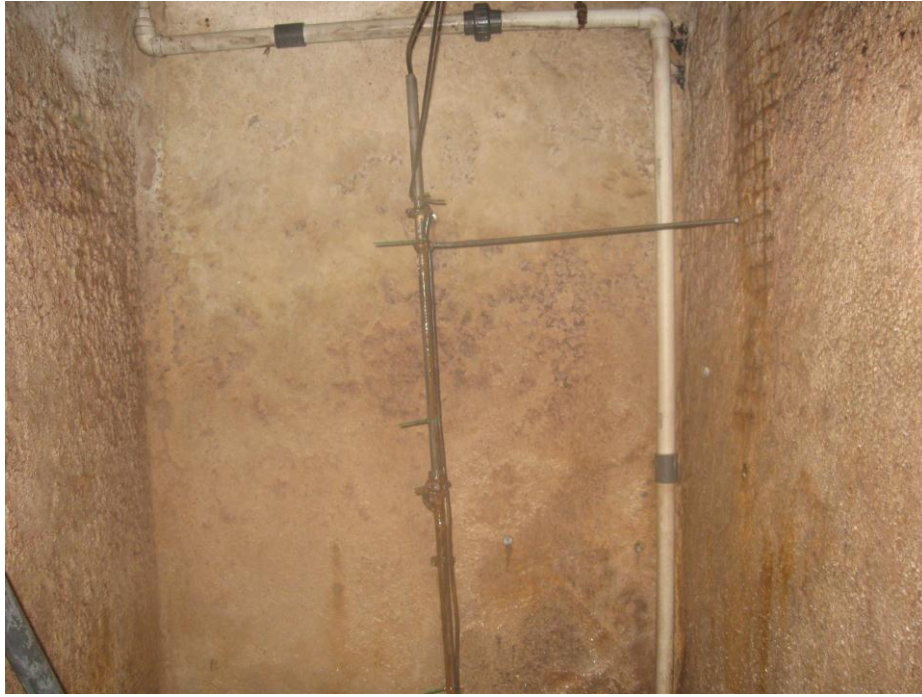
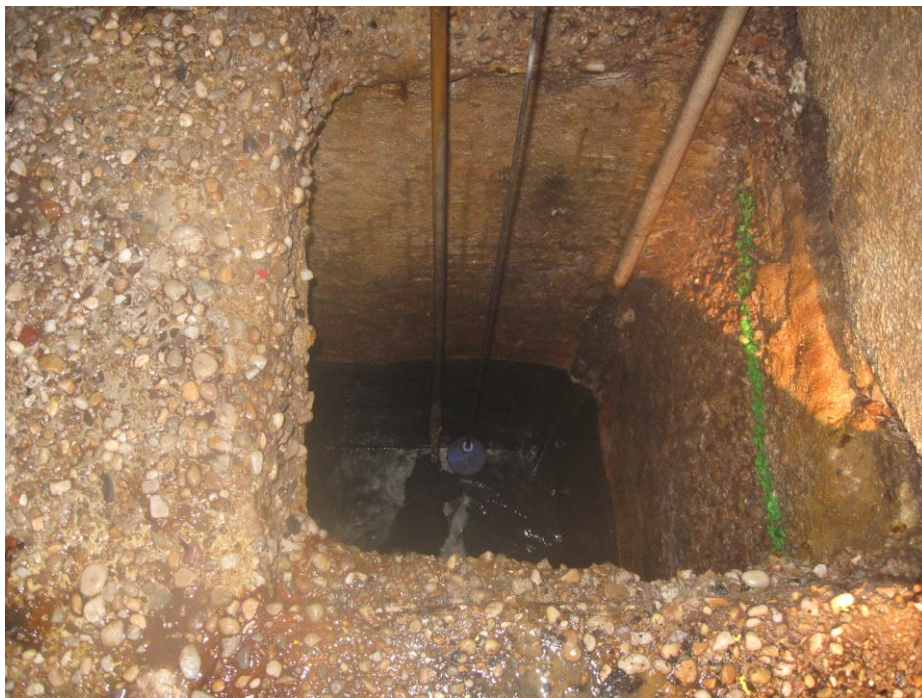
After the initial round of inspections, HRSD used a specialty contractor to revisit select stations for wet well structural inspections including concrete strength tests. Test results showed that the Rodman Ave wet well is deteriorating. This wet well will be addressed under the Prompt Repair Program.

Figure 145-3. Rodman Ave Wet Well Walls

Figure 145-4. Rodman Ave Wet Well Deck

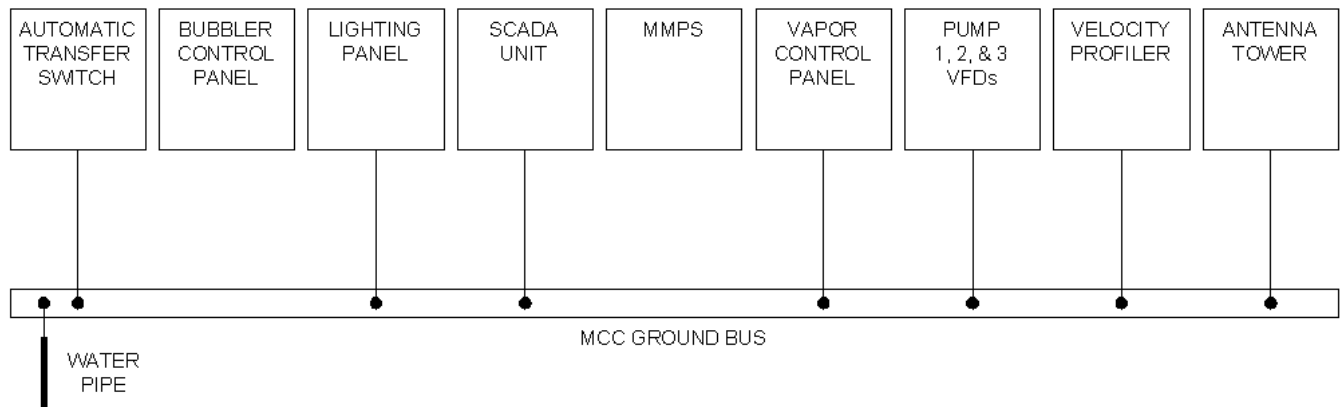
Figure 145-5. Rodman Ave Grounding System

- Service Entrance Surge Protection Device Installed
- Air Terminals Installed and Bonded to Ground System
- Ground Rod Test Wells Noticeable
- Ground Rods Noticeable
  - 0 Rod(s) Noticeable
- Indications of a Building Ground Ring
- No History of Lightning Strikes
- No History of Failures Resulting in SSO in Past 5 Years
- Equipment properly Surge Protected:
  - SCADA Unit has no surge suppression on coax between Antenna & radio
  - Velocity profiler, vapor control panel, & bubbler control panel are not protected by a surge suppressor
- Equipment properly Grounded:
  - MMPS, bubbler control panel, & velocity profiler are not bonded to the station grounding system

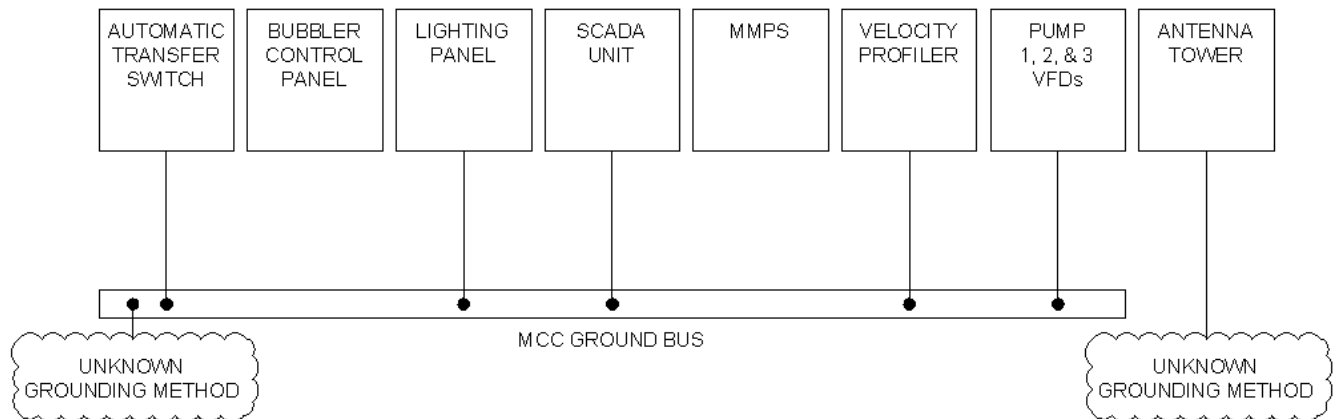
Figure 146-3. Camden Ave Grounding System

- Service Entrance Surge Protection Device Installed
- Air Terminals Installed and Bonded to Ground System
- Ground Rod Test Wells Noticeable
- Ground Rods Noticeable
  - 0 Rod(s) Noticeable
- Indications of a Building Ground Ring
- No History of Lightning Strikes
- No History of Failures Resulting in SSO in Past 5 Years
- Equipment properly Surge Protected:
  - SCADA Unit has no surge suppression on coax between Antenna & radio
  - Bubbler control panel is not protected by a surge suppressor
- Equipment properly grounded:
  - MMPS & bubbler control panel are not bonded to the station grounding system

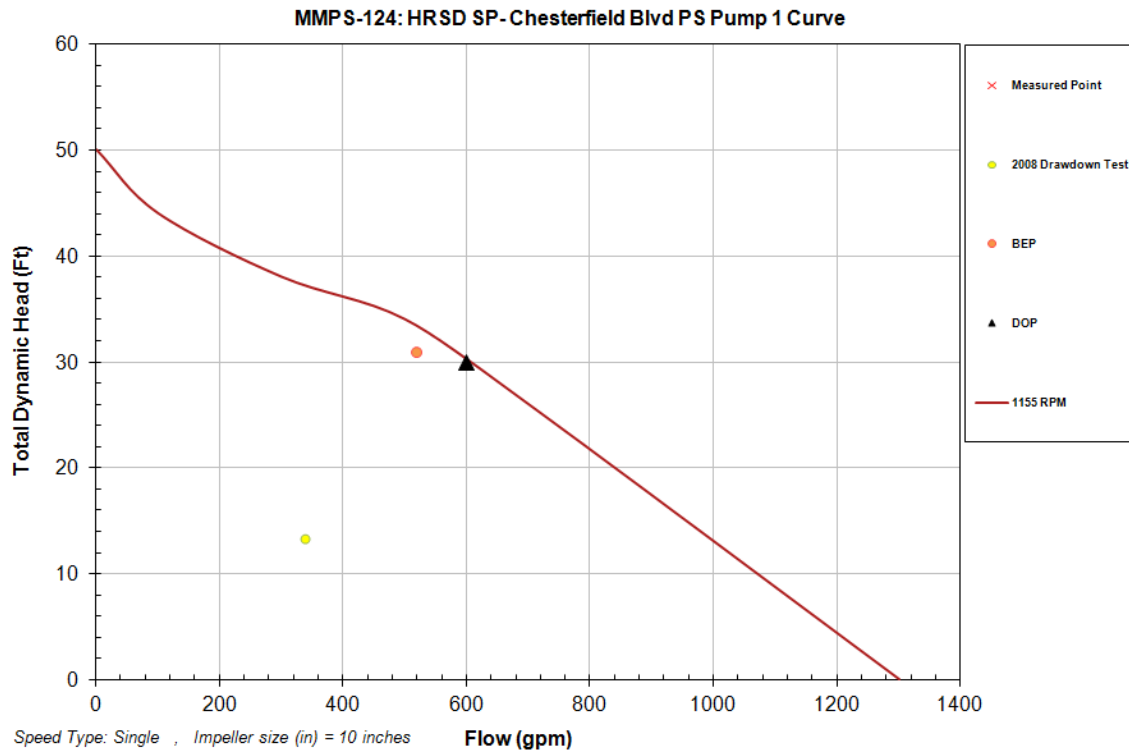
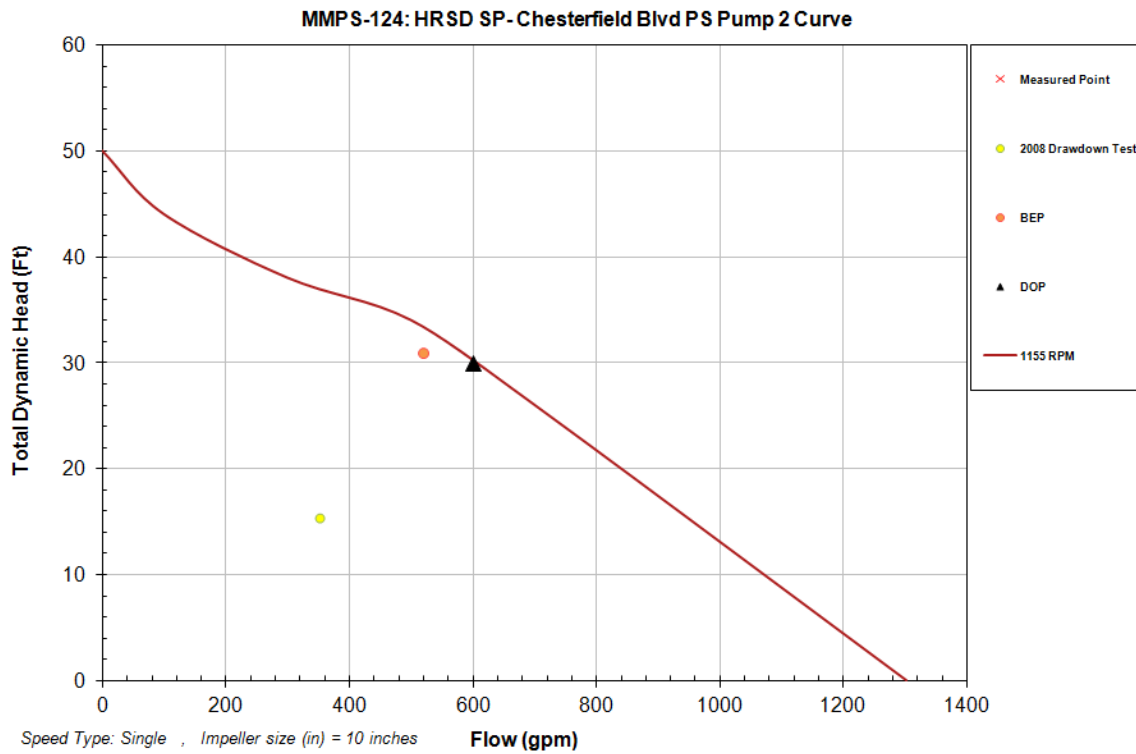
There is no measured point reported because the flow meter was removed from Chesterfield Blvd PS.

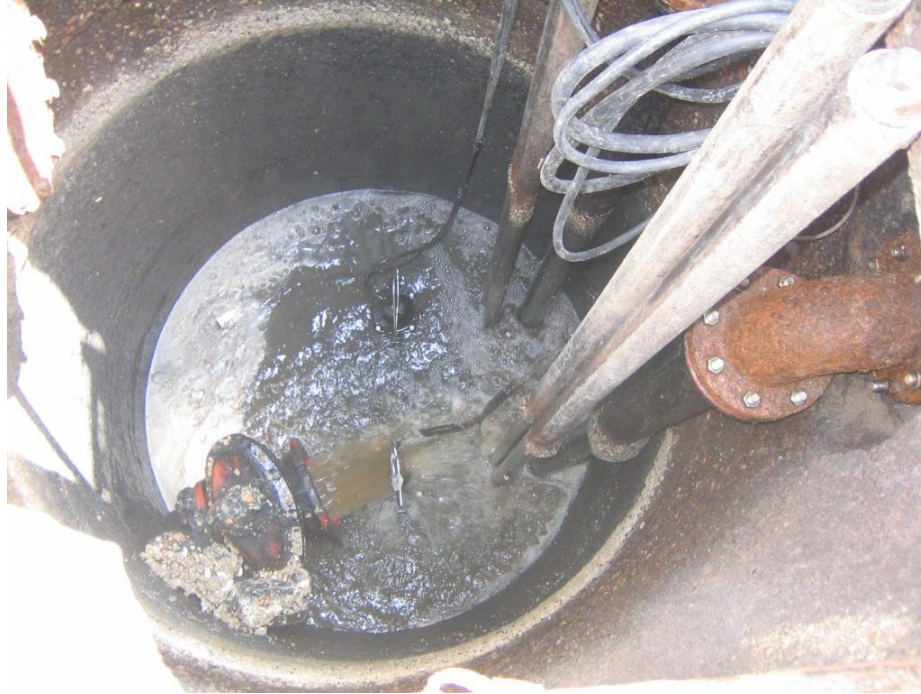
Figure 147-3. Chesterfield Blvd Wet Well

After the initial round of inspections, HRSD used a specialty contractor to revisit select stations for wet well structural inspections including concrete strength tests. Test results showed that the Chesterfield Blvd wet well is deteriorating. Chesterfield Blvd PS is being abandoned as part of the Interim System Improvements.

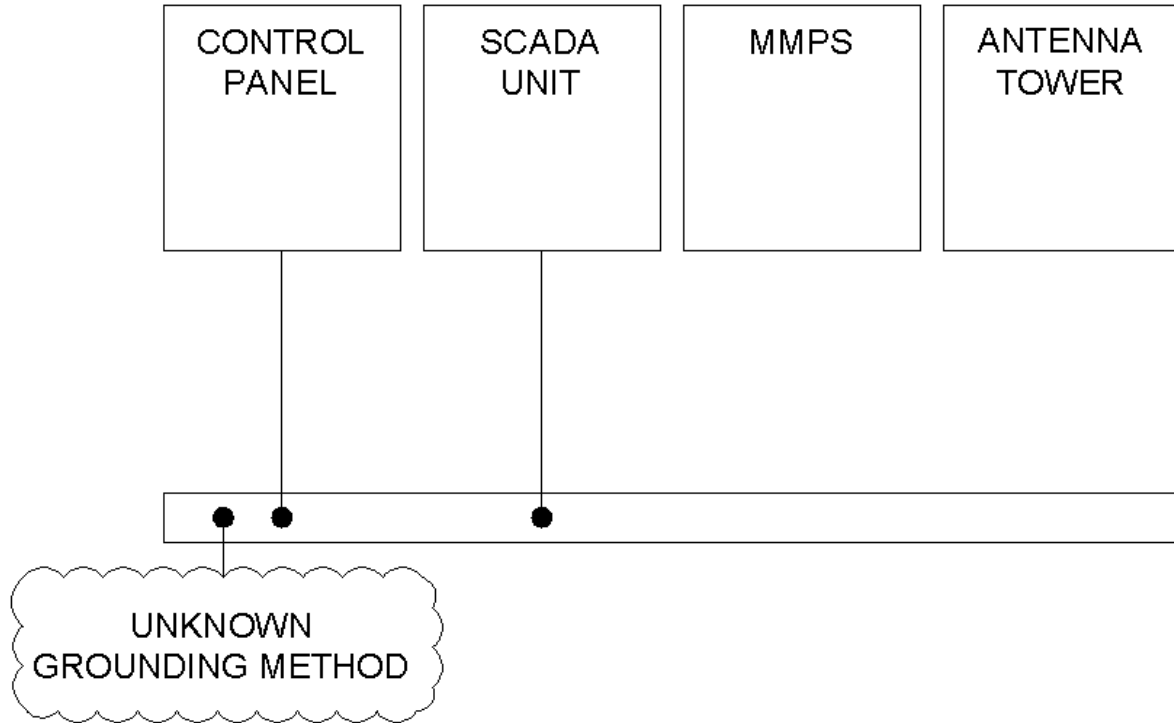
Figure 147-4. Chesterfield Blvd Grounding System

- Service Entrance Surge Protection Device Installed
- Air Terminals Installed and Bonded to Ground System
- Ground Rod Test Wells Noticeable
- Ground Rods Noticeable
  - 0 Rod(s) Noticeable
- Indications of a Building Ground Ring
- No History of Lightning Strikes
- No History of Failures Resulting in SSO in Past 5 Years
- Equipment properly Surge Protected:
  - SCADA Unit has no surge suppression on coax between Antenna & radio
  - Velocity Profiler is not protected by a surge suppressor
- Equipment properly Grounded:
  - Velocity Profiler & MMPS are not bonded to the station grounding system

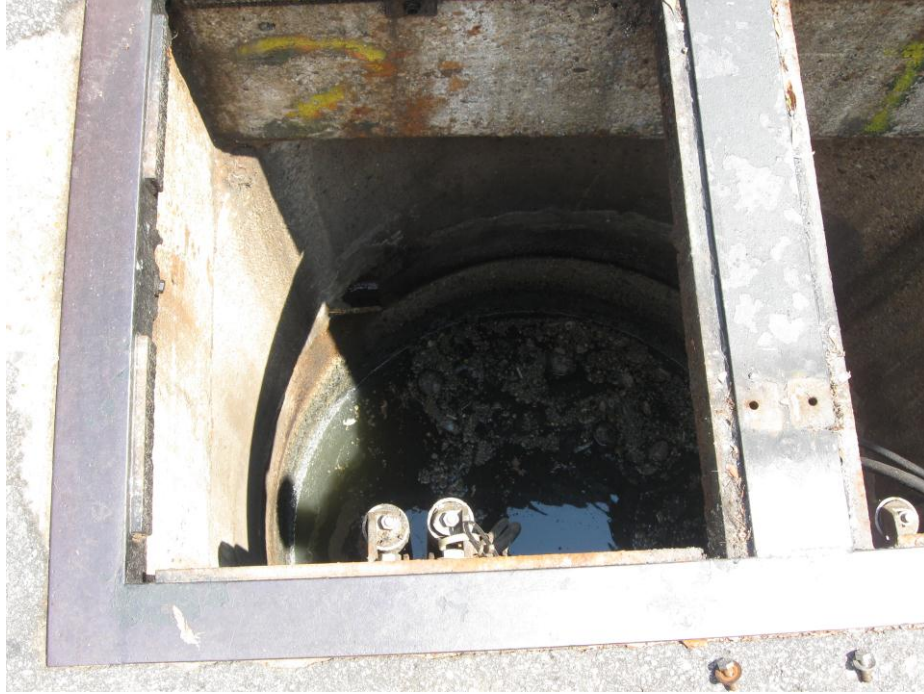
Figure 148-3. Ingleside Rd Wet Well.

PS	PS Name	Asset Type	Asset Description	Condition Rating	Performance Rating	Field Observations	Recommendation	Comments	Region
148	Ingleside Road	Wet well	Wet well	5	4	None to report	Replace/Refurbish	Hatches damaged from vehicular traffic and corrosion. Likely too light/thin for traffic rating. There is exposed aggregate in the wet well. 5/2012: HRSD PM inspection on 03/06/2012 indicates no major changes from the 2008 wet well data.	5
148	Ingleside Road	Motor 1	Wastewater Pump Motor and Controller	2	1	Good	No Immediate Action Required	Could not verify, submerged.	1
148	Ingleside Road	Motor 2	Wastewater Pump Motor and Controller	2	1	Good	No Immediate Action Required	Could not verify, submersed.	1
148	Ingleside Road	Pump 1	Pump	2	1	Good	No Immediate Action Required	Fluid swirls in wet well during pump operation.	1
148	Ingleside Road	Pump 2	Pump	2	2	Good	No Immediate Action Required	Possible discharge leaking indicated by bubbles during pump operation. Fluid swirls in wet well during pump operation.	1

After the initial round of inspections, HRSD used a specialty contractor to revisit select stations for wet well structural inspections including concrete strength tests. Test results showed that the Ingleside Rd wet well is deteriorating and the hatch should be replaced. The hatch is scheduled for replacement under the Prompt Repairs Program.

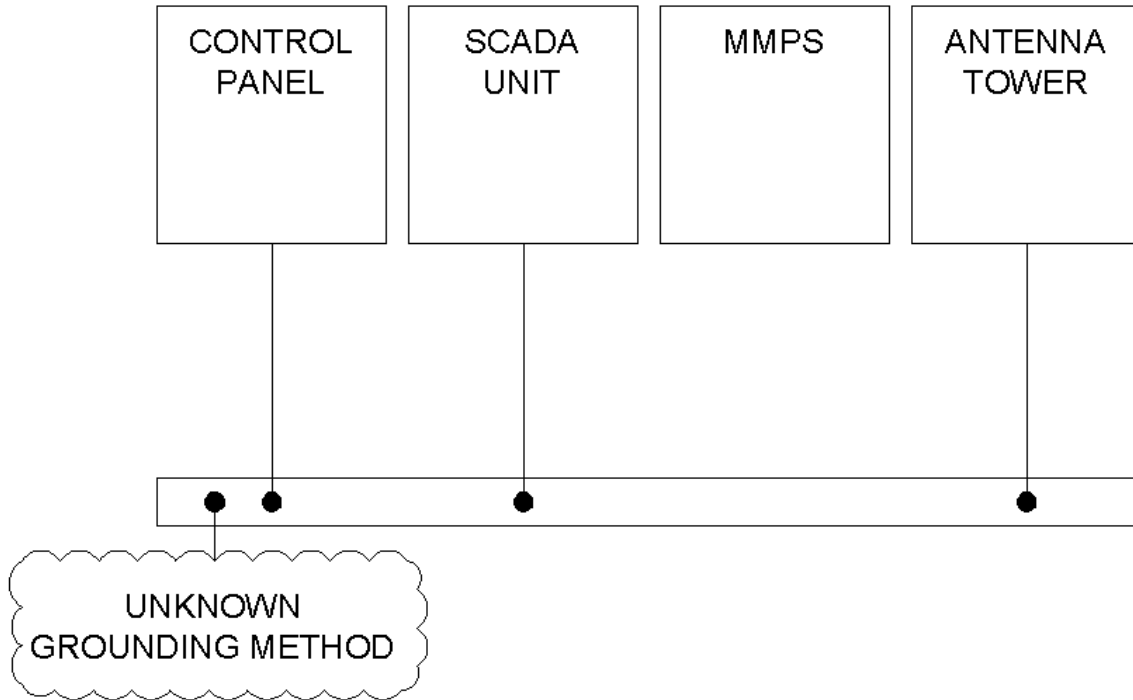
Figure 148-4. Ingleside Rd Grounding System

- Service Entrance Surge Protection Device Installed
- Air Terminals Installed and Bonded to Ground System
- Ground Rod Test Wells Noticeable
- Ground Rods Noticeable
  - 0 Rod(s) Noticeable
- Indications of a Building Ground Ring
- No History of Lightning Strikes
- No History of Failures Resulting in SSO in Past 5 Years
- Equipment properly Surge Protected:
  - SCADA Unit has no surge suppression on coax between Antenna & radio
- Equipment properly Grounded:
  - MMPS is not bonded to the station grounding system

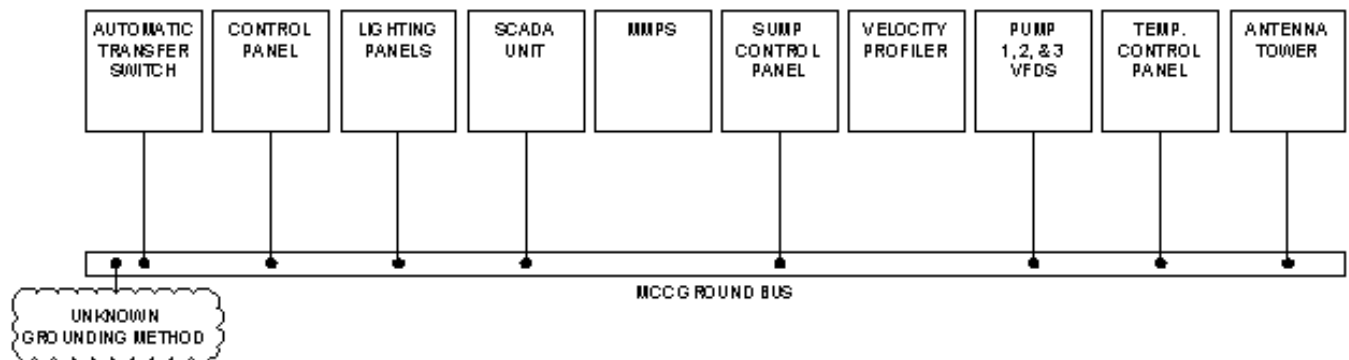
Figure 151-3. Kempsville Rd Grounding System

- Service Entrance Surge Protection Device Installed
- Air Terminals Installed and Bonded to Ground System
- Ground Rod Test Wells Noticeable
- Ground Rods Noticeable
  - 0 Rod(s) Noticeable
- Indications of a Building Ground Ring
- No History of Lightning Strikes
- No History of Failures Resulting in SSO in Past 5 Years
- Equipment properly Surge Protected:
  - SCADA Unit has no surge suppression on coax between Antenna & radio
  - Velocity profiler & control panel are not protected by a surge suppressor
- Equipment properly Grounded:
  - Velocity profiler & MMPS are not bonded to the station grounding system
  - Remote radiator structure is not grounded

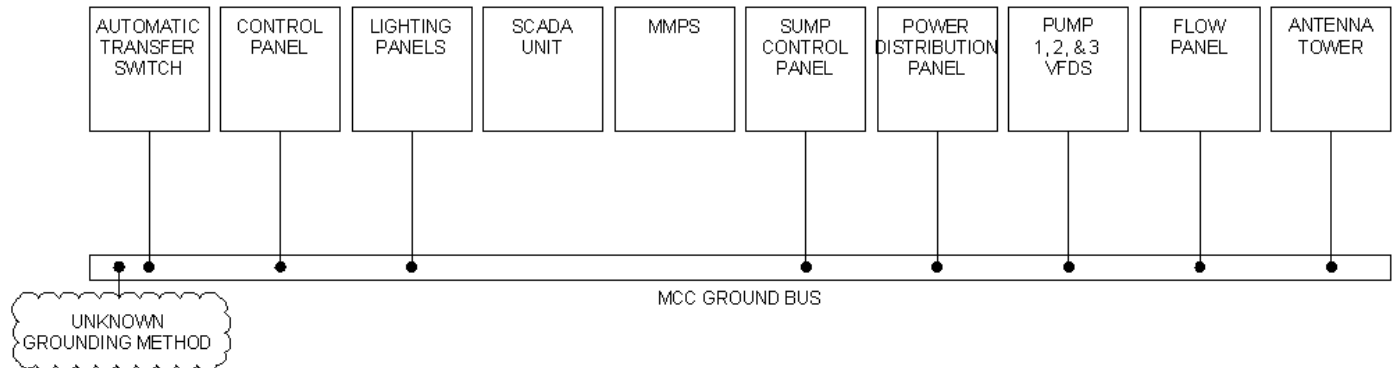
Figure 152-3. Terminal Blvd Grounding System

- Service Entrance Surge Protection Device Installed
- Air Terminals Installed and Bonded to Ground System
- Ground Rod Test Wells Noticeable
- Ground Rods Noticeable
  - 0 Rod(s) Noticeable
- Indications of a Building Ground Ring
- No History of Lightning Strikes
- No History of Failures Resulting in SSO in Past 5 Years
- Equipment properly Surge Protected:
  - SCADA Unit has no surge suppression on coax between Antenna & radio
  - Flow transmitter panel & control panel are not protected by a surge suppressor
- Equipment properly Grounded:
  - Flow transmitter panel & MMPS are not bonded to the station grounding system
  - Remote radiator structure is not grounded

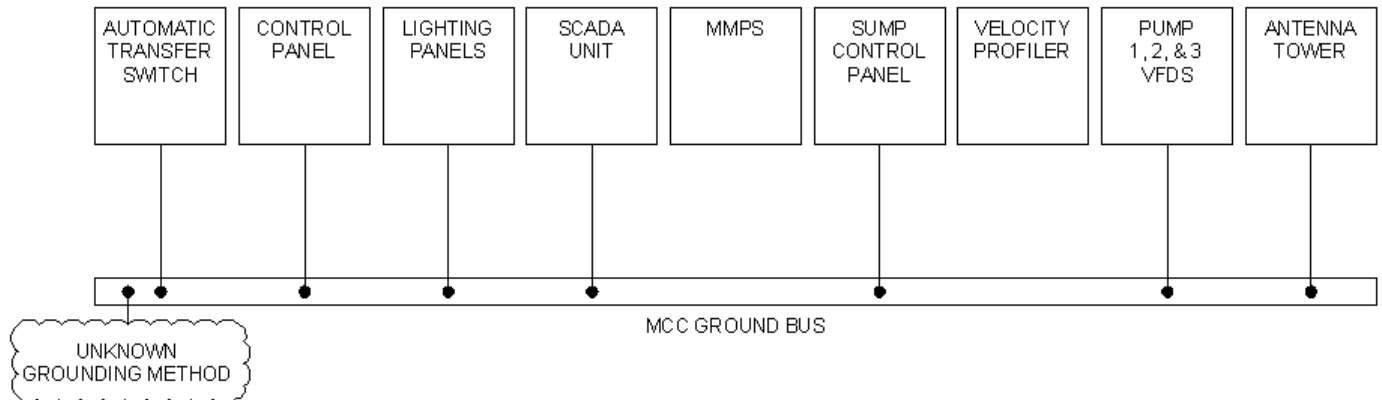
Figure 153-3. Laskin Rd Grounding System

- Service Entrance Surge Protection Device Installed
- Air Terminals Installed and Bonded to Ground System
- Ground Rod Test Wells Noticeable
- Ground Rods Noticeable
  - 0 Rod(s) Noticeable
- Indications of a Building Ground Ring
- No History of Lightning Strikes
- No History of Failures Resulting in SSO in Past 5 Years
- Equipment properly Surge Protected:
  - SCADA Unit has no surge suppression on coax between Antenna & radio
  - Control panel & velocity profiler are not protected by a surge suppressor
- Equipment properly Grounded:
  - SCADA Unit, velocity profiler, & MMPS are not bonded to the station grounding system
  - Remote radiator structure is not grounded

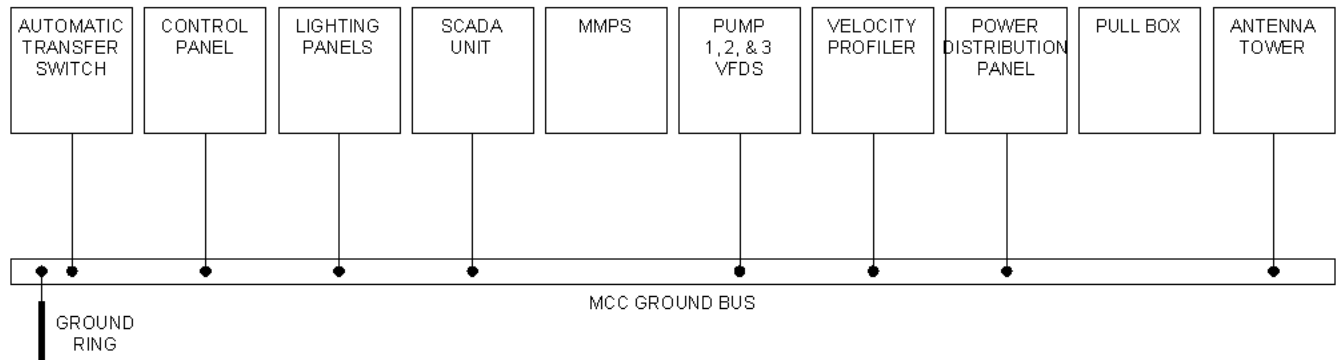
Figure 154-3. RT 337 Grounding System

- Service Entrance Surge Protection Device Installed
- Air Terminals Installed and Bonded to Ground System
- Ground Rod Test Wells Noticeable
- Ground Rods Noticeable
  - 0 Rod(s) Noticeable
- Indications of a Building Ground Ring
- No History of Lightning Strikes
- No History of Failures Resulting in SSO in Past 5 Years
- Equipment properly Surge Protected:
  - SCADA Unit has no surge suppression on coax between Antenna & radio
  - Velocity profiler is not protected by a surge suppressor
- Equipment properly Grounded:
  - Pull box & MMPS are not bonded to the station grounding system
  - Remote radiator structure is not grounded

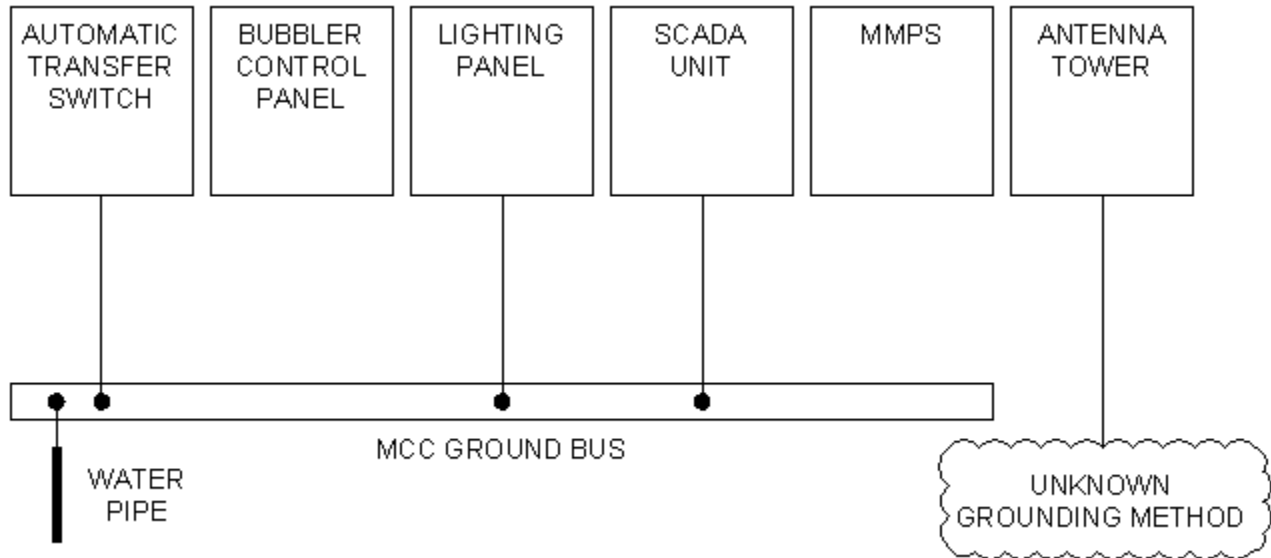
Figure 201-3. 25<sup>th</sup> St Grounding System

- Service Entrance Surge Protection Device Installed
- Air Terminals Installed and Bonded to Ground System
- Ground Rod Test Wells Noticeable
- Ground Rods Noticeable
  - 0 Rod(s) Noticeable
- Indications of a Building Ground Ring
- No History of Lightning Strikes
- No History of Failures Resulting in SSO in Past 5 Years
- Equipment properly Surge Protected:
  - Bubbler Control Panel is not protected with surge suppression
  - SCADA Unit has no surge suppression on coax between Antenna & radio
- Equipment properly Grounded:
  - Bubbler control panel & MMPS are not properly bonded to the station grounding system
