# Appendix B: Pump Station Final Condition Assessment Report

This report is an Appendix to HRSD's Rehabilitation Action (Rehab) Plan to satisfy the requirements of the United State's Environmental Protection Agency (EPA) Consent Decree as well as the Virginia Department of Environmental Quality (DEQ) Special Order by Consent (SOC) for reporting on results of the Condition Assessment Program (CAP). This document summarizes condition assessment results related to HRSD's pumping facilities. Appendices A, C, D, and E satisfy the remaining reporting requirements of the CAP. Assets found at material risk of failure, as described further in this report, are addressed in the main document, the Rehab Plan. The primary purpose of the HRSD CAP was to find sanitary sewer assets presenting an actual material risk of failure. For the purposes of this document, "failure" means any condition resulting in a sanitary sewer overflow, pipe leakage, or interruption of service to HRSD's customers, due to a physical condition defect in the system.

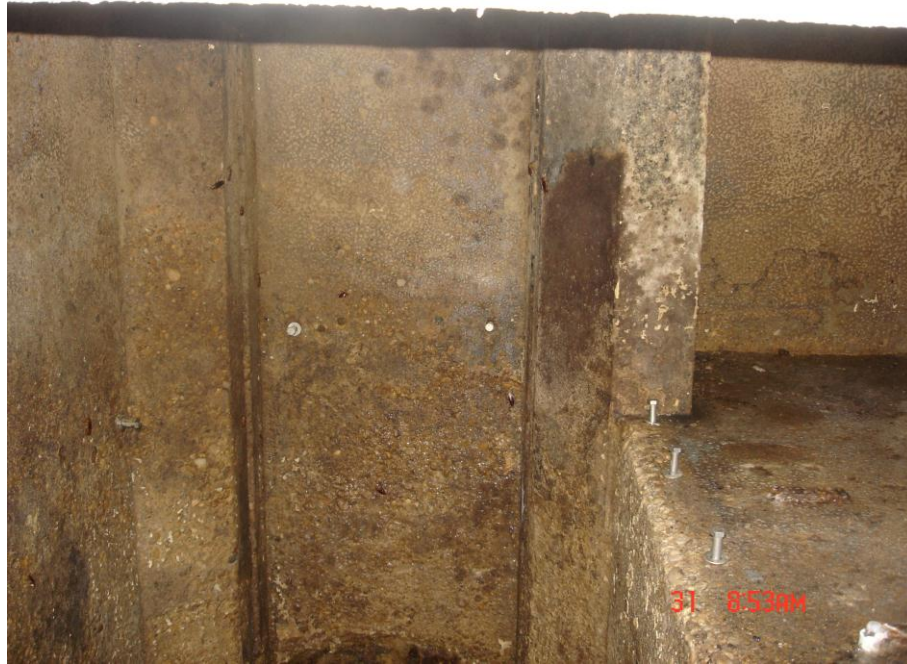
Figure 202-3. 33<sup>rd</sup> St Wet Well

33<sup>rd</sup> St pump station is scheduled for action as part of the Interim System Improvements. After the initial round of inspections, HRSD used a specialty contractor to revisit select stations for wet well structural inspections including concrete strength tests. Test results showed that the 33<sup>rd</sup> St wet well is deteriorating.

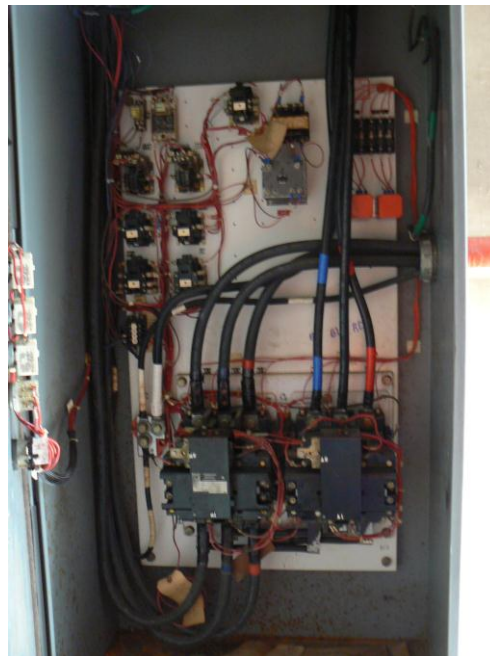
Figure 202-4. 33<sup>rd</sup> St Transfer Switch

There is corrosion present on the electrical equipment.

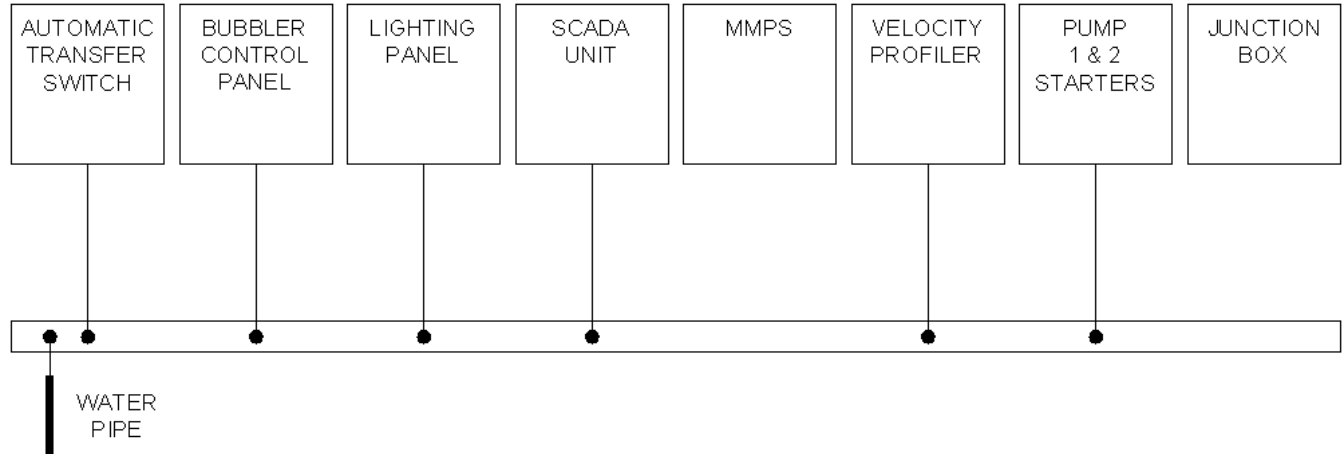
Figure 202-6. 33<sup>rd</sup> St Grounding System

- Service Entrance Surge Protection Device Installed
- Air Terminals Installed and Bonded to Ground System
- Ground Rod Test Wells Noticeable
- Ground Rods Noticeable
  - 0 Rod(s) Noticeable
- Indications of a Building Ground Ring
- No History of Lightning Strikes
- No History of Failures Resulting in SSO in Past 5 Years
- Equipment properly Surge Protected:
  - SCADA Unit has no surge suppression on coax between Antenna & radio
  - Bubbler control panel & velocity profiler are not protected by a surge suppressor
- Equipment properly Surge Protected:
  - Motor starters & MMPS are not bonded to the station grounding system

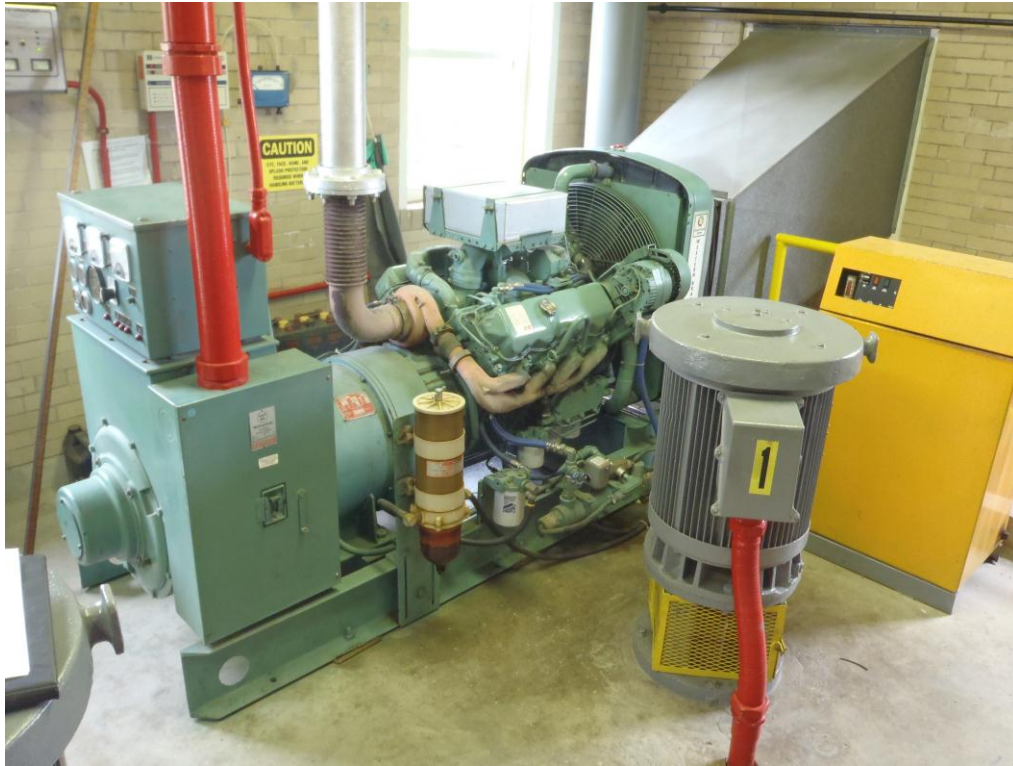
Figure 203-3. Bay Shore Lane Generator

The Bay Shore Lane generator overheated during station preventive maintenance activities. The Motor Control Center (MCC) is deteriorating and shows evidence of a previous fire.

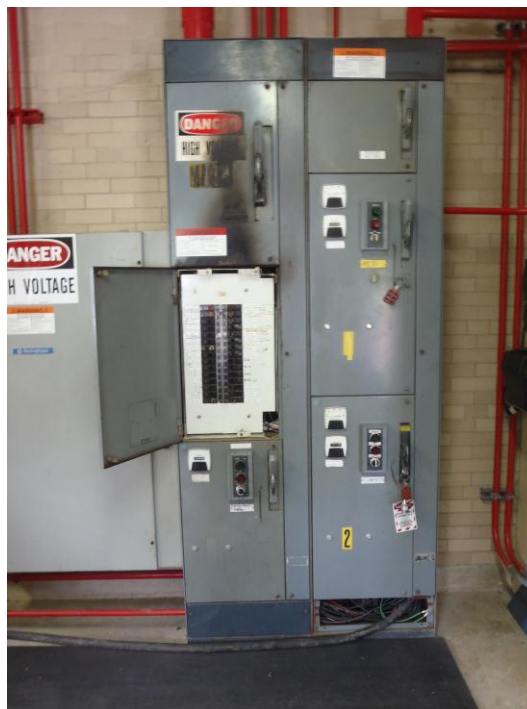
Figure 203-4. Bay Shore Lane MCC

- Required nameplates and signage readable
- Equipment Labeled Where it is being Fed From
- Equipment Properly Grounded
- Correct Voltage Warning Signs
- Doors Close Properly
- Conduit Entrances are not obstructed
- Conduits Entering from Outside are Sealed
- Circuit Breakers Labeled Correctly with Loads
- Breaker Handle and Lock out Loop Intact
- Equipment Accommodates Lock Out / Tag Out
- Required Receptacles Provided
- Necessary Disconnecting Means Provided
- Buses Free of Corrosion
- Lugs Free of Corrosion
- Building Electrical Plans Provided
- Other
  - MCC needs to be replaced

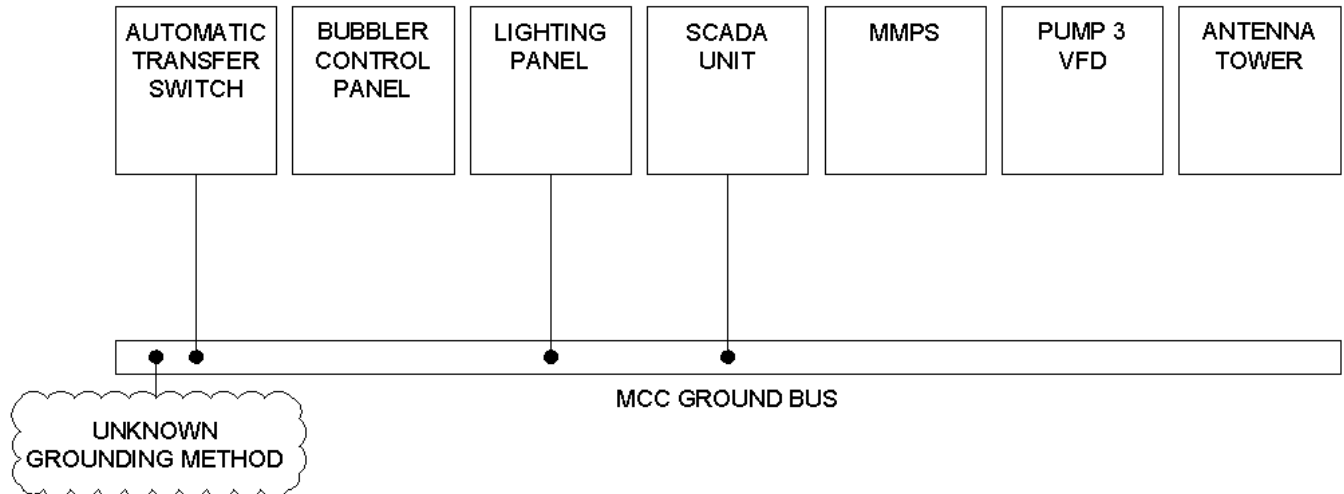
Figure 203-5. Bay Shore Lane Grounding System

- Service Entrance Surge Protection Device Installed
- Air Terminals Installed and Bonded to Ground System
- Ground Rod Test Wells Noticeable
- Ground Rods Noticeable
  - 0 Rod(s) Noticeable
- Indications of a Building Ground Ring
- No History of Lightning Strikes
- No History of Failures Resulting in SSO in Past 5 Years
- Equipment properly Surge Protected:
  - Bubbler control panel is not protected with surge suppression
  - SCADA Unit has no surge suppression on coax between Antenna & radio
- Equipment properly Grounded:
  - Bubbler control panel & MMPS are not properly bonded to the station grounding system

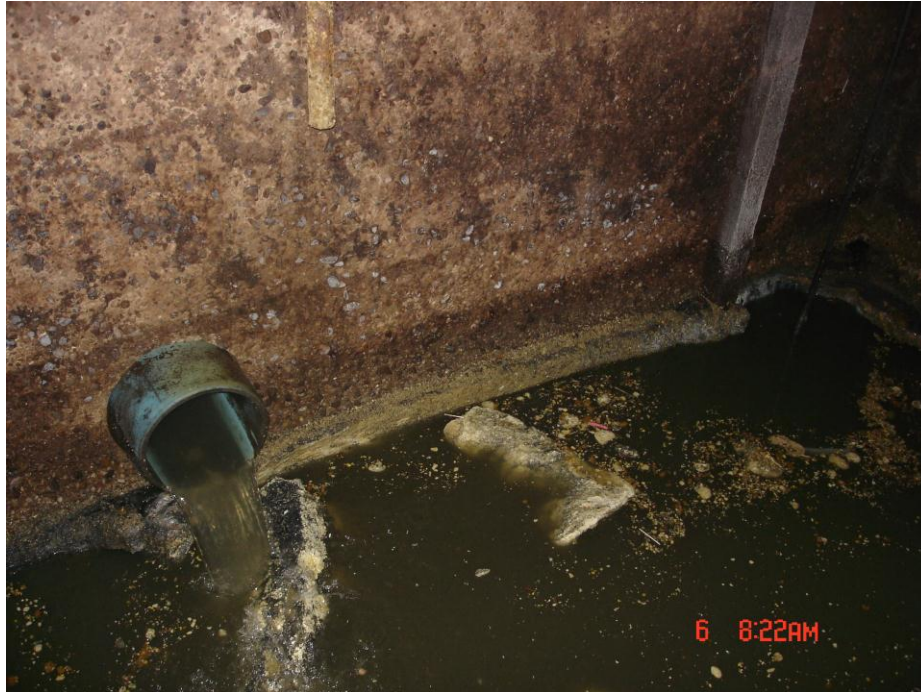
Figure 204-3. Bloxoms Corner Wet Well

After the initial round of inspections, HRSD used a specialty contractor to revisit select stations for wet well structural inspections including concrete strength tests. Test results showed that the Bloxoms Corner wet well is deteriorating.

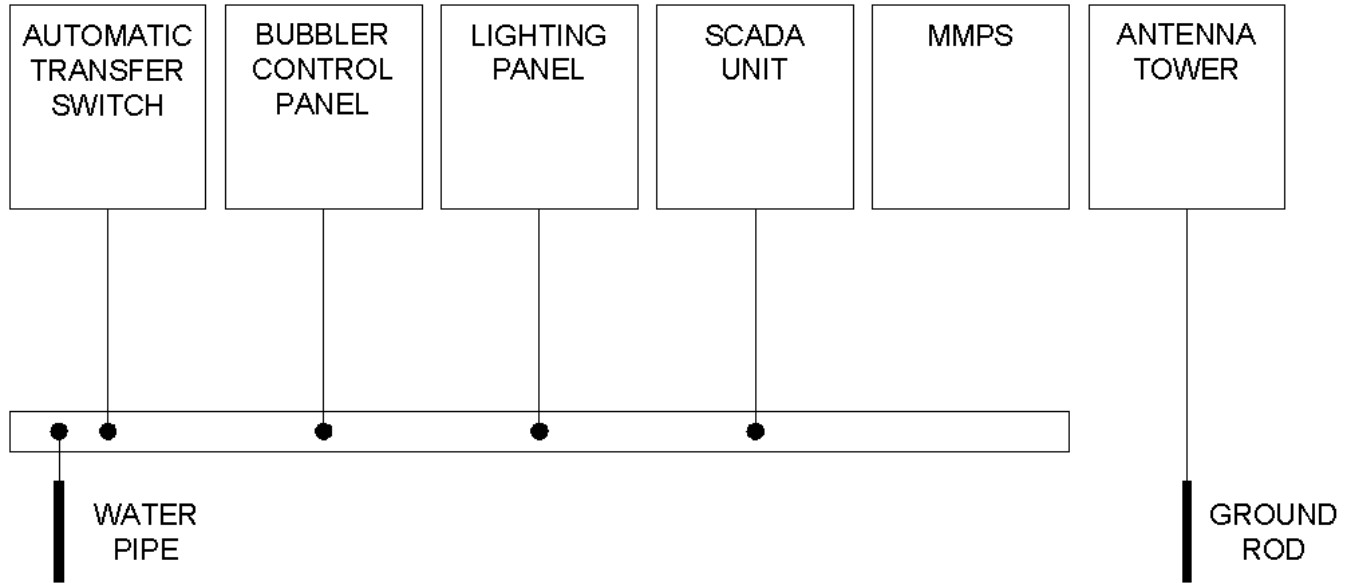
Figure 204-4. Bloxoms Corner Grounding System

- Service Entrance Surge Protection Device Installed
- Air Terminals Installed and Bonded to Ground System
- Ground Rod Test Wells Noticeable
- Ground Rods Noticeable
  - 1 Rod(s) Noticeable
- Indications of a Building Ground Ring
- No History of Lightning Strikes
- No History of Failures Resulting in SSO in Past 5 Years
- Equipment properly Surge Protected:
  - SCADA Unit has no surge suppression on coax between Antenna & radio
  - Bubbler control panel is not protected by a surge suppressor
- Equipment properly Grounded:
  - MMPS is not bonded to the station grounding system

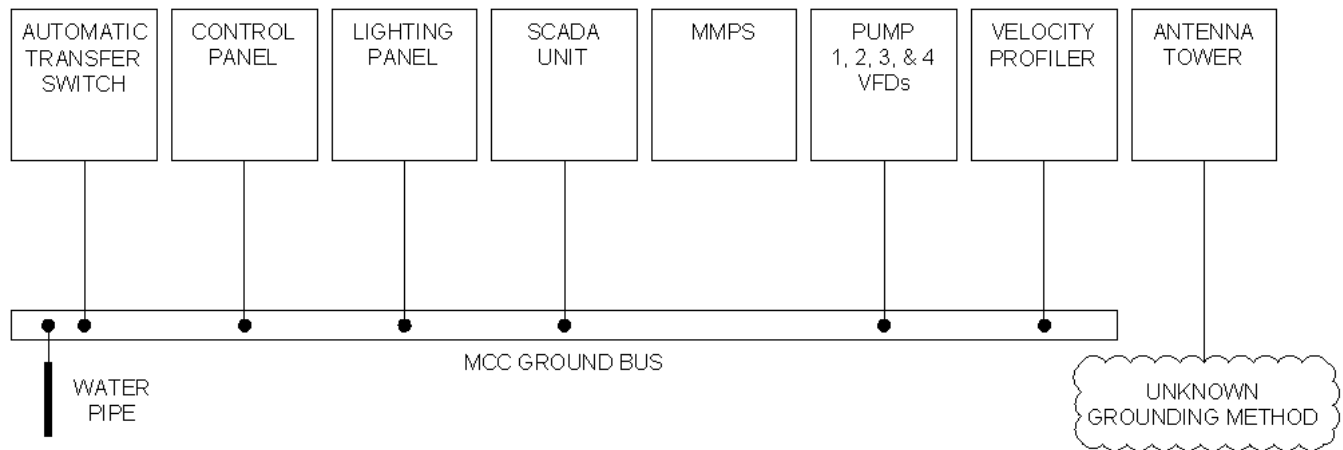
Figure 205-3. Big Bethel Grounding System

- Service Entrance Surge Protection Device Installed
- Air Terminals Installed and Bonded to Ground System
- Ground Rod Test Wells Noticeable
- Ground Rods Noticeable
  - 0 Rod(s) Noticeable
- Indications of a Building Ground Ring
- No History of Lightning Strikes
- No History of Failures Resulting in SSO in Past 5 Years
- Equipment properly Surge Protected:
  - SCADA Unit has no surge suppression on coax between Antenna & radio
  - Control panel & velocity profiler are not protected by a surge suppressor
- Equipment properly Grounded:
  - MMPS is not bonded to the station grounding system

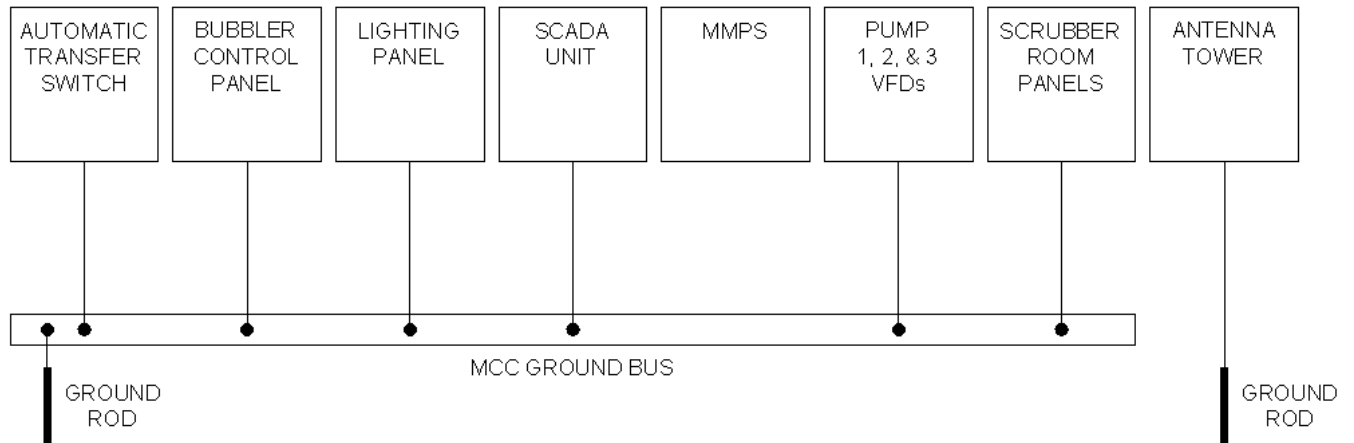
Figure 206-3. Bridge St Grounding System

- Service Entrance Surge Protection Device Installed
- Air Terminals Installed and Bonded to Ground System
- Ground Rod Test Wells Noticeable
- Ground Rods Noticeable
  - 2 Rod(s) Noticeable
- Indications of a Building Ground Ring
- No History of Lightning Strikes
- No History of Failures Resulting in SSO in Past 5 Years
- Equipment properly Surge Protected:
  - SCADA Unit has no surge suppression on coax between Antenna & radio
  - Bubbler control panel & scrubber room panels are not protected by a surge suppressor
- Equipment properly Grounded:
  - MMPS is not bonded to the station grounding system

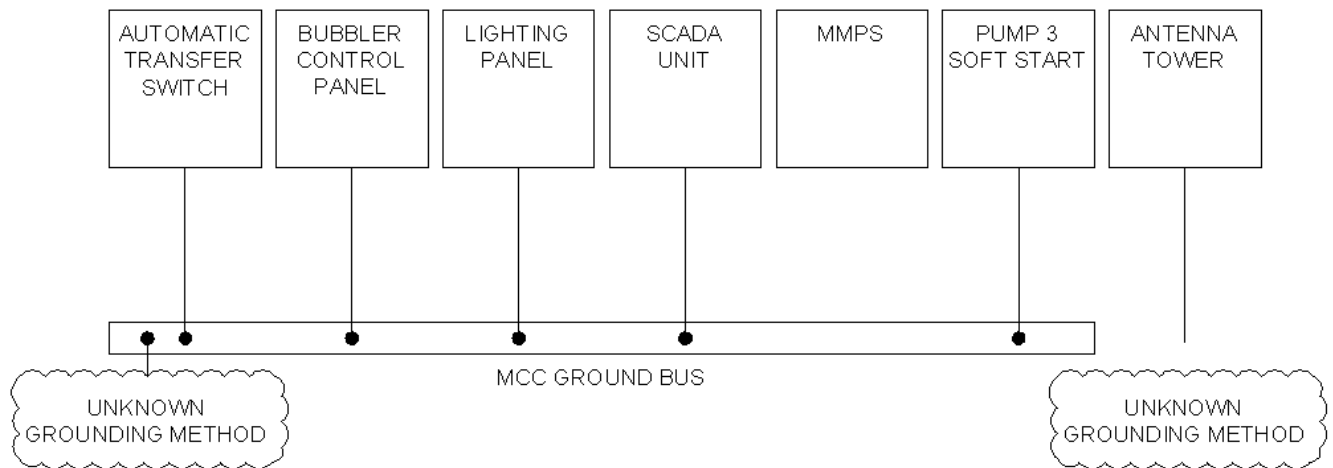
Figure 207-3. Center Ave Grounding System

- Service Entrance Surge Protection Device Installed
- Air Terminals Installed and Bonded to Ground System
- Ground Rod Test Wells Noticeable
- Ground Rods Noticeable
  - 0 Rod(s) Noticeable
- Indications of a Building Ground Ring
- No History of Lightning Strikes
- No History of Failures Resulting in SSO in Past 5 Years
- Equipment properly Surge Protected:
  - SCADA Unit has no surge suppression on coax between Antenna & radio
  - Bubbler control panel is not protected by a surge suppressor
- Equipment properly Grounded:
  - MMPS is not bonded to the station grounding system
  - Antenna tower ground wire is broken

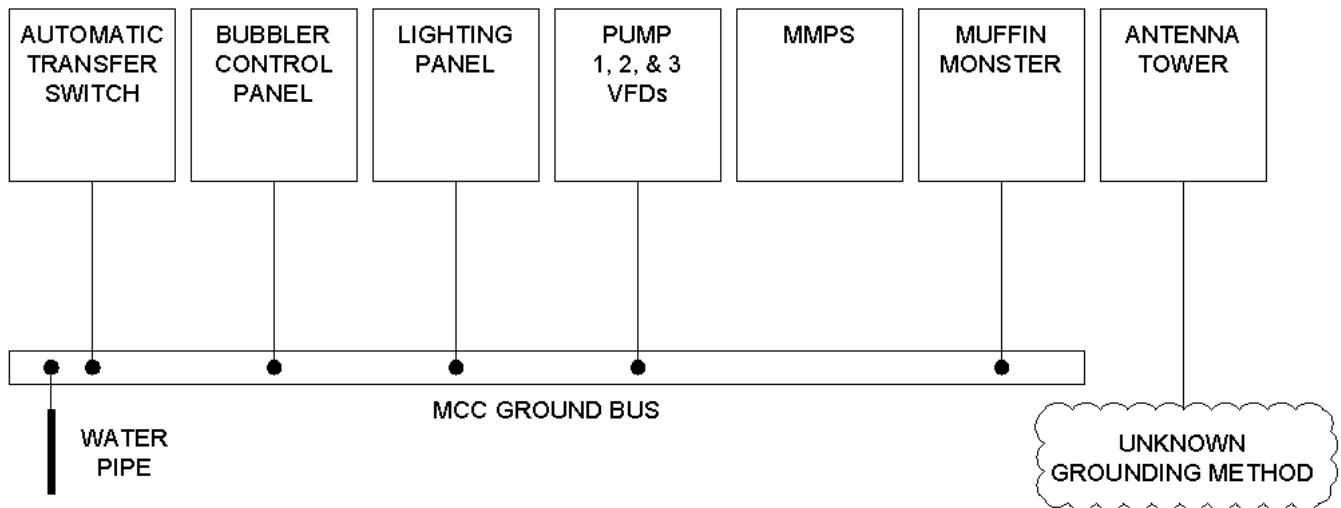
Figure 208-3. Claremont Ave Grounding System

- Service Entrance Surge Protection Device Installed
- Air Terminals Installed and Bonded to Ground System
- Ground Rod Test Wells Noticeable
- Ground Rods Noticeable
  - 0 Rod(s) Noticeable
- Indications of a Building Ground Ring
- No History of Lightning Strikes
- No History of Failures Resulting in SSO in Past 5 Years
- Equipment properly Surge Protected:
  - SCADA Unit has no surge suppression on coax between Antenna & radio
- Equipment properly Grounded:
  - MMPS is not bonded to the station grounding system

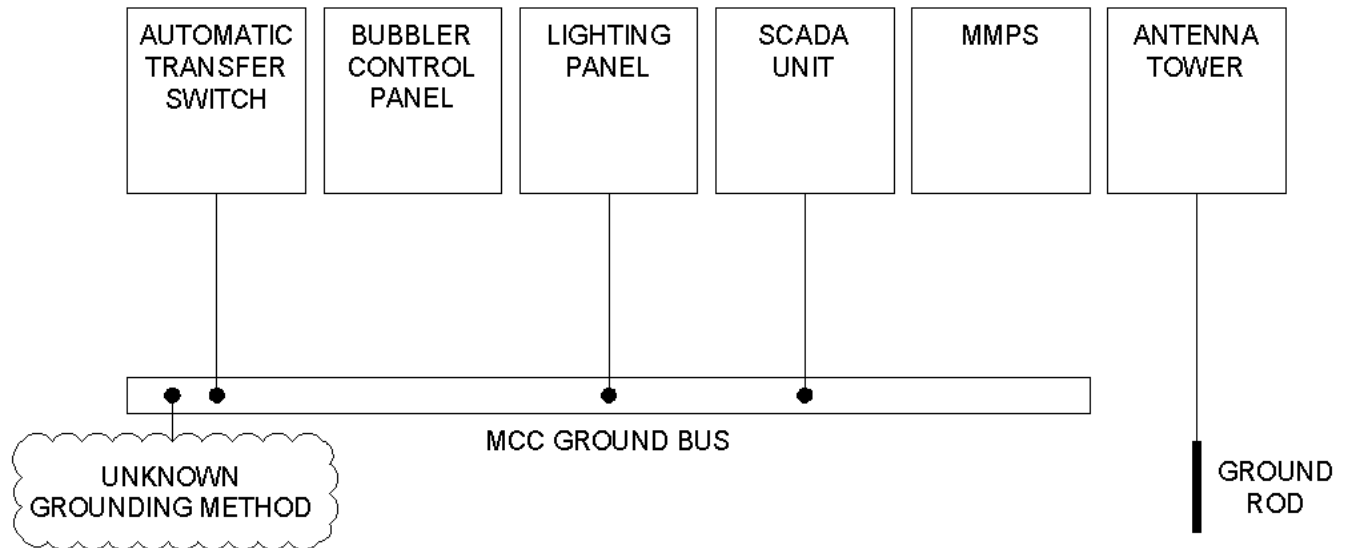
Figure 209-3. Copeland Park Grounding System

- Service Entrance Surge Protection Device Installed
- Air Terminals Installed and Bonded to Ground System
- Ground Rod Test Wells Noticeable
- Ground Rods Noticeable
  - 1 Rod(s) Noticeable
- Indications of a Building Ground Ring
- No History of Lightning Strikes
- No History of Failures Resulting in SSO in Past 5 Years
- Equipment properly Surge Protected:
  - SCADA Unit has no surge suppression on coax between Antenna & radio
  - Bubbler control panel is not protected by a surge suppressor
- Equipment properly Grounded:
  - Bubbler control panel & MMPS is not bonded to the station grounding system

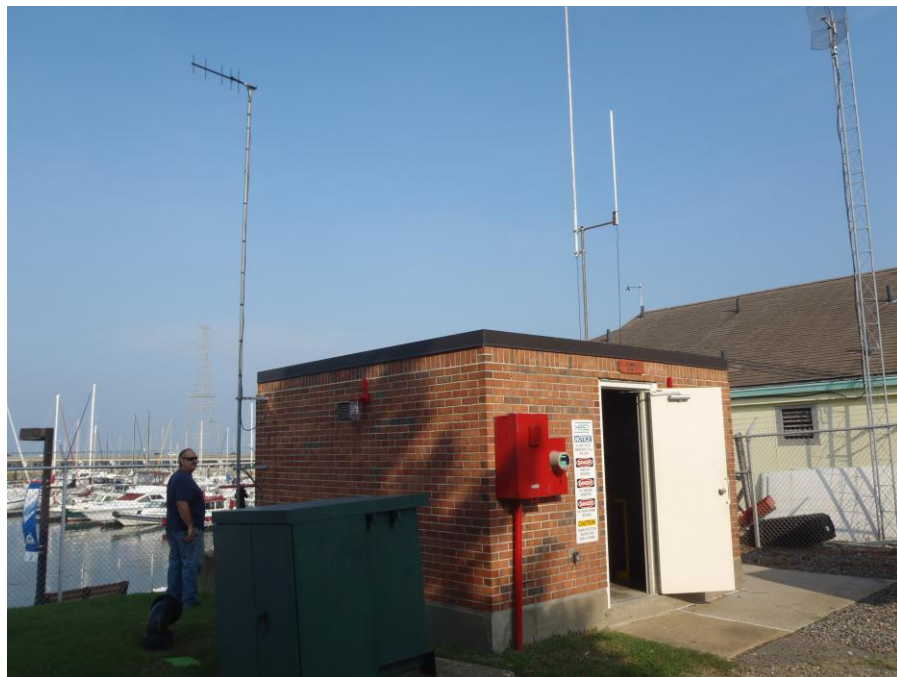
Figure 210-2. Ferguson Park Pump Station

210	Ferguson Park	Motor 2	Electrical Pump Motor and Controller	2	1	Good Makes Noise	No Immediate Action Required	Nameplate illegible. Strobe - 1172rpm. Motor makes a faint squeak.	1
210	Ferguson Park	Pump 1	Pump	2	2	Good	No Immediate Action Required	Painted nameplate. Clanking noise on startup. Site frequently has low flow conditions.	1
210	Ferguson Park	Pump 2	Pump	2	1	Good	No Immediate Action Required	Painted nameplate. Site frequently has low flow conditions.	1
210	Ferguson Park	Pump 3	Sump Pump	2	1	Good	No Immediate Action Required	No Comment	1
210	Ferguson Park	Valves System	All Station Valves	2	1	Good	No Immediate Action Required	7/11: HRSD inspections indicate no problems with isolation valve operation.	1
210	Ferguson Park	Suction Isolation Valve Pump 1	Suction Isolation Valve	2	1	See Valves System Field Observations	No Immediate Action Required	See Valves System Comments	1
210	Ferguson Park	Suction Isolation Valve Pump 2	Suction Isolation Valve	2	1	See Valves System Field Observations	No Immediate Action Required	See Valves System Comments	1

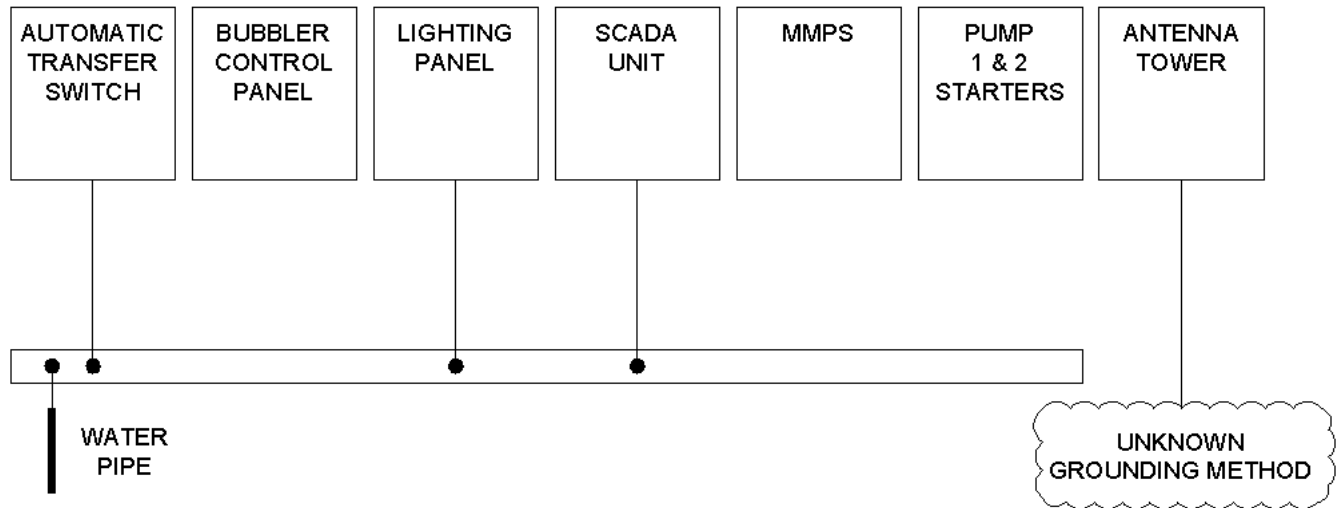
Figure 210-3. Ferguson Park Grounding System

- Service Entrance Surge Protection Device Installed
- Air Terminals Installed and Bonded to Ground System
- Ground Rod Test Wells Noticeable
- Ground Rods Noticeable
  - 0 Rod(s) Noticeable
- Indications of a Building Ground Ring
- No History of Lightning Strikes
- No History of Failures Resulting in SSO in Past 5 Years
- Equipment properly Surge Protected:
  - SCADA Unit has no surge suppression on coax between Antenna & radio
  - Bubbler control panel is not protected by a surge suppressor
- Equipment properly Grounded:
  - Bubbler control panel & MMPS is not bonded to the station grounding system

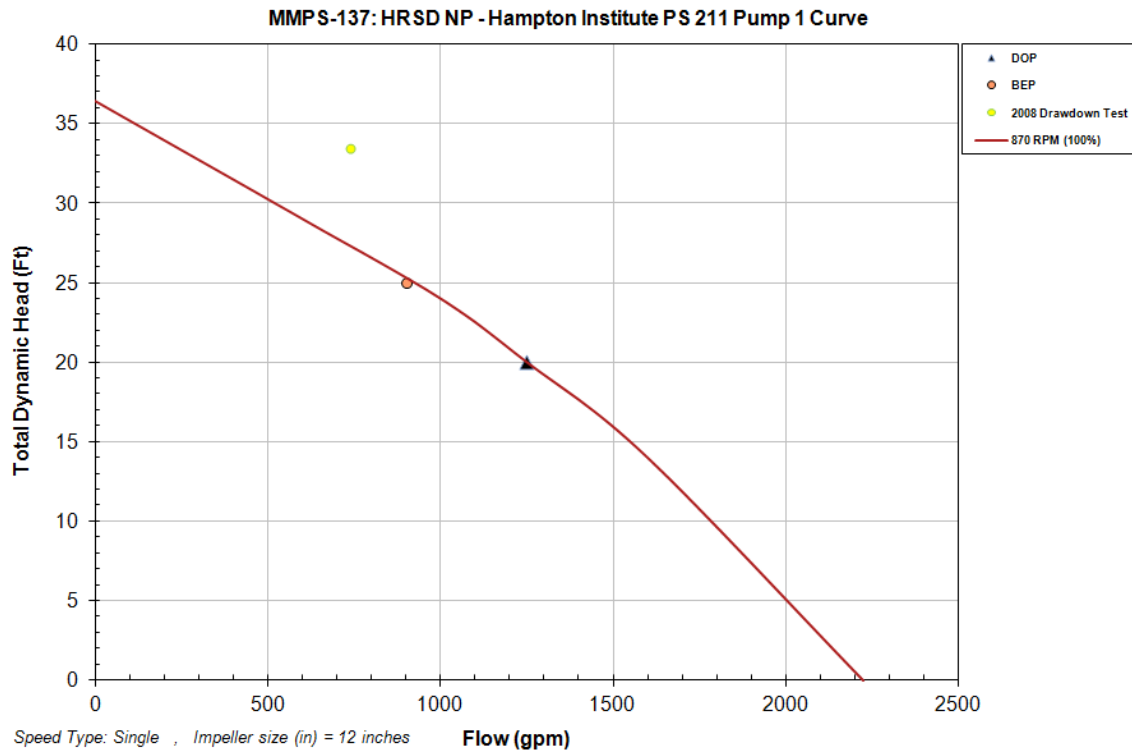
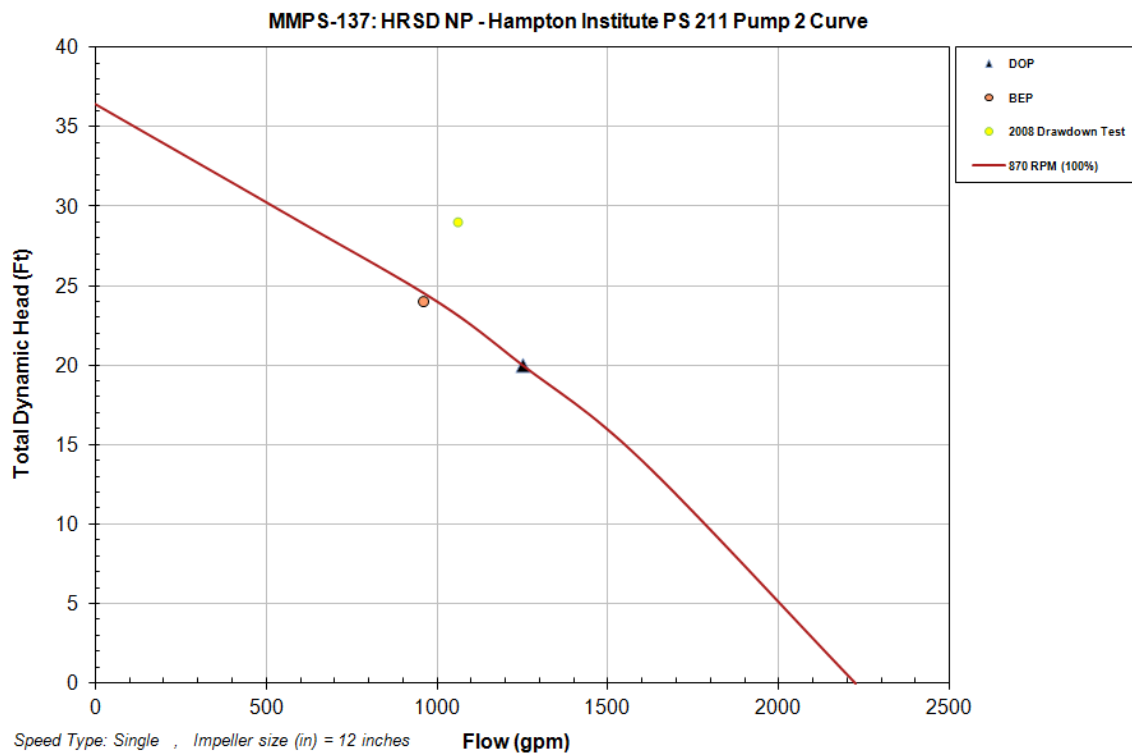
There is no measured point reported because the flow meter was removed from Hampton Institute PS.

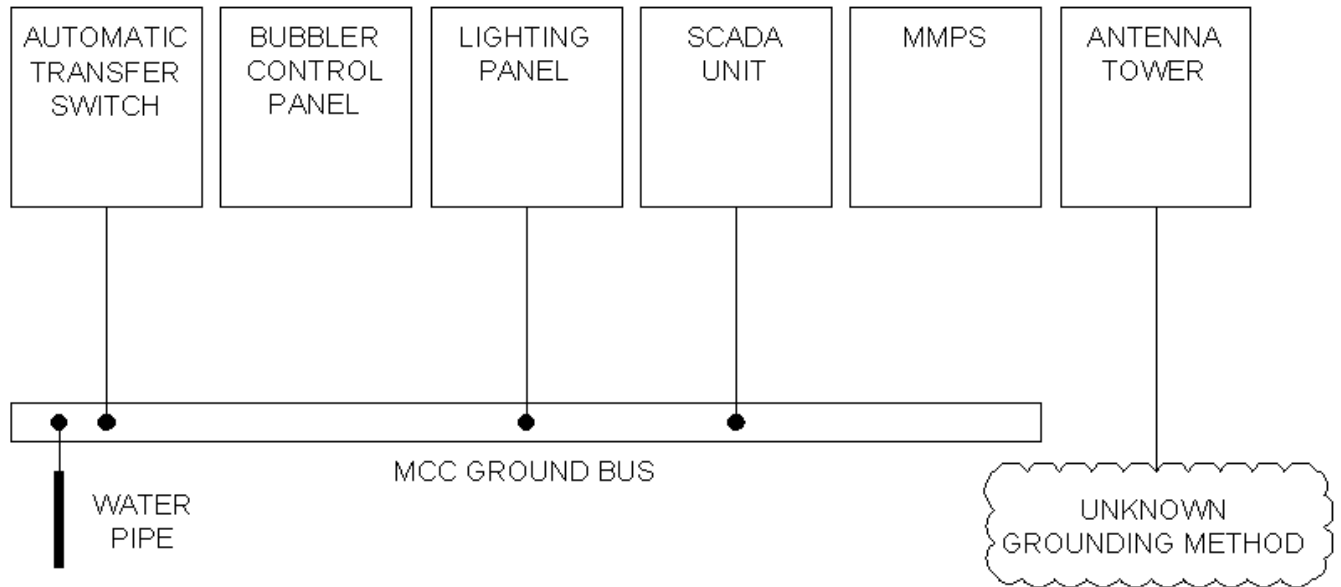
Figure 211-3. Hampton University Grounding System

- Service Entrance Surge Protection Device Installed
- Air Terminals Installed and Bonded to Ground System
- Ground Rod Test Wells Noticeable
- Ground Rods Noticeable
  - 0 Rod(s) Noticeable
- Indications of a Building Ground Ring
- No History of Lightning Strikes
- No History of Failures Resulting in SSO in Past 5 Years
- Equipment properly Surge Protected:
  - SCADA Unit has no surge suppression on coax between Antenna & radio
  - Bubbler control panel is not protected by a surge suppressor
- Equipment properly Grounded:
  - Bubbler control panel & MMPS is not bonded to the station grounding system

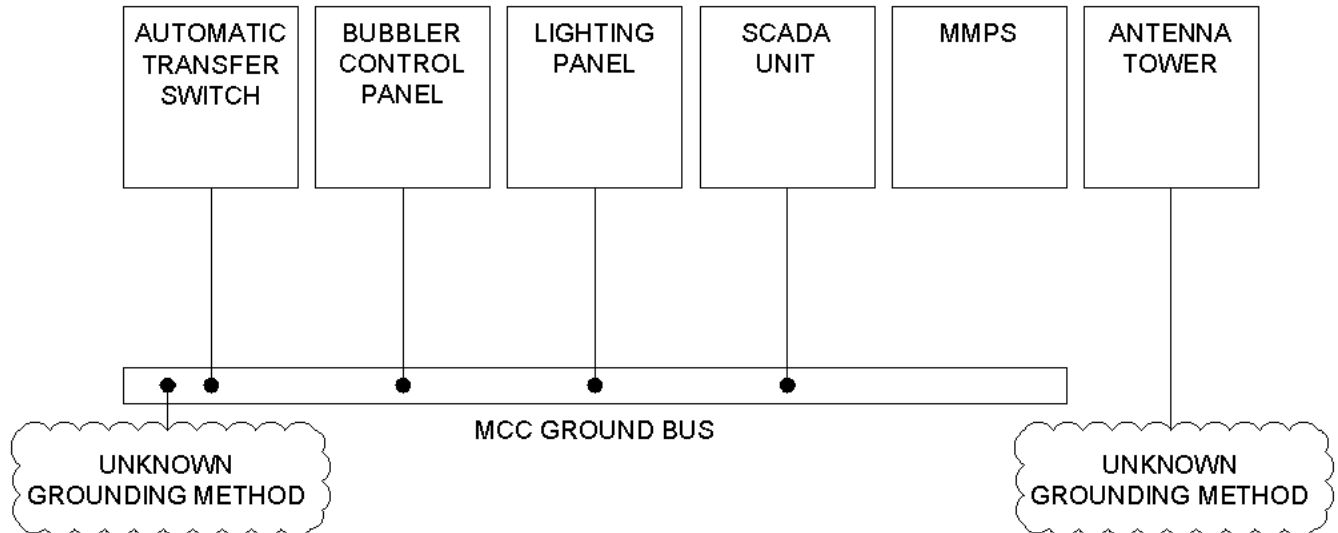
Figure 212-3. Hilton School Grounding System

- Service Entrance Surge Protection Device Installed
- Air Terminals Installed and Bonded to Ground System
- Ground Rod Test Wells Noticeable
- Ground Rods Noticeable
  - 0 Rod(s) Noticeable
- Indications of a Building Ground Ring
- No History of Lightning Strikes
- No History of Failures Resulting in SSO in Past 5 Years
- Equipment properly Surge Protected:
  - Velocity Profiler has no surge suppression on coax between Antenna & radio
  - Bubbler control panel is not protected by a surge suppressor
- Equipment properly Grounded:
  - Velocity Profiler & MMPS are not bonded to the station grounding system

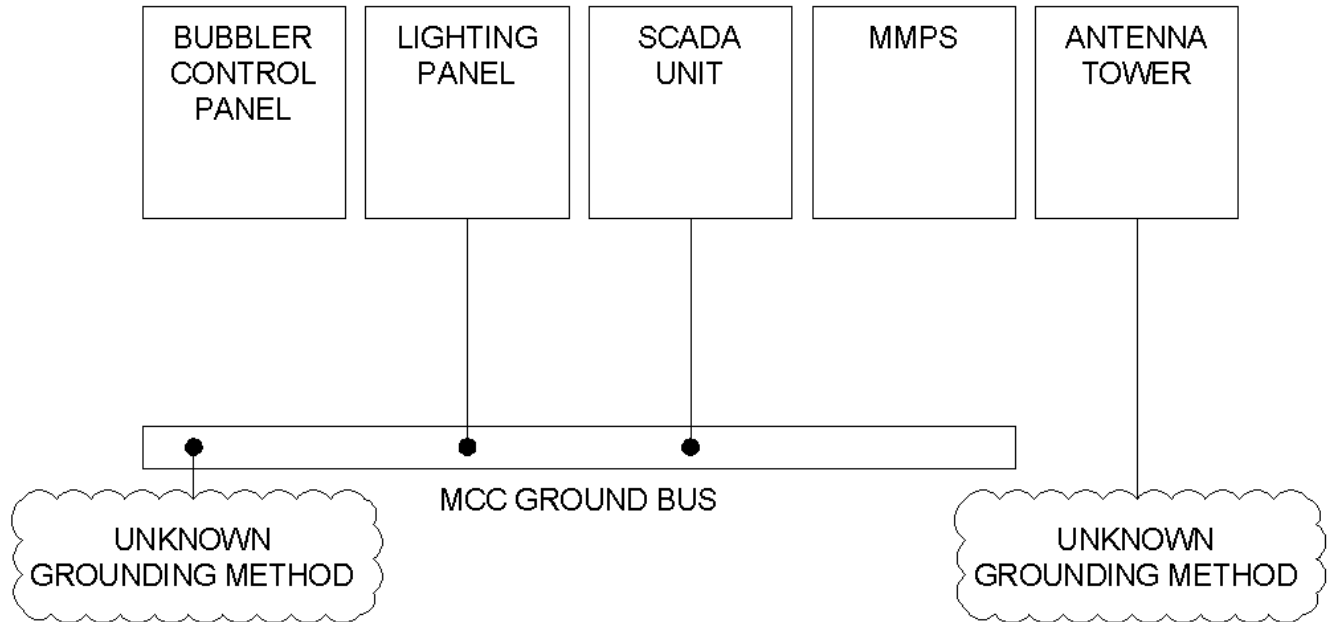
Figure 213-3. Jefferson Ave Grounding System

- Service Entrance Surge Protection Device Installed
- Air Terminals Installed and Bonded to Ground System
- Ground Rod Test Wells Noticeable
- Ground Rods Noticeable
  - 0 Rod(s) Noticeable
- Indications of a Building Ground Ring
- No History of Lightning Strikes
- No History of Failures Resulting in SSO in Past 5 Years
- Equipment properly Surge Protected:
  - SCADA Unit has no surge suppression on coax between Antenna & radio
  - Bubbler control panel is not protected by a surge suppressor
- Equipment properly Grounded:
  - MMPS & bubbler control panel are not bonded to the station grounding system

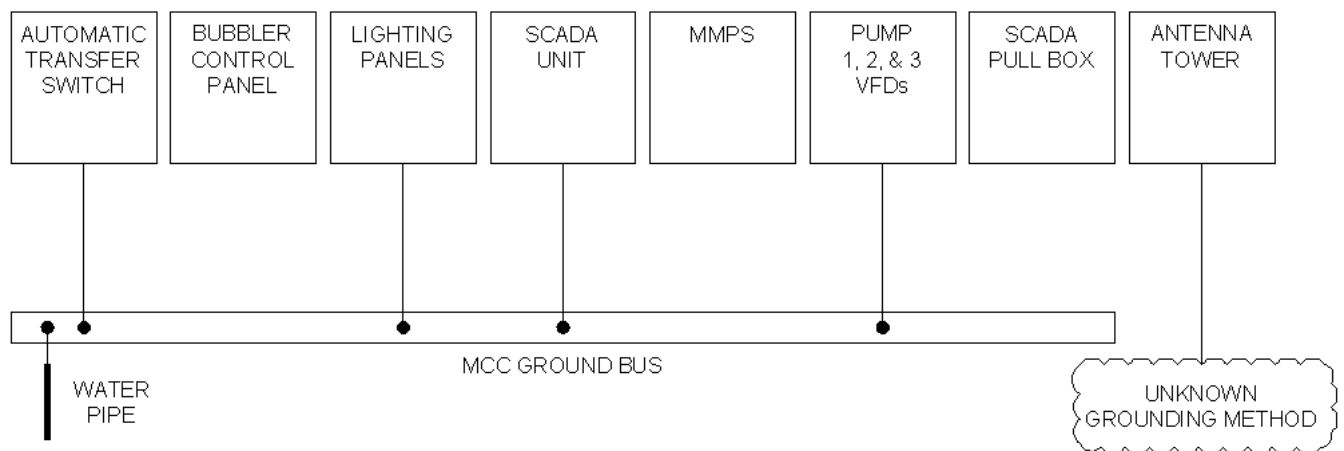
Figure 214-3. Kingsmill Grounding System

- Service Entrance Surge Protection Device Installed
- Air Terminals Installed and Bonded to Ground System
- Ground Rod Test Wells Noticeable
- Ground Rods Noticeable
  - 0 Rod(s) Noticeable
- Indications of a Building Ground Ring
- No History of Lightning Strikes
- No History of Failures Resulting in SSO in Past 5 Years
- Equipment properly Surge Protected:
  - SCADA Unit has no surge suppression on coax between Antenna & radio
  - Bubbler control panel is not protected by a surge suppressor
- Equipment properly Grounded:
  - MMPS, SCADA pull box, & Bubbler control panel are not bonded to the station grounding system

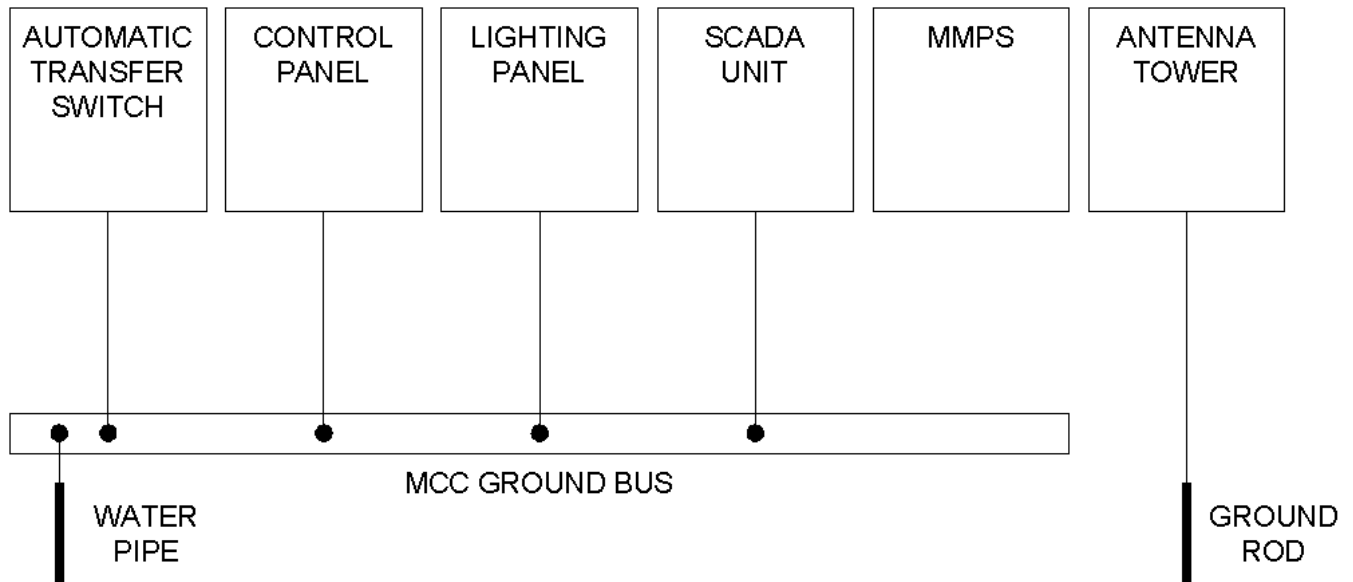
Figure 215-3. Lee Hall Grounding System

- Service Entrance Surge Protection Device Installed
- Air Terminals Installed and Bonded to Ground System
- Ground Rod Test Wells Noticeable
- Ground Rods Noticeable
  - 1 Rod(s) Noticeable
- Indications of a Building Ground Ring
- No History of Lightning Strikes
- No History of Failures Resulting in SSO in Past 5 Years
- Equipment properly Surge Protected:
  - SCADA Unit has no surge suppression on coax between Antenna & radio
  - SCADA unit, MMPS, & control panel are not protected by a surge suppressor
- Equipment properly Grounded:
  - MMPS is not bonded to the station grounding system

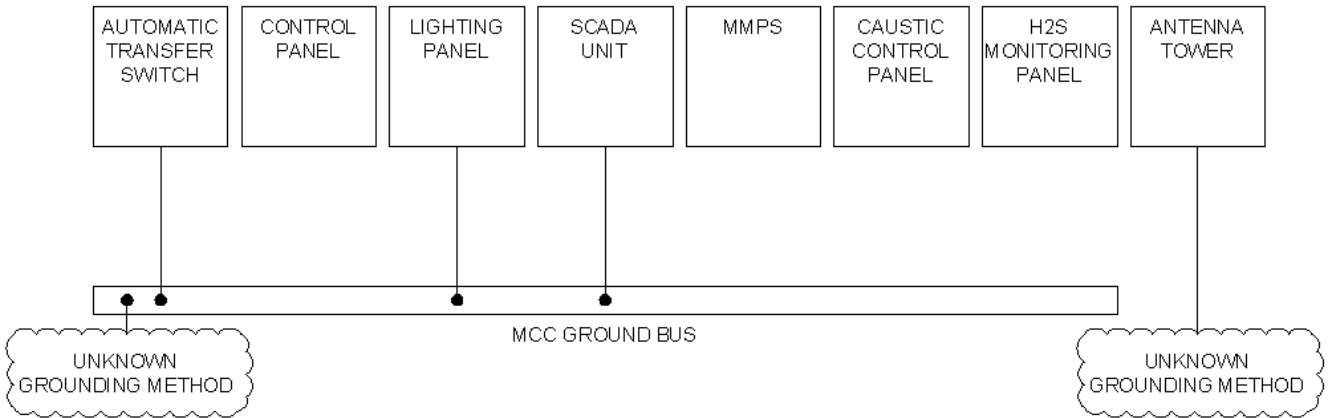
Figure 216-3. Lucas Creek Grounding System

- Service Entrance Surge Protection Device Installed
- Air Terminals Installed and Bonded to Ground System
- Ground Rod Test Wells Noticeable
- Ground Rods Noticeable
  - 0 Rod(s) Noticeable
- Indications of a Building Ground Ring
- No History of Lightning Strikes
- No History of Failures Resulting in SSO in Past 5 Years
- Equipment properly Surge Protected:
  - SCADA Unit has no surge suppression on coax between Antenna & radio
  - Control panel & gas monitoring panels are not protected by a surge suppressor
- Equipment properly Grounded:
  - MMPS & gas monitoring panels are not bonded to the station grounding system

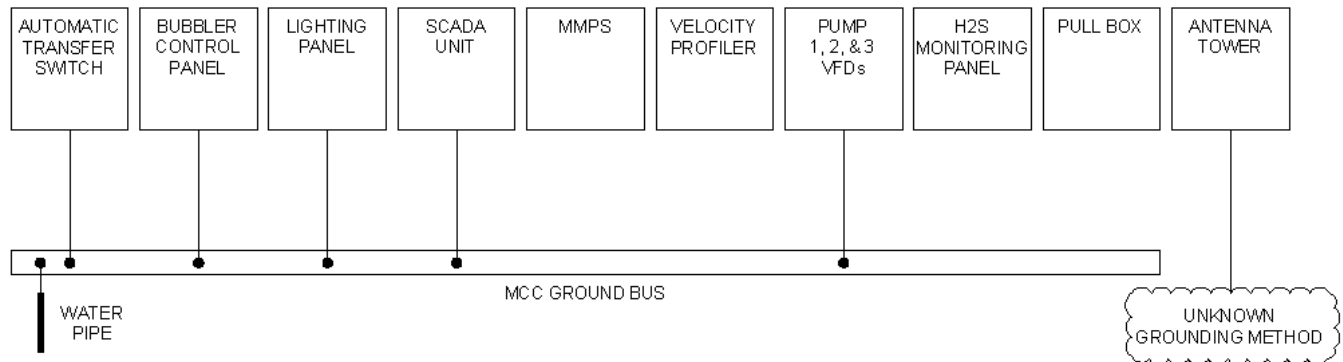
Figure 217-3. Langley Circle Grounding System

- Service Entrance Surge Protection Device Installed
- Air Terminals Installed and Bonded to Ground System
- Ground Rod Test Wells Noticeable
- Ground Rods Noticeable
  - 0 Rod(s) Noticeable
- Indications of a Building Ground Ring
- No History of Lightning Strikes
- No History of Failures Resulting in SSO in Past 5 Years
- Equipment properly Surge Protected:
  - SCADA Unit has no surge suppression on coax between Antenna & radio
  - Control panels, velocity profiler, & gas monitoring panels are not protected by a surge suppressor
- Equipment properly Grounded:
  - MMPS, velocity profiler, & gas monitoring panels are not bonded to the station grounding system

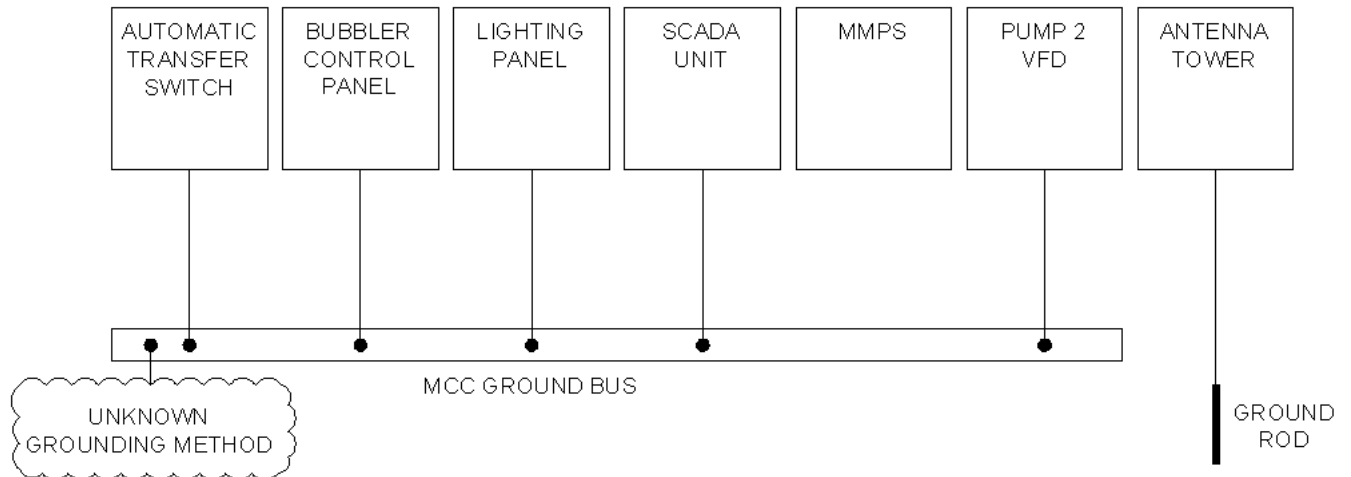
Figure 218-3. Morrison Ave Grounding System

- Service Entrance Surge Protection Device Installed
- Air Terminals Installed and Bonded to Ground System
- Ground Rod Test Wells Noticeable
- Ground Rods Noticeable
  - 0 Rod(s) Noticeable
- Indications of a Building Ground Ring
- No History of Lightning Strikes
- No History of Failures Resulting in SSO in Past 5 Years
- Equipment properly Surge Protected:
  - SCADA Unit has no surge suppression on coax between Antenna & radio.
  - Velocity Profiler is not protected by a surge suppressor.
- Equipment properly Grounded:
  - Velocity Profiler & MMPS are not bonded to the station grounding system.

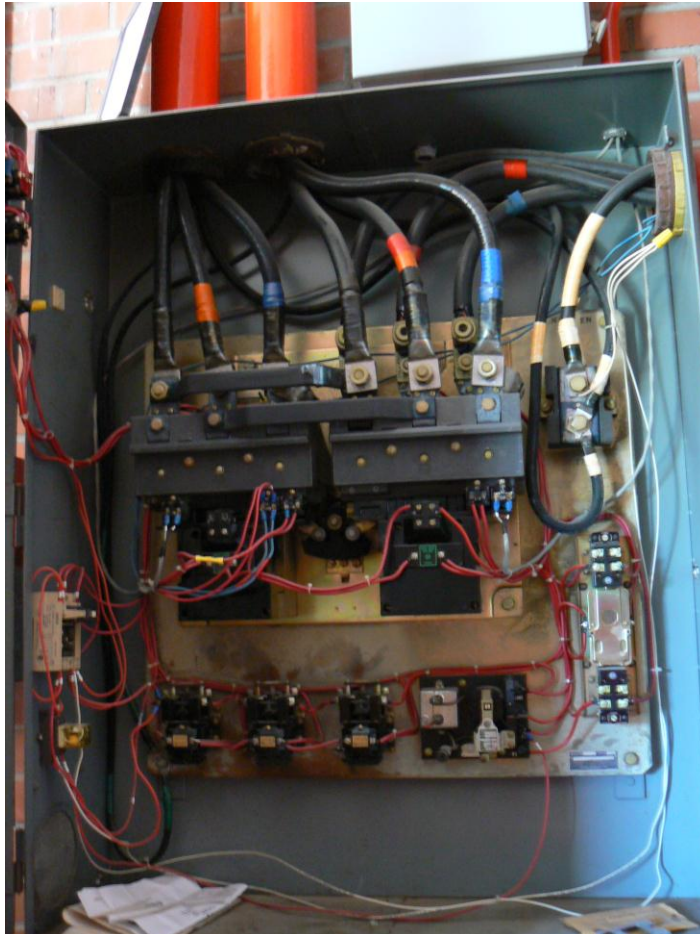
Figure 219-3. Newmarket Creek Transfer Switch

The Newmarket Creek Transfer switch is corroding and did not transfer during preventive maintenance.

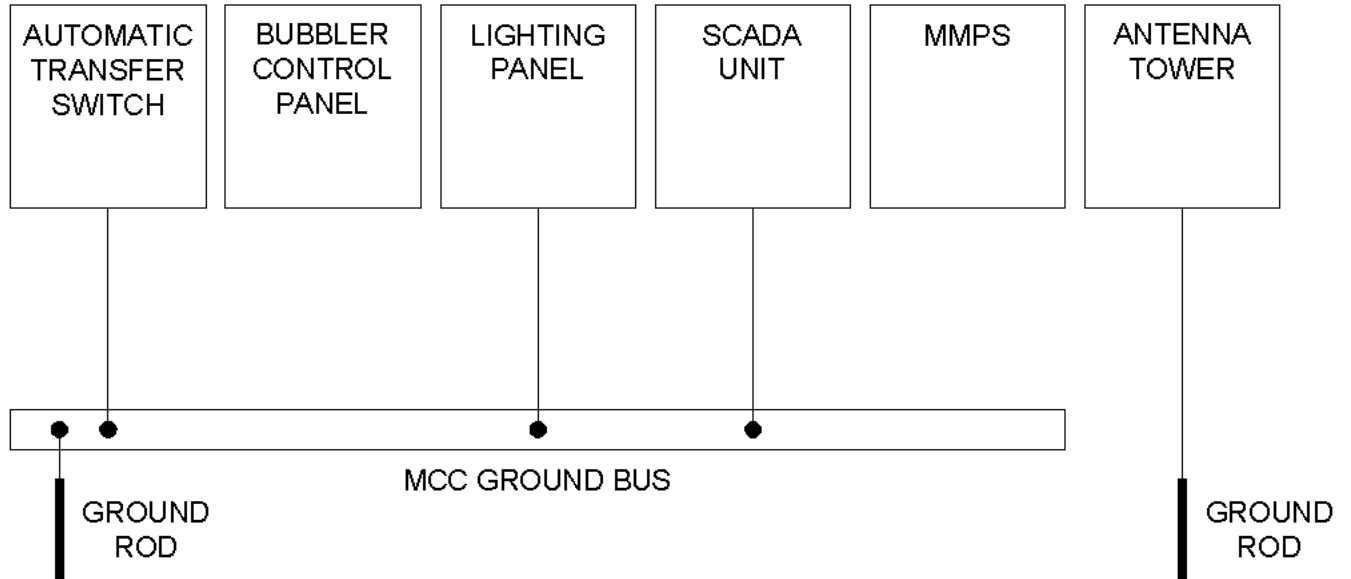
Figure 219-4. Newmarket Creek Grounding System

- Service Entrance Surge Protection Device Installed
- Air Terminals Installed and Bonded to Ground System
- Ground Rod Test Wells Noticeable
- Ground Rods Noticeable
  - 2 Rod(s) Noticeable
- Indications of a Building Ground Ring
- No History of Lightning Strikes
- No History of Failures Resulting in SSO in Past 5 Years
- Equipment properly Surge Protected:
  - SCADA Unit has no surge suppression on coax between Antenna & radio.
  - Bubbler control panel is not protected by a surge suppressor.
- Equipment properly Grounded:
  - MMPS & bubbler control panel are not bonded to the station grounding system.
