# Appendix B: Pump Station Final Condition Assessment Report

This report is an Appendix to HRSD's Rehabilitation Action (Rehab) Plan to satisfy the requirements of the United State's Environmental Protection Agency (EPA) Consent Decree as well as the Virginia Department of Environmental Quality (DEQ) Special Order by Consent (SOC) for reporting on results of the Condition Assessment Program (CAP). This document summarizes condition assessment results related to HRSD's pumping facilities. Appendices A, C, D, and E satisfy the remaining reporting requirements of the CAP. Assets found at material risk of failure, as described further in this report, are addressed in the main document, the Rehab Plan. The primary purpose of the HRSD CAP was to find sanitary sewer assets presenting an actual material risk of failure. For the purposes of this document, "failure" means any condition resulting in a sanitary sewer overflow, pipe leakage, or interruption of service to HRSD's customers, due to a physical condition defect in the system.

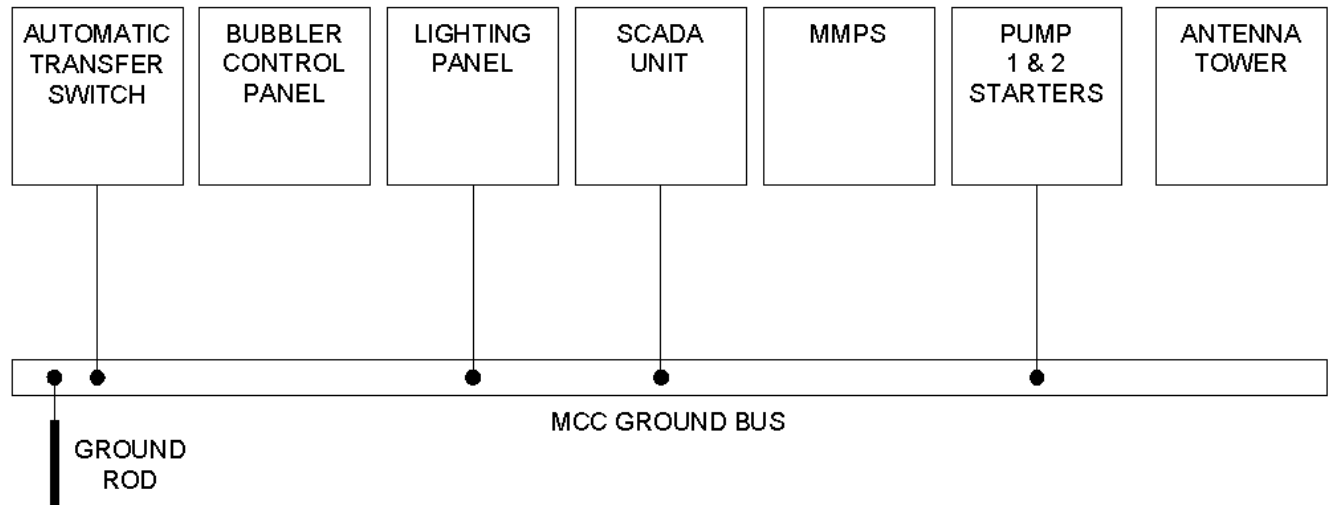
Figure 220-3. Normandy Ln Grounding System

- Service Entrance Surge Protection Device Installed
- Air Terminals Installed and Bonded to Ground System
- Ground Rod Test Wells Noticeable
- Ground Rods Noticeable
  - 1 Rod(s) Noticeable
- Indications of a Building Ground Ring
- No History of Lightning Strikes
- No History of Failures Resulting in SSO in Past 5 Years
- Equipment properly Surge Protected:
  - SCADA Unit has no surge suppression on coax between Antenna & radio.
  - Bubbler control panel is not protected by a surge suppressor.
- Equipment properly Grounded:
  - MMPS & bubbler control panel are not bonded to the station grounding system.

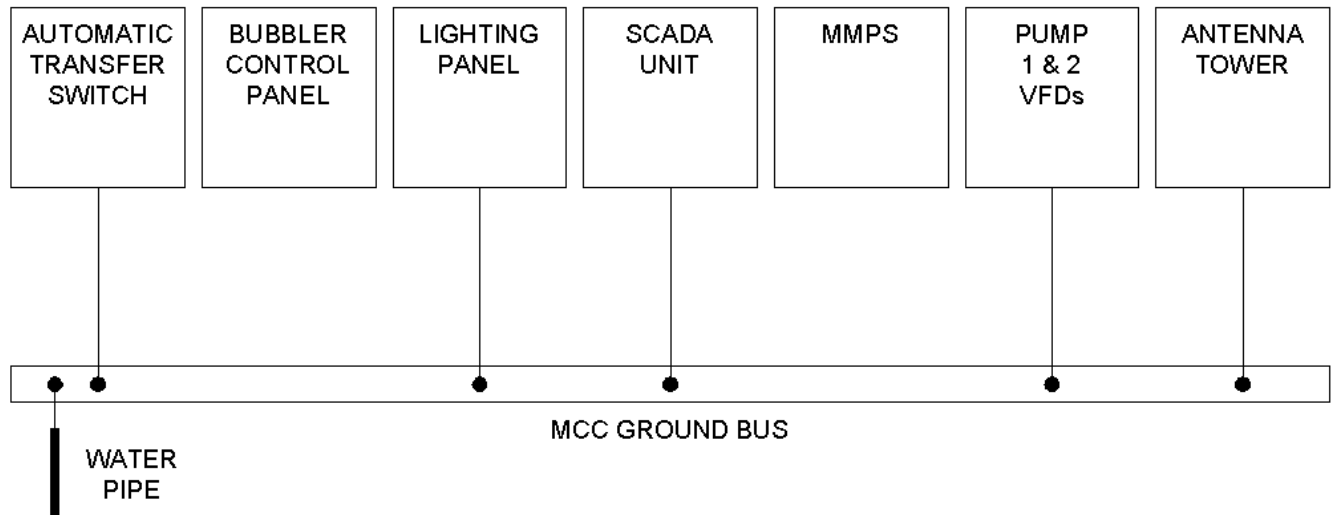
Figure 221-3. Patrick Henry Grounding System

- Service Entrance Surge Protection Device Installed
- Air Terminals Installed and Bonded to Ground System
- Ground Rod Test Wells Noticeable
- Ground Rods Noticeable
  - 0 Rod(s) Noticeable
- Indications of a Building Ground Ring
- No History of Lightning Strikes
- No History of Failures Resulting in SSO in Past 5 Years
- Equipment properly Surge Protected:
  - SCADA Unit has no surge suppression on coax between Antenna & radio
  - Bubbler control panel is not protected by a surge suppressor
- Equipment properly Grounded:
  - MMPS & bubbler control panel are not bonded to the station grounding system

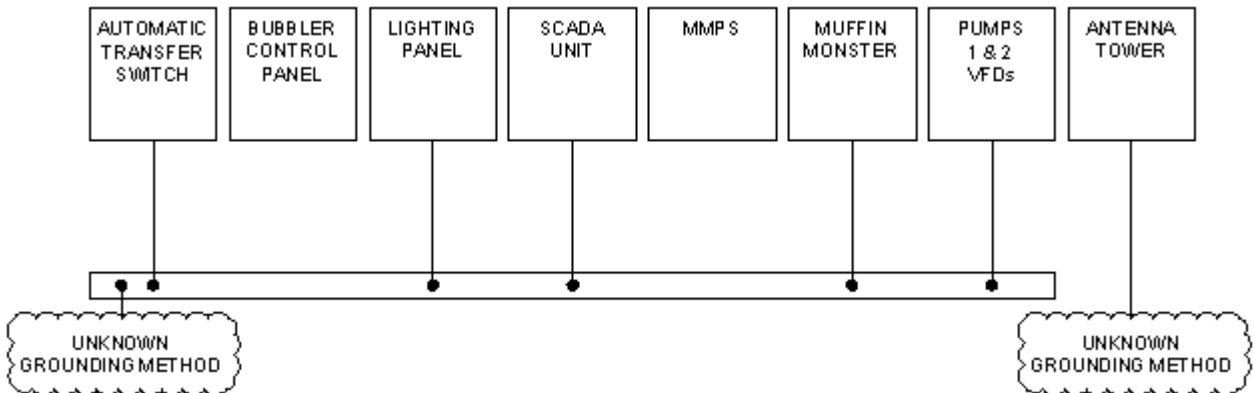
Figure 223-3. Washington St Grounding System

- Service Entrance Surge Protection Device Installed
- Air Terminals Installed and Bonded to Ground System
- Ground Rod Test Wells Noticeable
- Ground Rods Noticeable
  - 0 Rod(s) Noticeable
- Indications of a Building Ground Ring
- No History of Lightning Strikes
- No History of Failures Resulting in SSO in Past 5 Years
- Equipment properly Surge Protected:
  - SCADA Unit has no surge suppression on coax between Antenna & radio.
  - Bubbler control panel is not protected by a surge suppressor.
- Equipment properly Grounded:
  - MMPS & bubbler control panel are not bonded to the station grounding system.

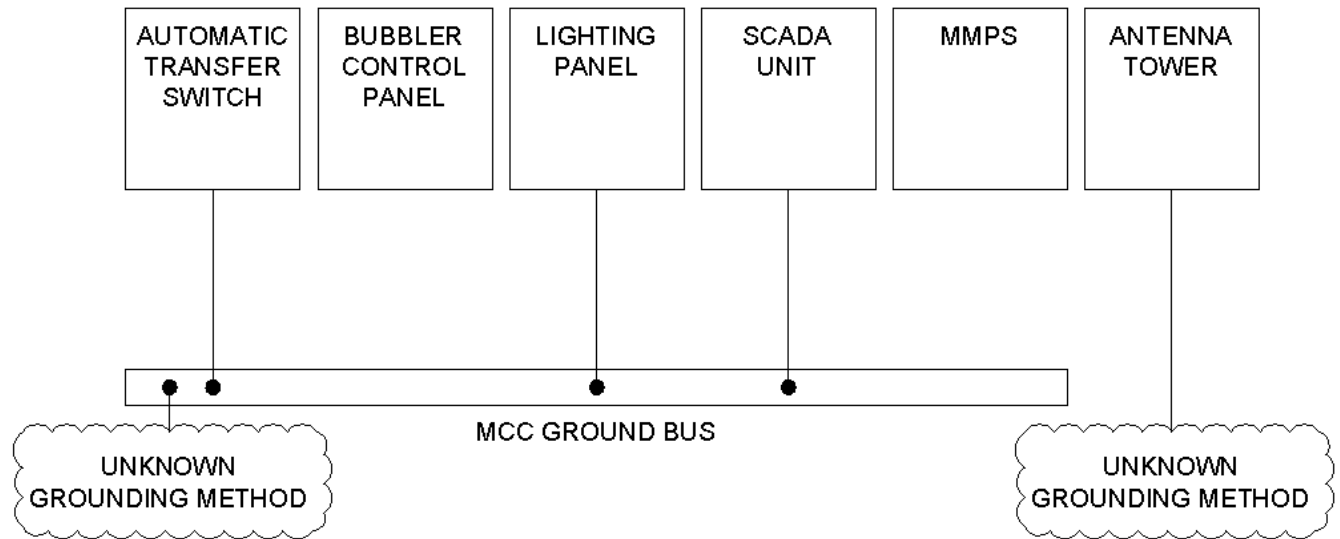
Figure 224-3. Woodland Rd Grounding System

- Service Entrance Surge Protection Device Installed
- Air Terminals Installed and Bonded to Ground System
- Ground Rod Test Wells Noticeable
- Ground Rods Noticeable
  - 0 Rod(s) Noticeable
- Indications of a Building Ground Ring
- No History of Lightning Strikes
- No History of Failures Resulting in SSO in Past 5 Years
- Equipment properly Surge Protected:
  - SCADA Unit has no surge suppression on coax between Antenna & radio.
  - Bubbler control panel is not protected by a surge suppressor.
- Equipment properly Grounded:
  - MMPS & bubbler control panel are not bonded to the station grounding system.

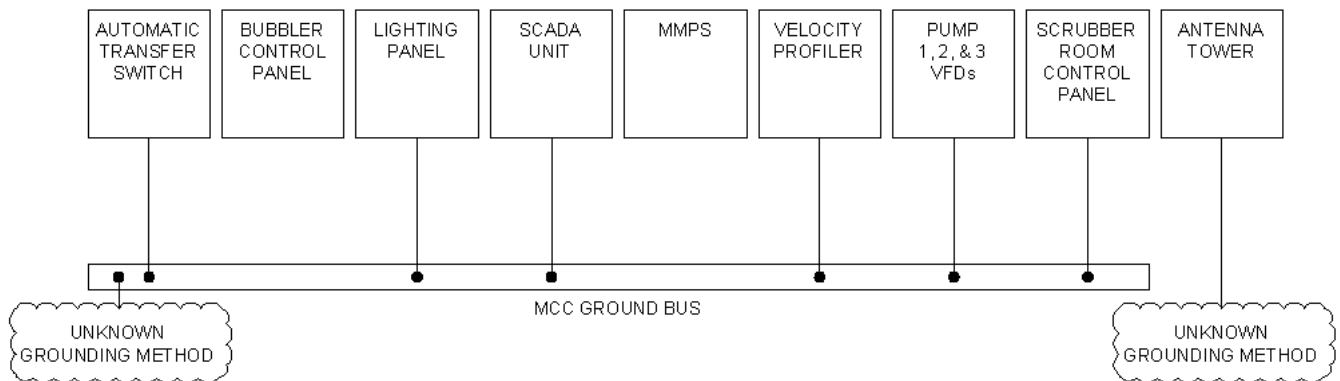
Figure 225-3. Willard Ave Grounding System

- Service Entrance Surge Protection Device Installed
- Air Terminals Installed and Bonded to Ground System
- Ground Rod Test Wells Noticeable
- Ground Rods Noticeable
  - 0 Rod(s) Noticeable
- Indications of a Building Ground Ring
- No History of Lightning Strikes
- No History of Failures Resulting in SSO in Past 5 Years
- Equipment properly Surge Protected:
  - SCADA Unit has no surge suppression on coax between Antenna & radio
  - Bubbler control panel, scrubber room control panel, & velocity profiler are not protected by a surge suppressor
- Equipment properly Grounded:
  - MMPS & bubbler control panel are not bonded to the station grounding system

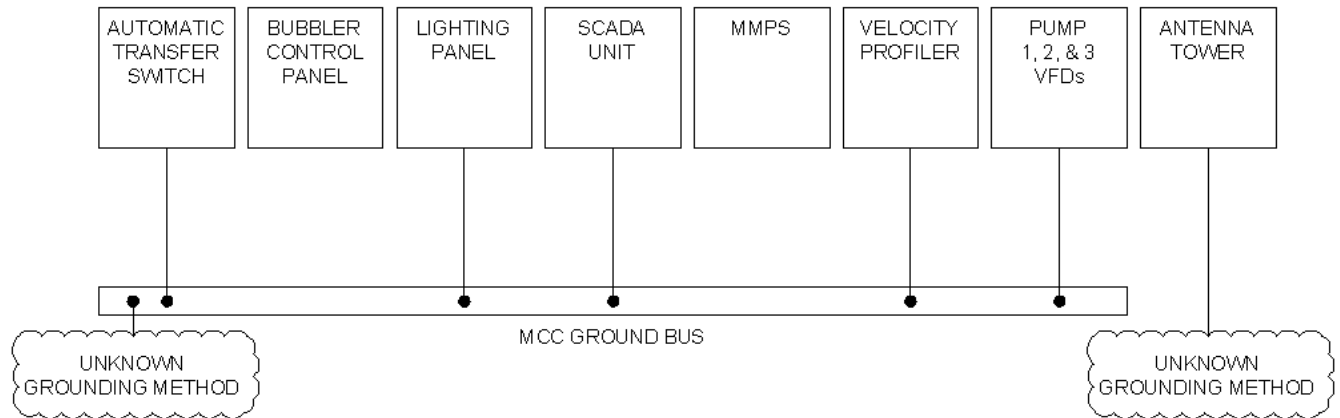
Figure 226-3. Williamsburg Grounding System

- Service Entrance Surge Protection Device Installed
- Air Terminals Installed and Bonded to Ground System
- Ground Rod Test Wells Noticeable
- Ground Rods Noticeable
  - 0 Rod(s) Noticeable
- Indications of a Building Ground Ring
- No History of Lightning Strikes
- No History of Failures Resulting in SSO in Past 5 Years
- Equipment properly Surge Protected:
  - SCADA Unit has no surge suppression on coax between Antenna & radio.
  - Bubbler control panel & velocity profiler are not protected by a surge suppressor.
- Equipment properly Grounded:
  - MMPS is not bonded to the station grounding system

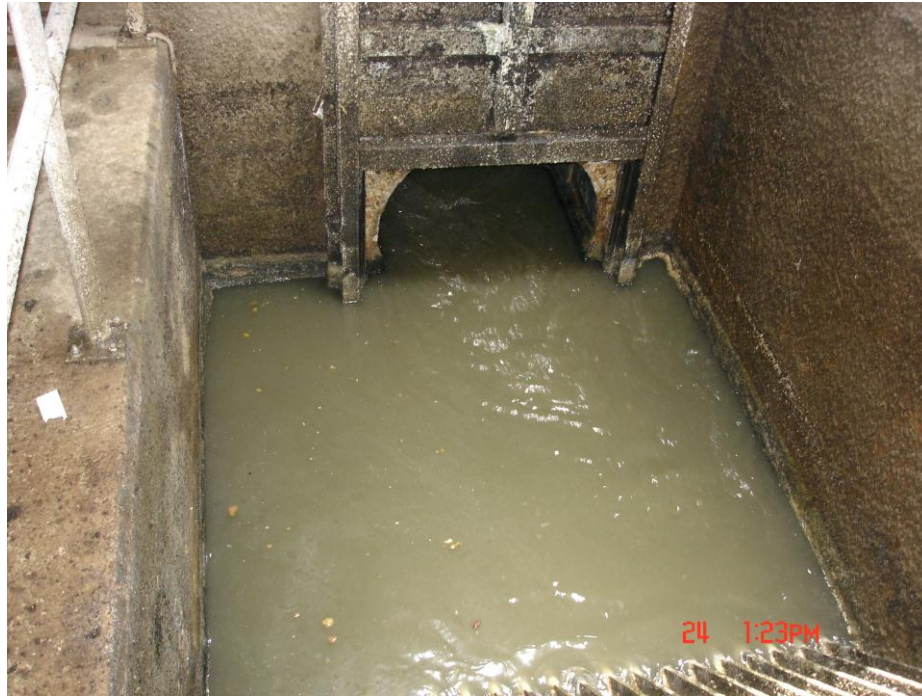
Figure 227-3. Ft. Eustis Influent Channel.

The influent channel configuration is causing operational issues.

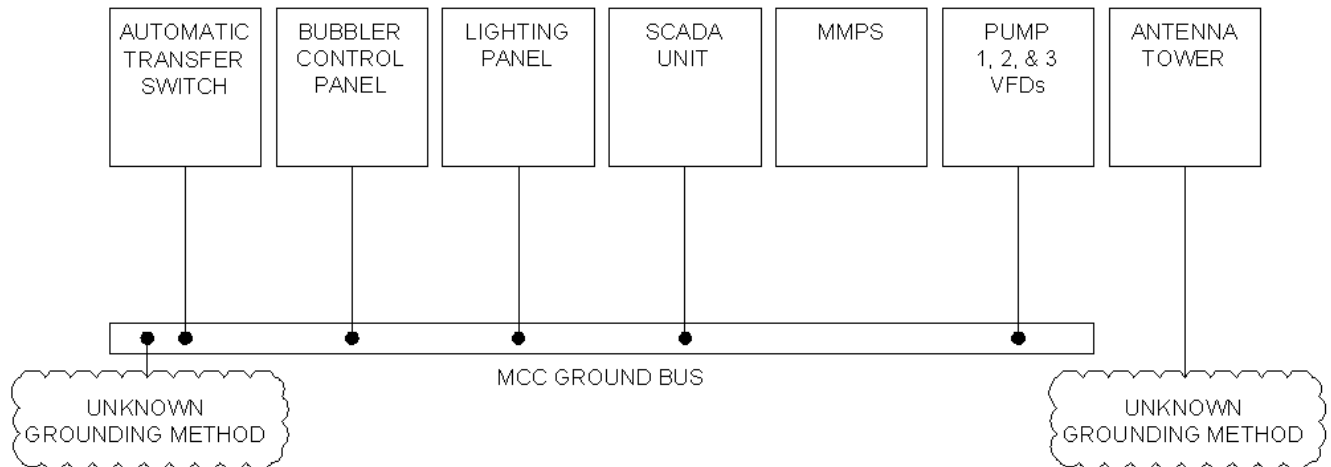
Figure 227-4. Fort Eustis Grounding System

- Service Entrance Surge Protection Device Installed
- Air Terminals Installed and Bonded to Ground System
- Ground Rod Test Wells Noticeable
- Ground Rods Noticeable
  - 0 Rod(s) Noticeable
- Indications of a Building Ground Ring
- No History of Lightning Strikes
- No History of Failures Resulting in SSO in Past 5 Years
- Equipment properly Surge Protected:
  - SCADA Unit has no surge suppression on coax between Antenna & radio
  - Bubbler control panel is not protected by a surge suppressor
- Equipment properly Grounded:
  - MMPS is not bonded to the station grounding system

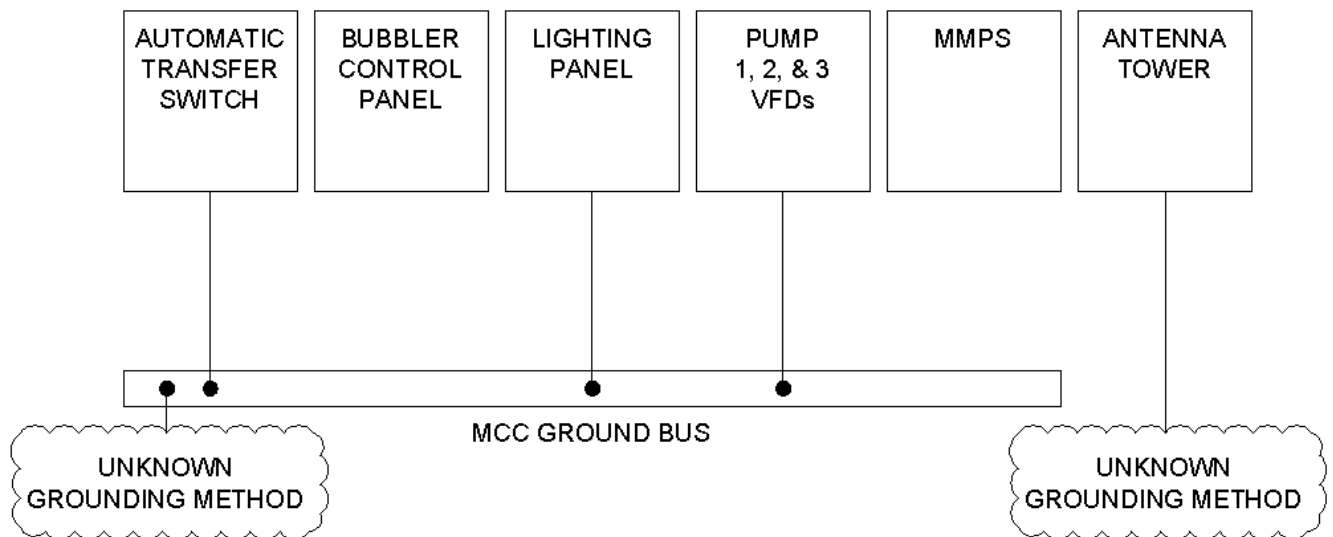
Figure 229-3. Colonial Williamsburg Grounding System

- Service Entrance Surge Protection Device Installed
- Air Terminals Installed and Bonded to Ground System
- Ground Rod Test Wells Noticeable
- Ground Rods Noticeable
  - 0 Rod(s) Noticeable
- Indications of a Building Ground Ring
- No History of Lightning Strikes
- No History of Failures Resulting in SSO in Past 5 Years
- Equipment properly Surge Protected:
  - SCADA Unit has no surge suppression on coax between Antenna & radio.
- Equipment properly Grounded:
  - MMPS is not bonded to the station grounding system

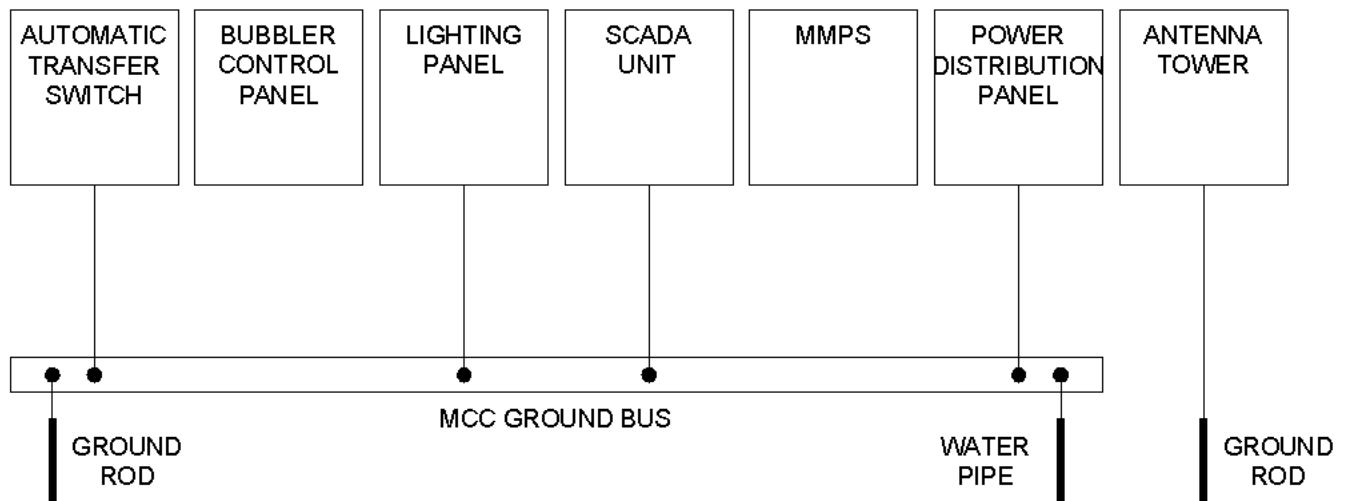
Figure 230-3. Rolling Hills Grounding System

- Service Entrance Surge Protection Device Installed
- Air Terminals Installed and Bonded to Ground System
- Ground Rod Test Wells Noticeable
- Ground Rods Noticeable
  - 2 Rod(s) Noticeable
- Indications of a Building Ground Ring
- No History of Lightning Strikes
- No History of Failures Resulting in SSO in Past 5 Years
- Equipment properly Surge Protected:
  - SCADA Unit has no surge suppression on coax between Antenna & radio.
  - Bubbler control panel is not protected by a surge suppressor.
- Equipment properly Grounded:
  - MMPS & Bubbler control panel are not bonded to the station grounding system.

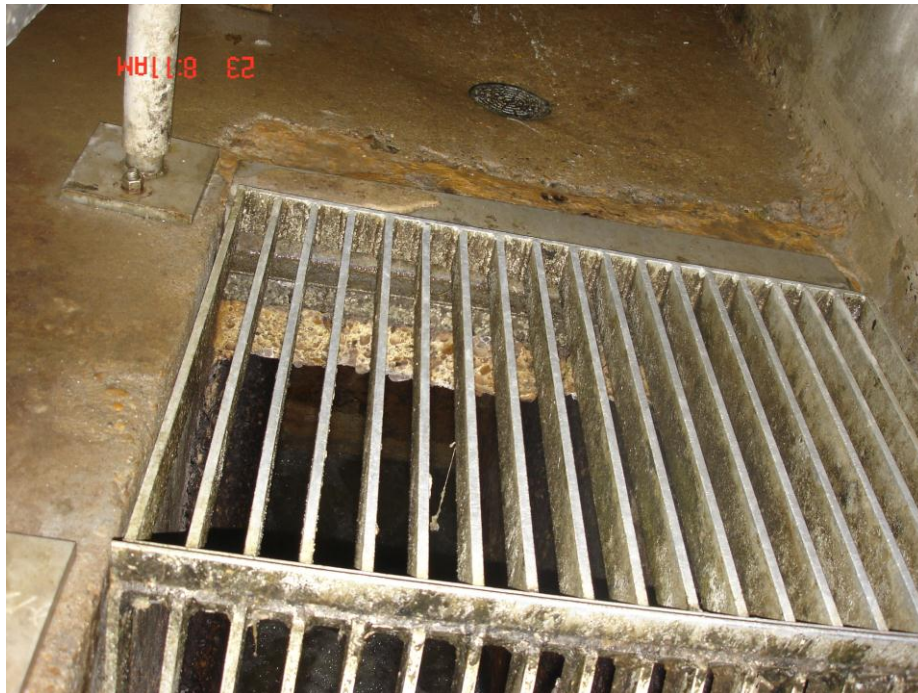
Figure 231-3. Fords Colony Wet Well Slab

After the initial round of inspections, HRSD used a specialty contractor to revisit select stations for wet well structural inspections including concrete strength tests. Test results showed that the Fords Colony wet well is deteriorating.

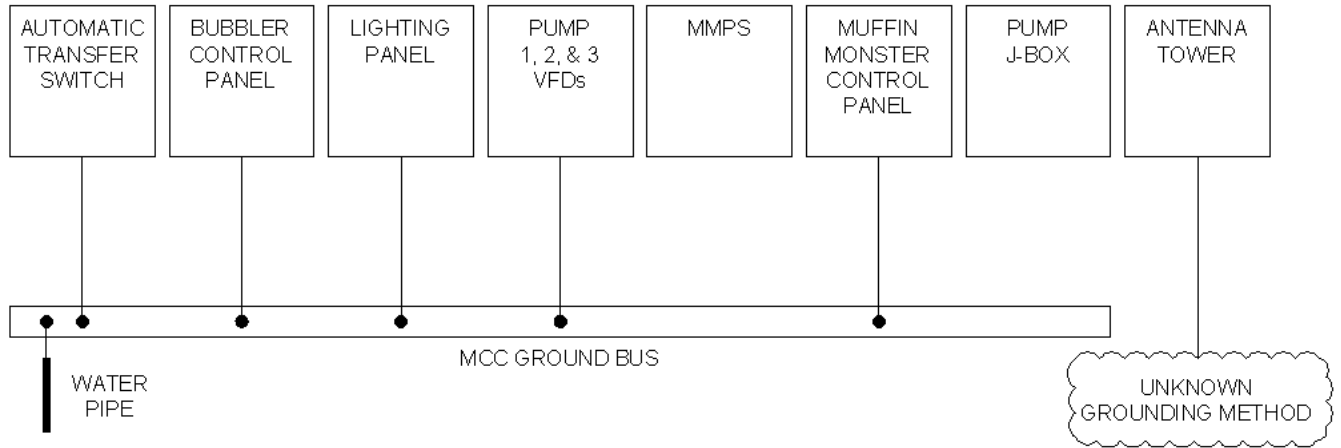
Figure 231-4. Fords Colony Grounding System

- Service Entrance Surge Protection Device Installed
- Air Terminals Installed and Bonded to Ground System
- Ground Rod Test Wells Noticeable
- Ground Rods Noticeable
  - 0 Rod(s) Noticeable
- Indications of a Building Ground Ring
- No History of Lightning Strikes
- No History of Failures Resulting in SSO in Past 5 Years
- Equipment properly Surge Protected:
  - SCADA Unit has no surge suppression on coax between Antenna & radio.
- Equipment properly Grounded:
  - MMPS & pump J-Box are not bonded to the station grounding system.

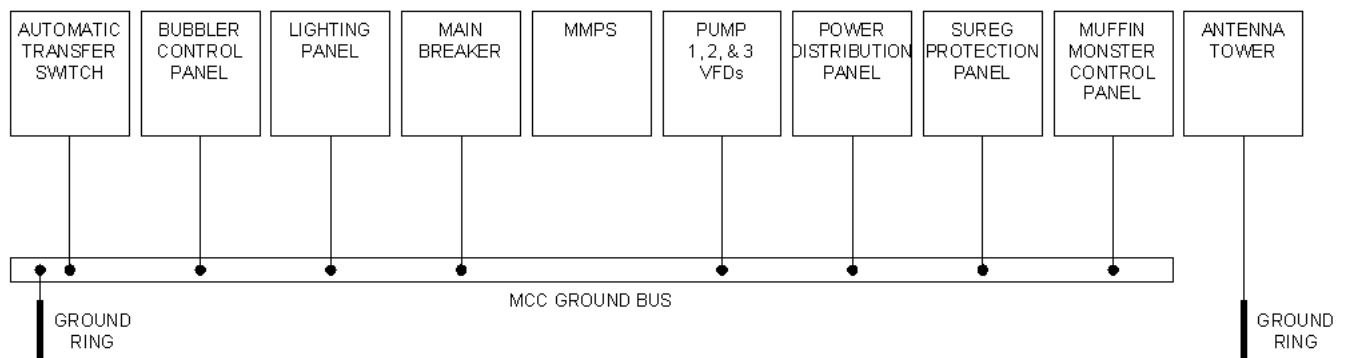
Figure 232-3. Greensprings Grounding System

- Service Entrance Surge Protection Device Installed
- Air Terminals Installed and Bonded to Ground System
- Ground Rod Test Wells Noticeable
- Ground Rods Noticeable
  - 0 Rod(s) Noticeable
- Indications of a Building Ground Ring
- No History of Lightning Strikes
- No History of Failures Resulting in SSO in Past 5 Years
- Equipment properly Surge Protected:
  - SCADA Unit has no surge suppression on coax between Antenna & radio.
- Equipment properly Grounded:
  - MMPS is not bonded to the station grounding system.

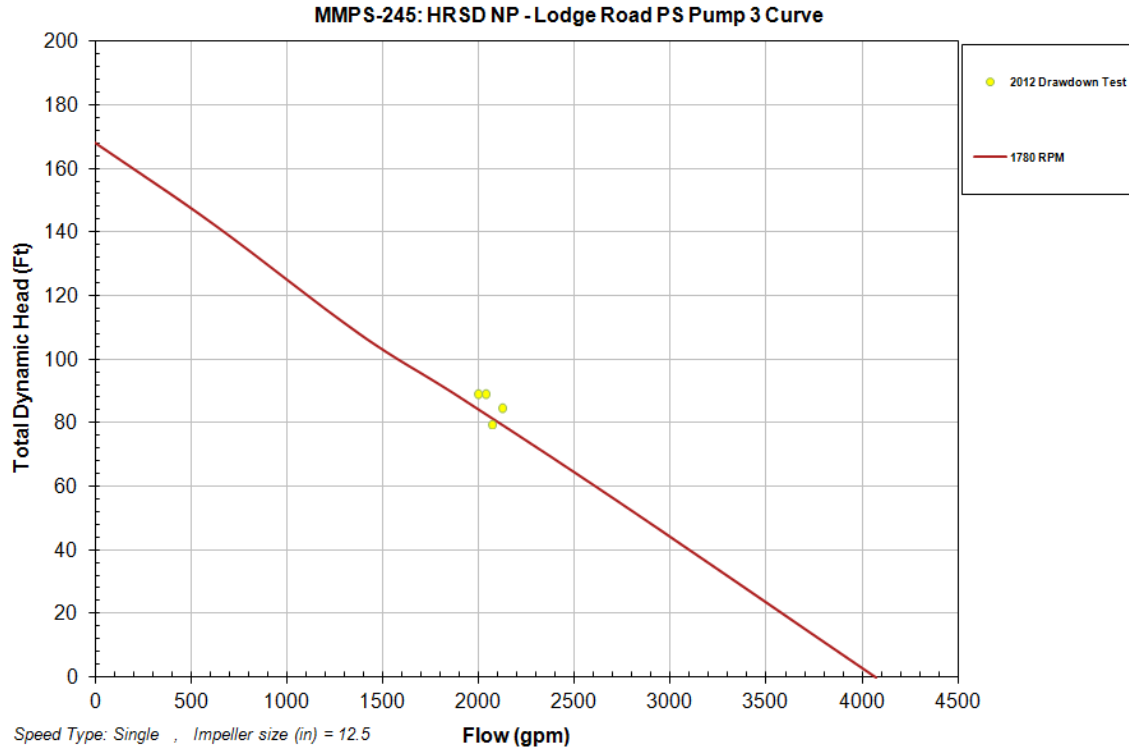
The drawdown test pump curves for Lodge Road Pump Station do not display the Best Efficiency Point (BEP) or the the Design Operating Point (DOP) due to the information not being readily available. HRSD performed physical draw down tests in 2012. A Telog-based Measured Point is not shown.

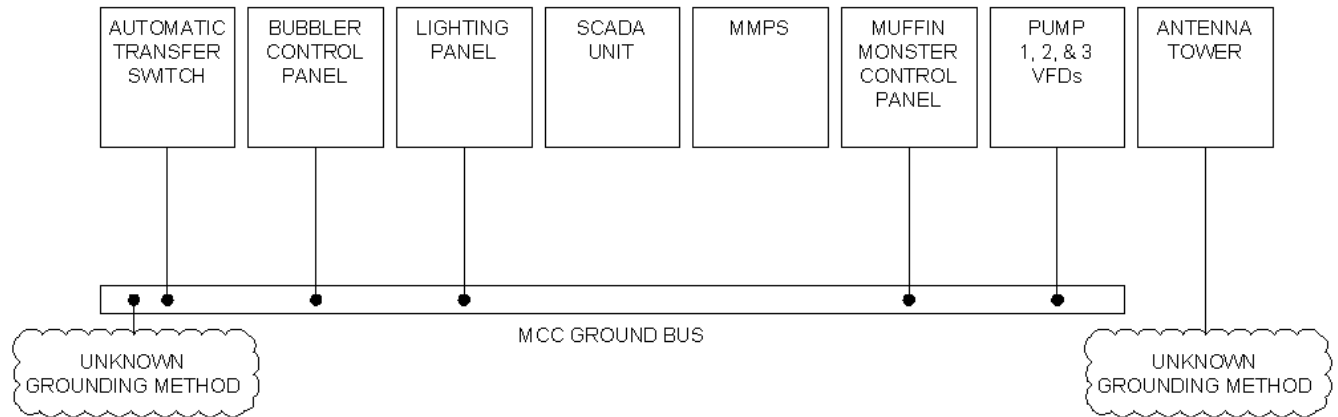
Figure 233-3. Lodge Rd Grounding System

- Service Entrance Surge Protection Device Installed
- Air Terminals Installed and Bonded to Ground System
- Ground Rod Test Wells Noticeable
- Ground Rods Noticeable
  - 0 Rod(s) Noticeable
- Indications of a Building Ground Ring
- No History of Lightning Strikes
- No History of Failures Resulting in SSO in Past 5 Years
- Equipment properly Surge Protected:
  - SCADA Unit has no surge suppression on coax between Antenna & radio
  - Bubbler control panel is not protected by a surge suppressor
- Equipment properly Grounded:
  - MMPS & SCADA Unit are not bonded to the station grounding system
