Sanitary Sewer Evaluation Survey (SSES) Plan

SANITARY SEWER EVALUATION SURVEY (SSES) PLAN

Prepared for
Hampton Roads Sanitation District
December 2008
Revised March 2009

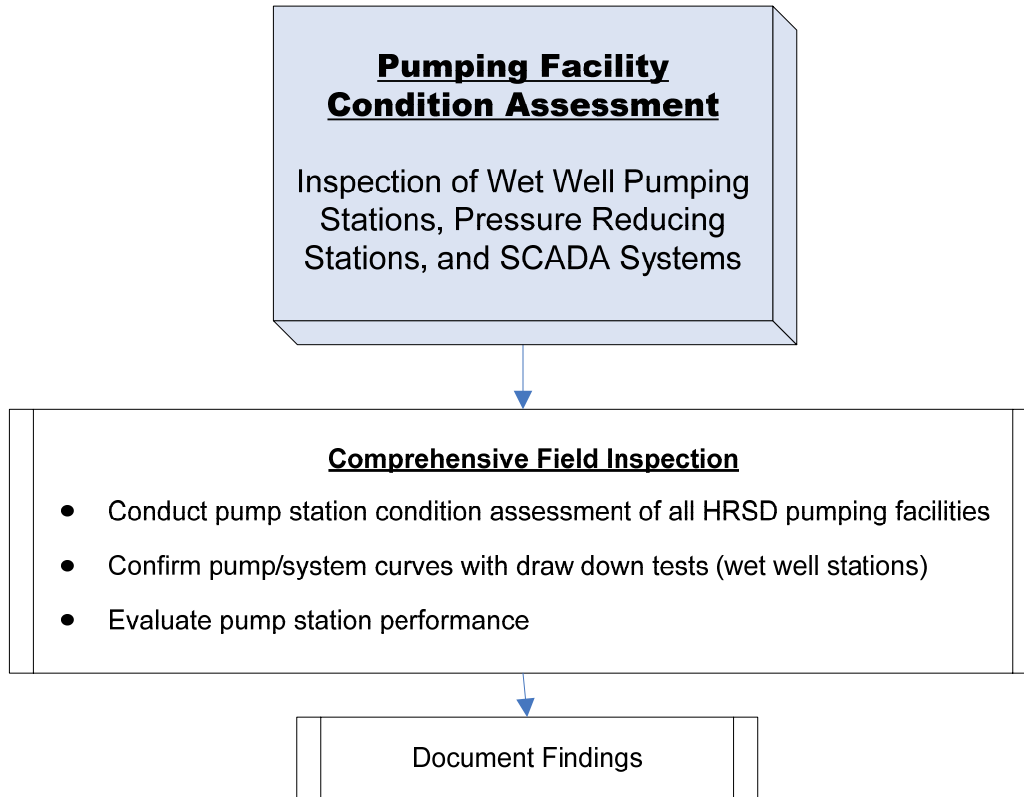
Figure 4-3. Pumping Facility Condition Assessment – Investigation Approach

Pumping facility condition assessments will be conducted using the investigation approach logic as depicted on Figure 4-3. This approach logic will be followed to collect sufficient data to adequately assess the condition of HRSD pumping facilities in conformance with the requirements of the RTS.

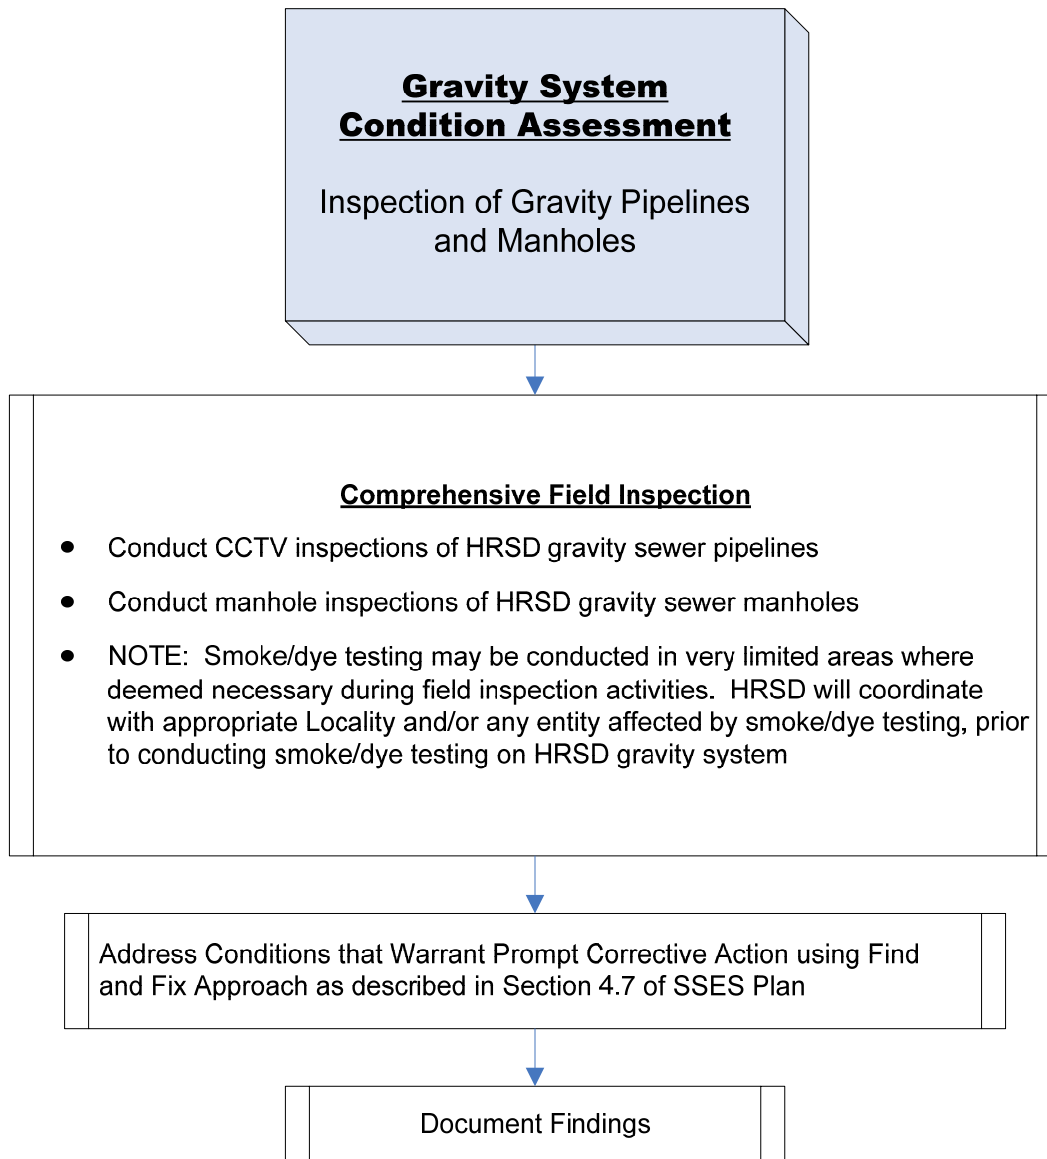
Figure 4-4. Gravity System Condition Assessment – Investigation Approach

Gravity system condition assessments will be conducted using the investigation approach logic as depicted on Figure 4-4. This approach logic will be followed to collect sufficient data to adequately assess the condition of HRSD gravity sewer pipelines and gravity sewer manholes in conformance with the requirements of the RTS.

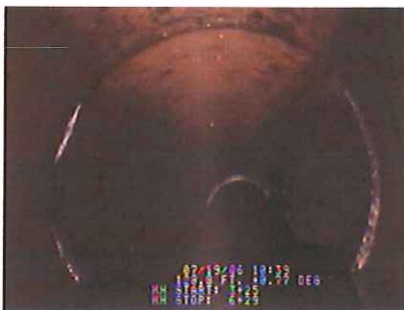
129.7	IR	No	11 / 8			
-------	----	----	--------	--	--	--

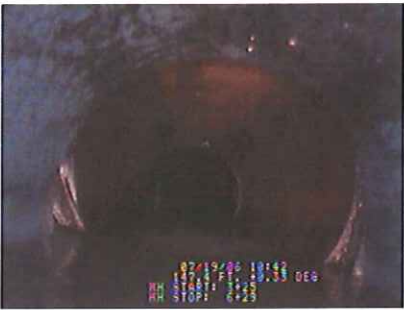
135.5	MMC	No	/			pipe repair (pvc)
148.1	MMC	No	/			pipe changes to vc

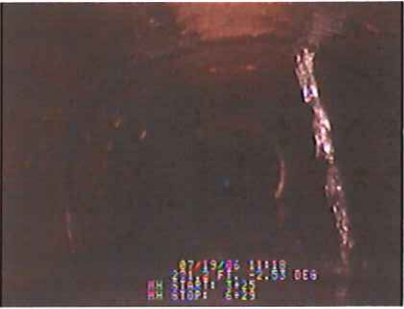
271.9	IR	No	1 /

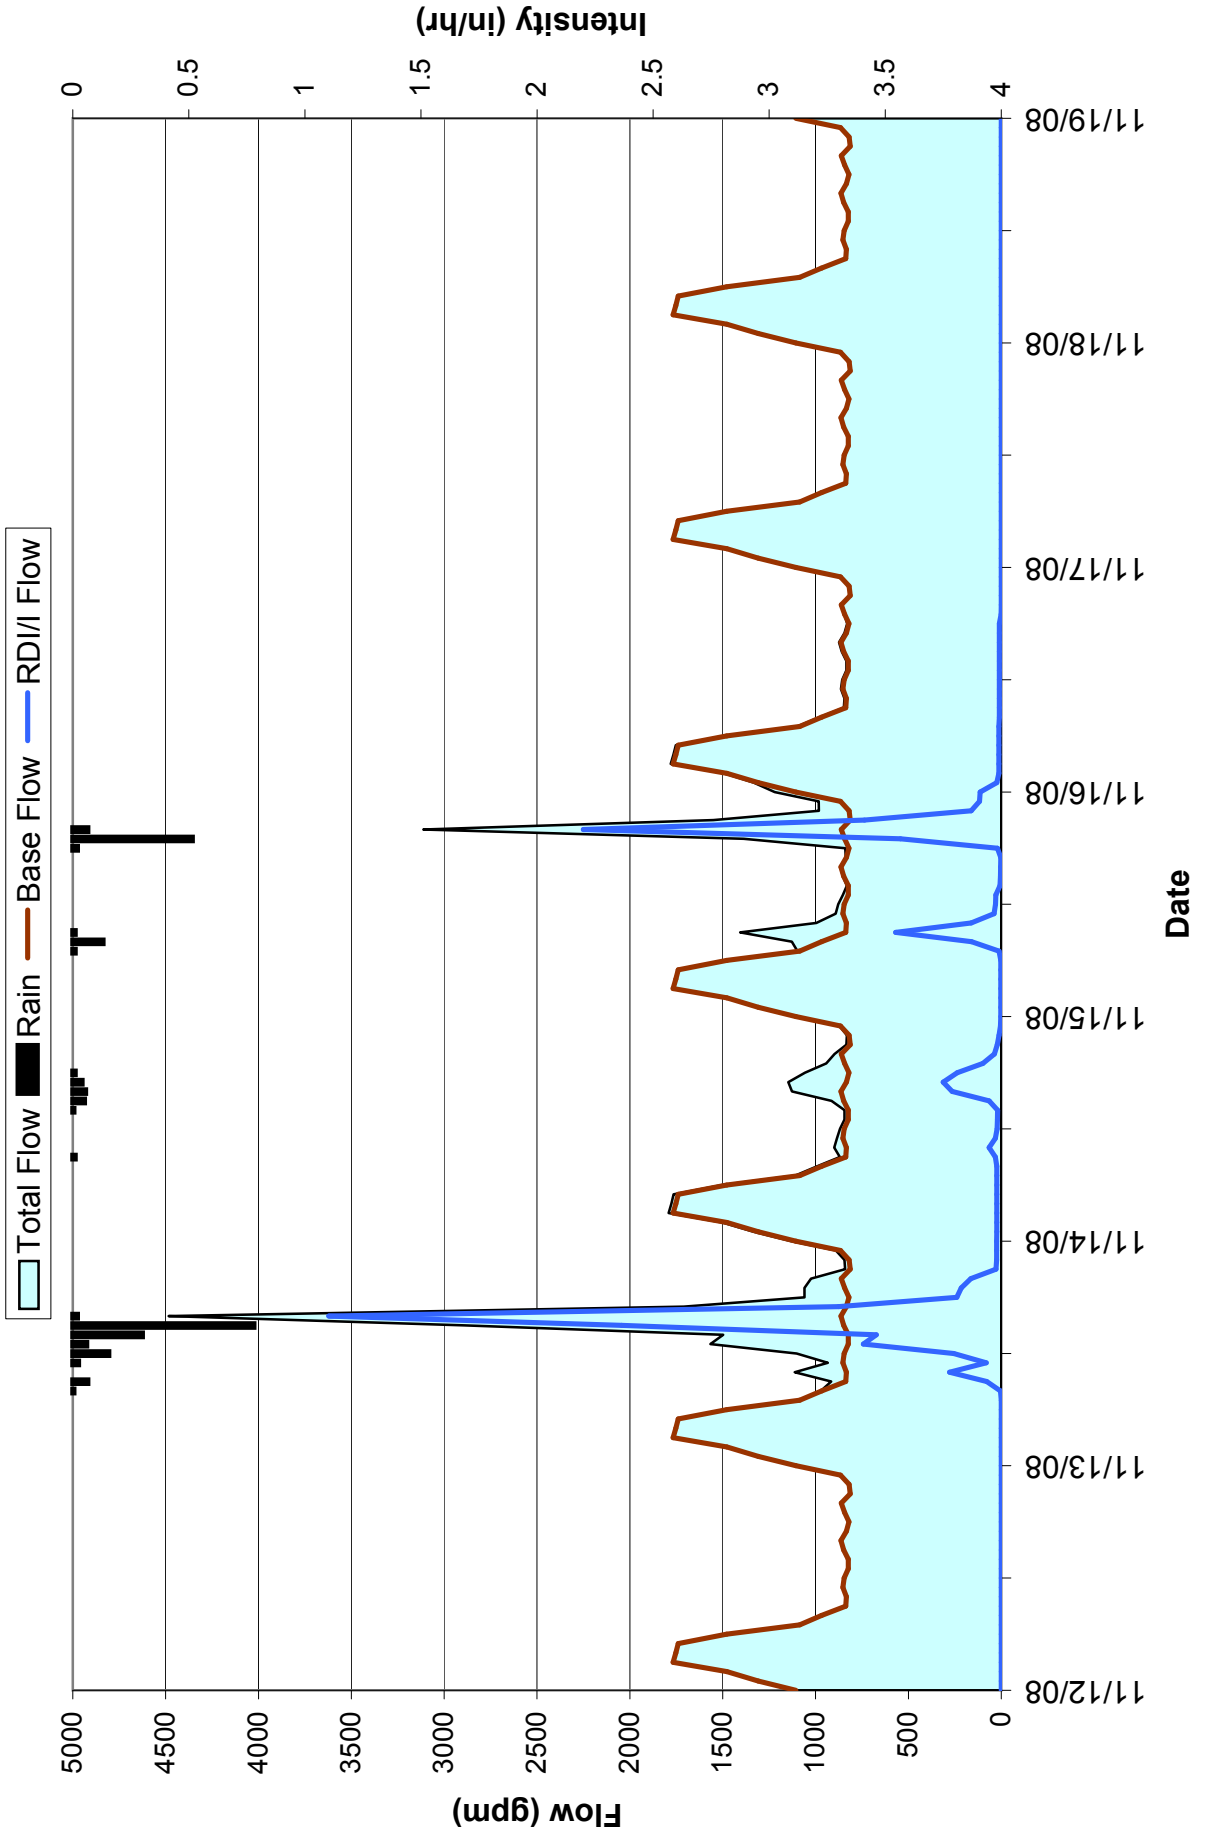
HRSD Gravity Flow Monitoring Program
Site 30 (115 Newtown Road - Newtown Road Pump Station #115)
Hydrograph Decomposition
11/12/08 - 11/19/08
