# **APPENDIX 4**

# CONDITION ASSESSMENT PLAN

Prepared for  
Hampton Roads Sanitation District  
February 2009  
Revised September 2009

# HAMPTON ROADS SANITATION DISTRICT CONDITION ASSESSMENT PLAN

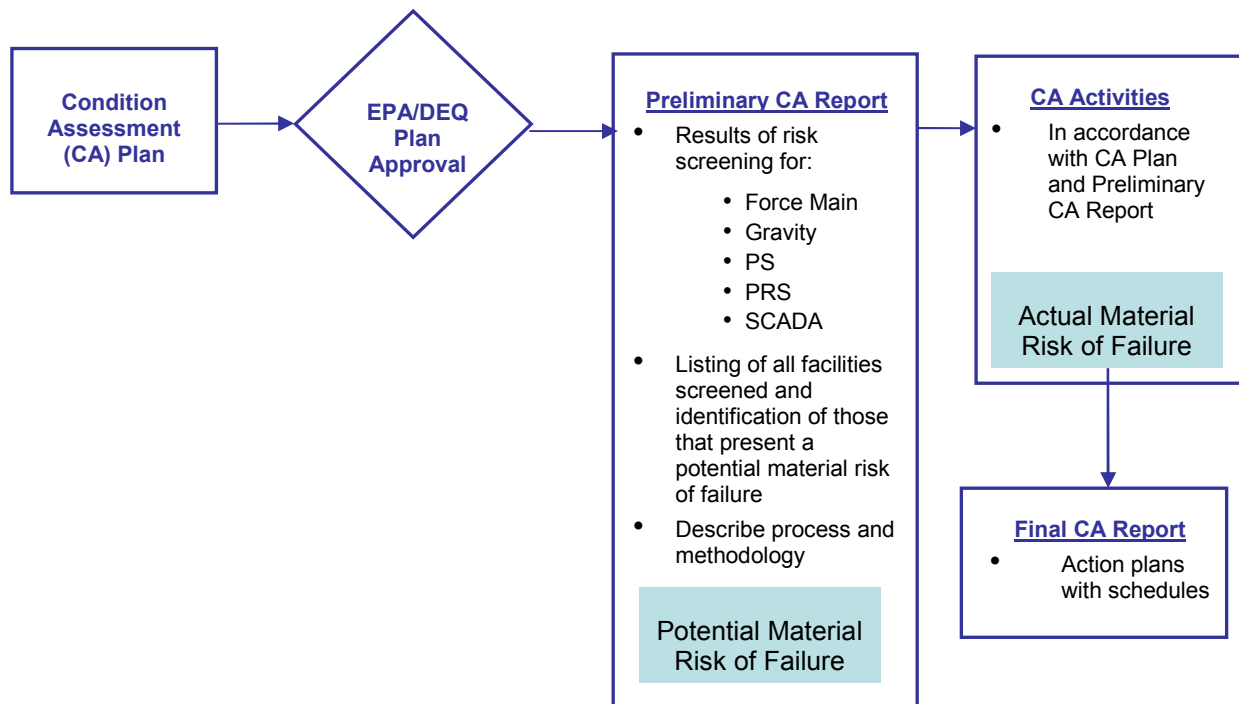
**Figure 1-1. Condition Assessment Program Phasing**

Once the initial screening is completed, HRSD will develop a Preliminary Condition Assessment Report that documents the results of this work and details the Condition Assessment Activities. Upon completion of field activities, the Final Condition Assessment Report will be developed that presents results along with Action Plans and schedules. The Action Plan will identify specific assets that will be rehabilitated or replaced in order to mitigate the actual material risk of failure and an associated schedule. This process is shown in Figure 1-1 below.

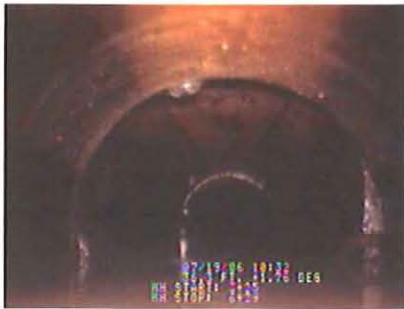
Distance	Length	Code	Reversed	Clock Pos.	Severity	Comment
0.0		START DOWNSTREA M	No	/		
0.0		AMH	No	/		3+25
0.0		MWL	No	/		
37.3		ID	No	3 / 11

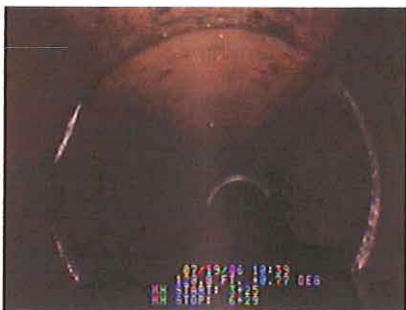
129.7	IR	No	11 / 8			
-------	----	----	--------	--	--	--

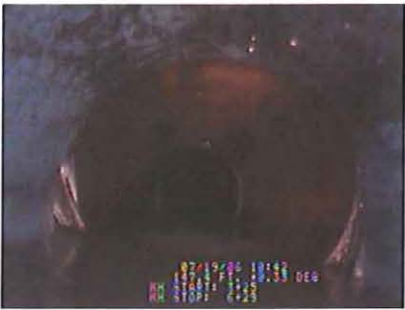
135.5	MMC	No	/			pipe repair (pvc)
148.1	MMC	No	/			pipe changes to vc
