Appendix D: Force Main System Final Condition Assessment Report

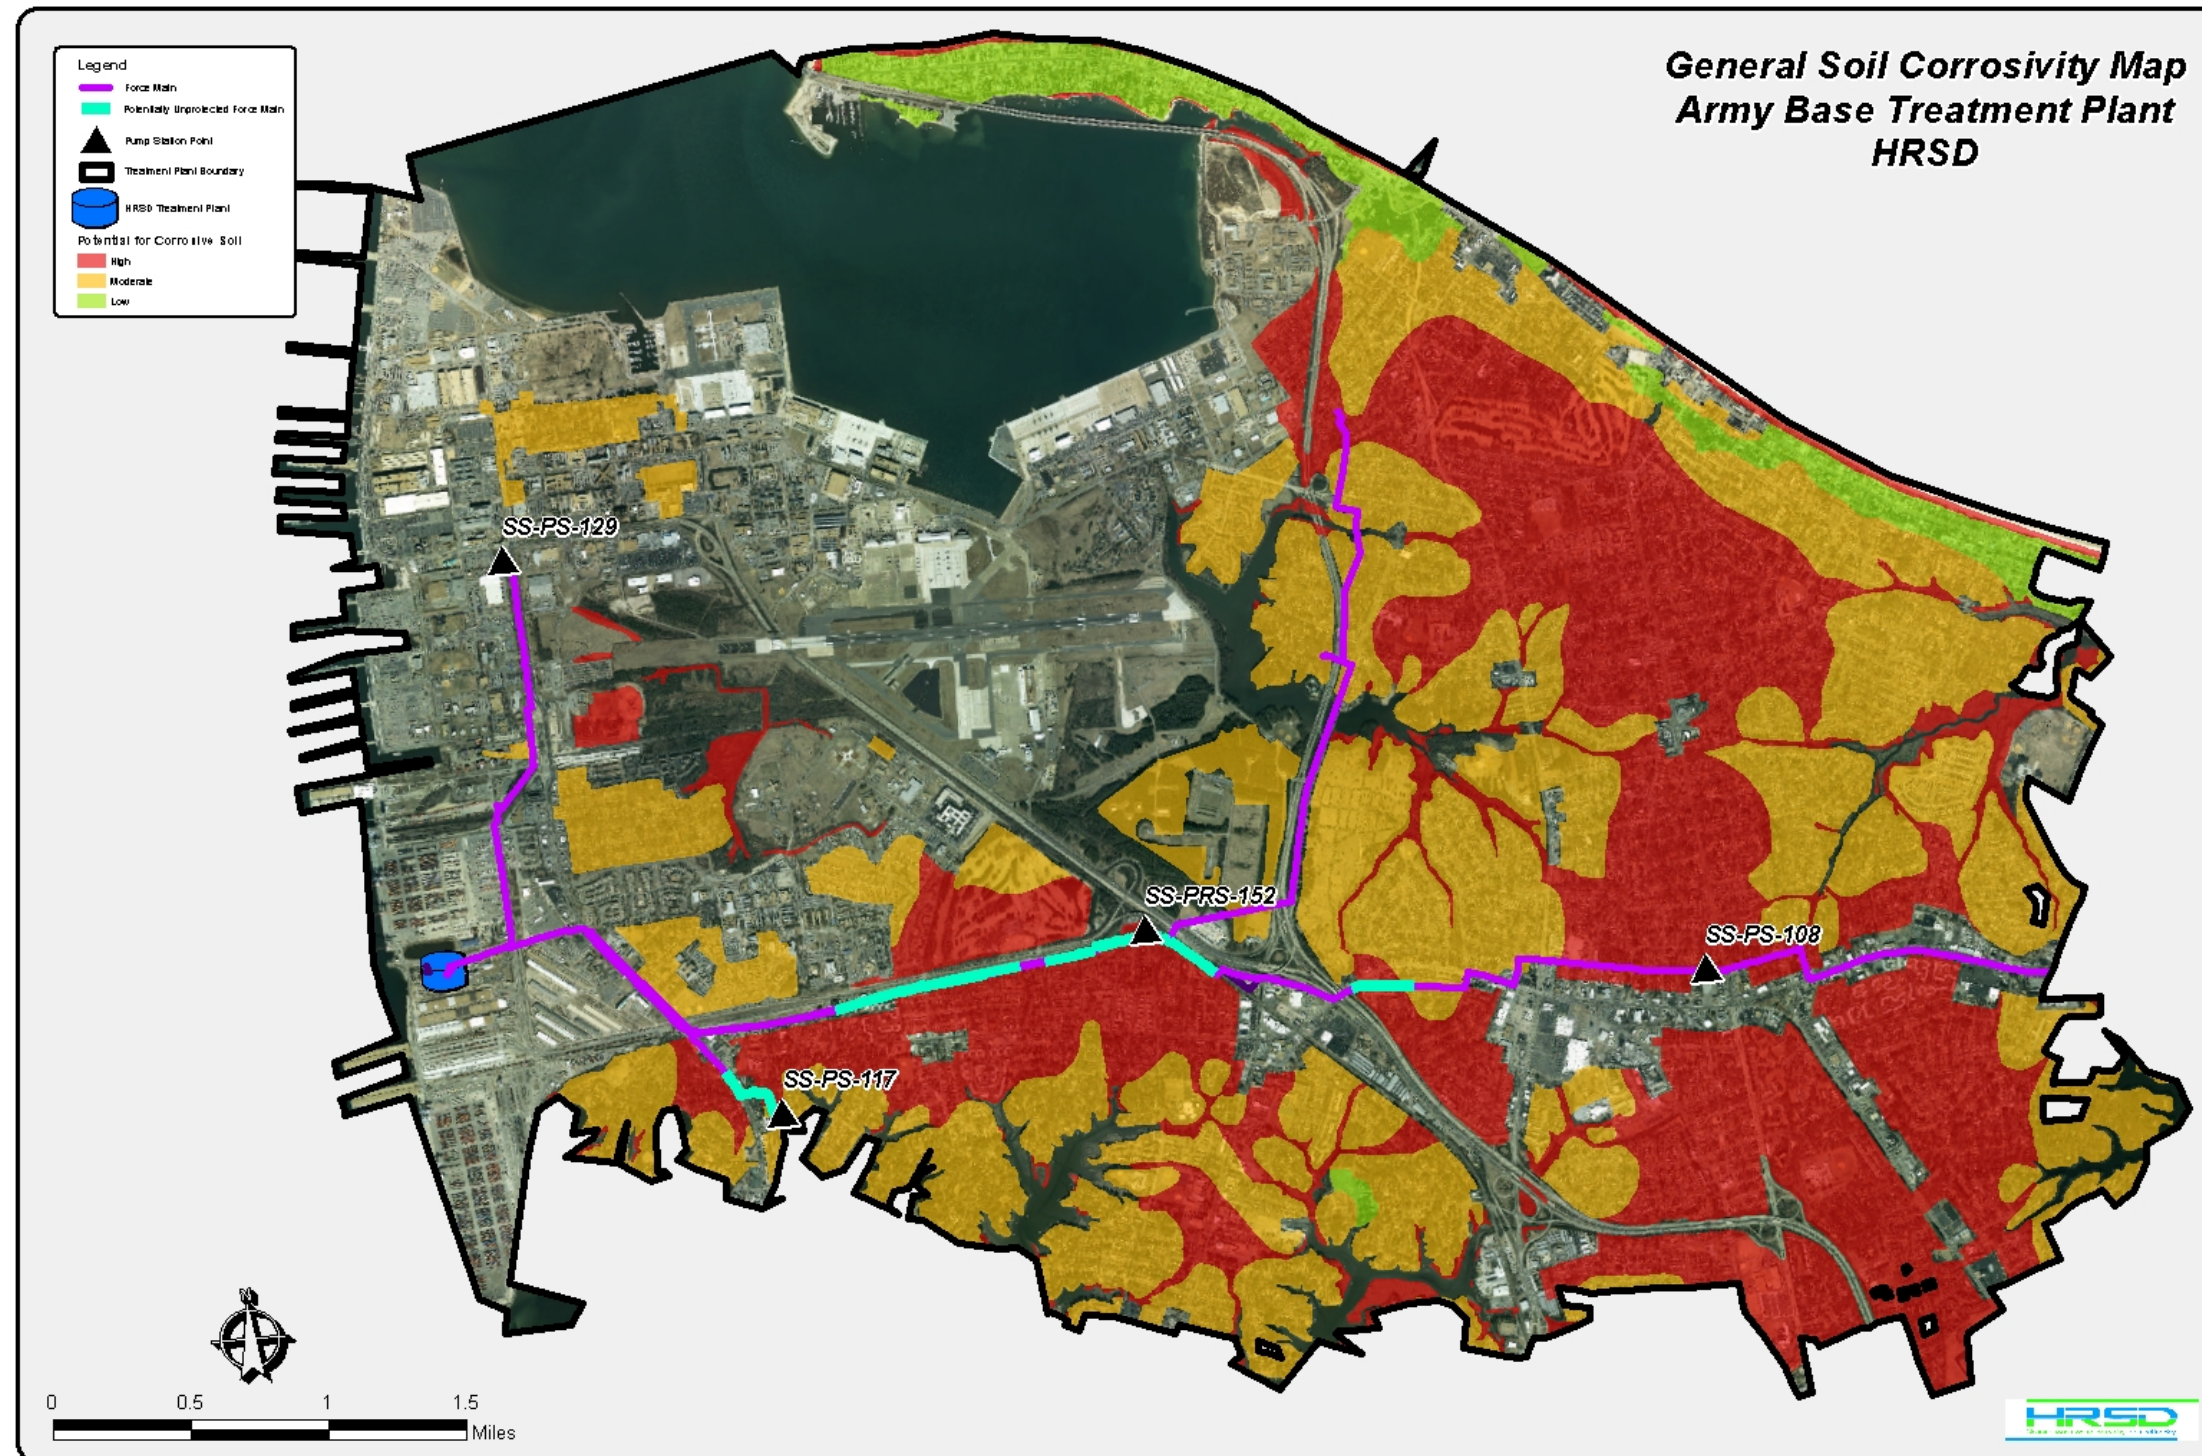
Figure D-1. General Soil Corrosivity Map for Army Base Treatment Plant Service Area

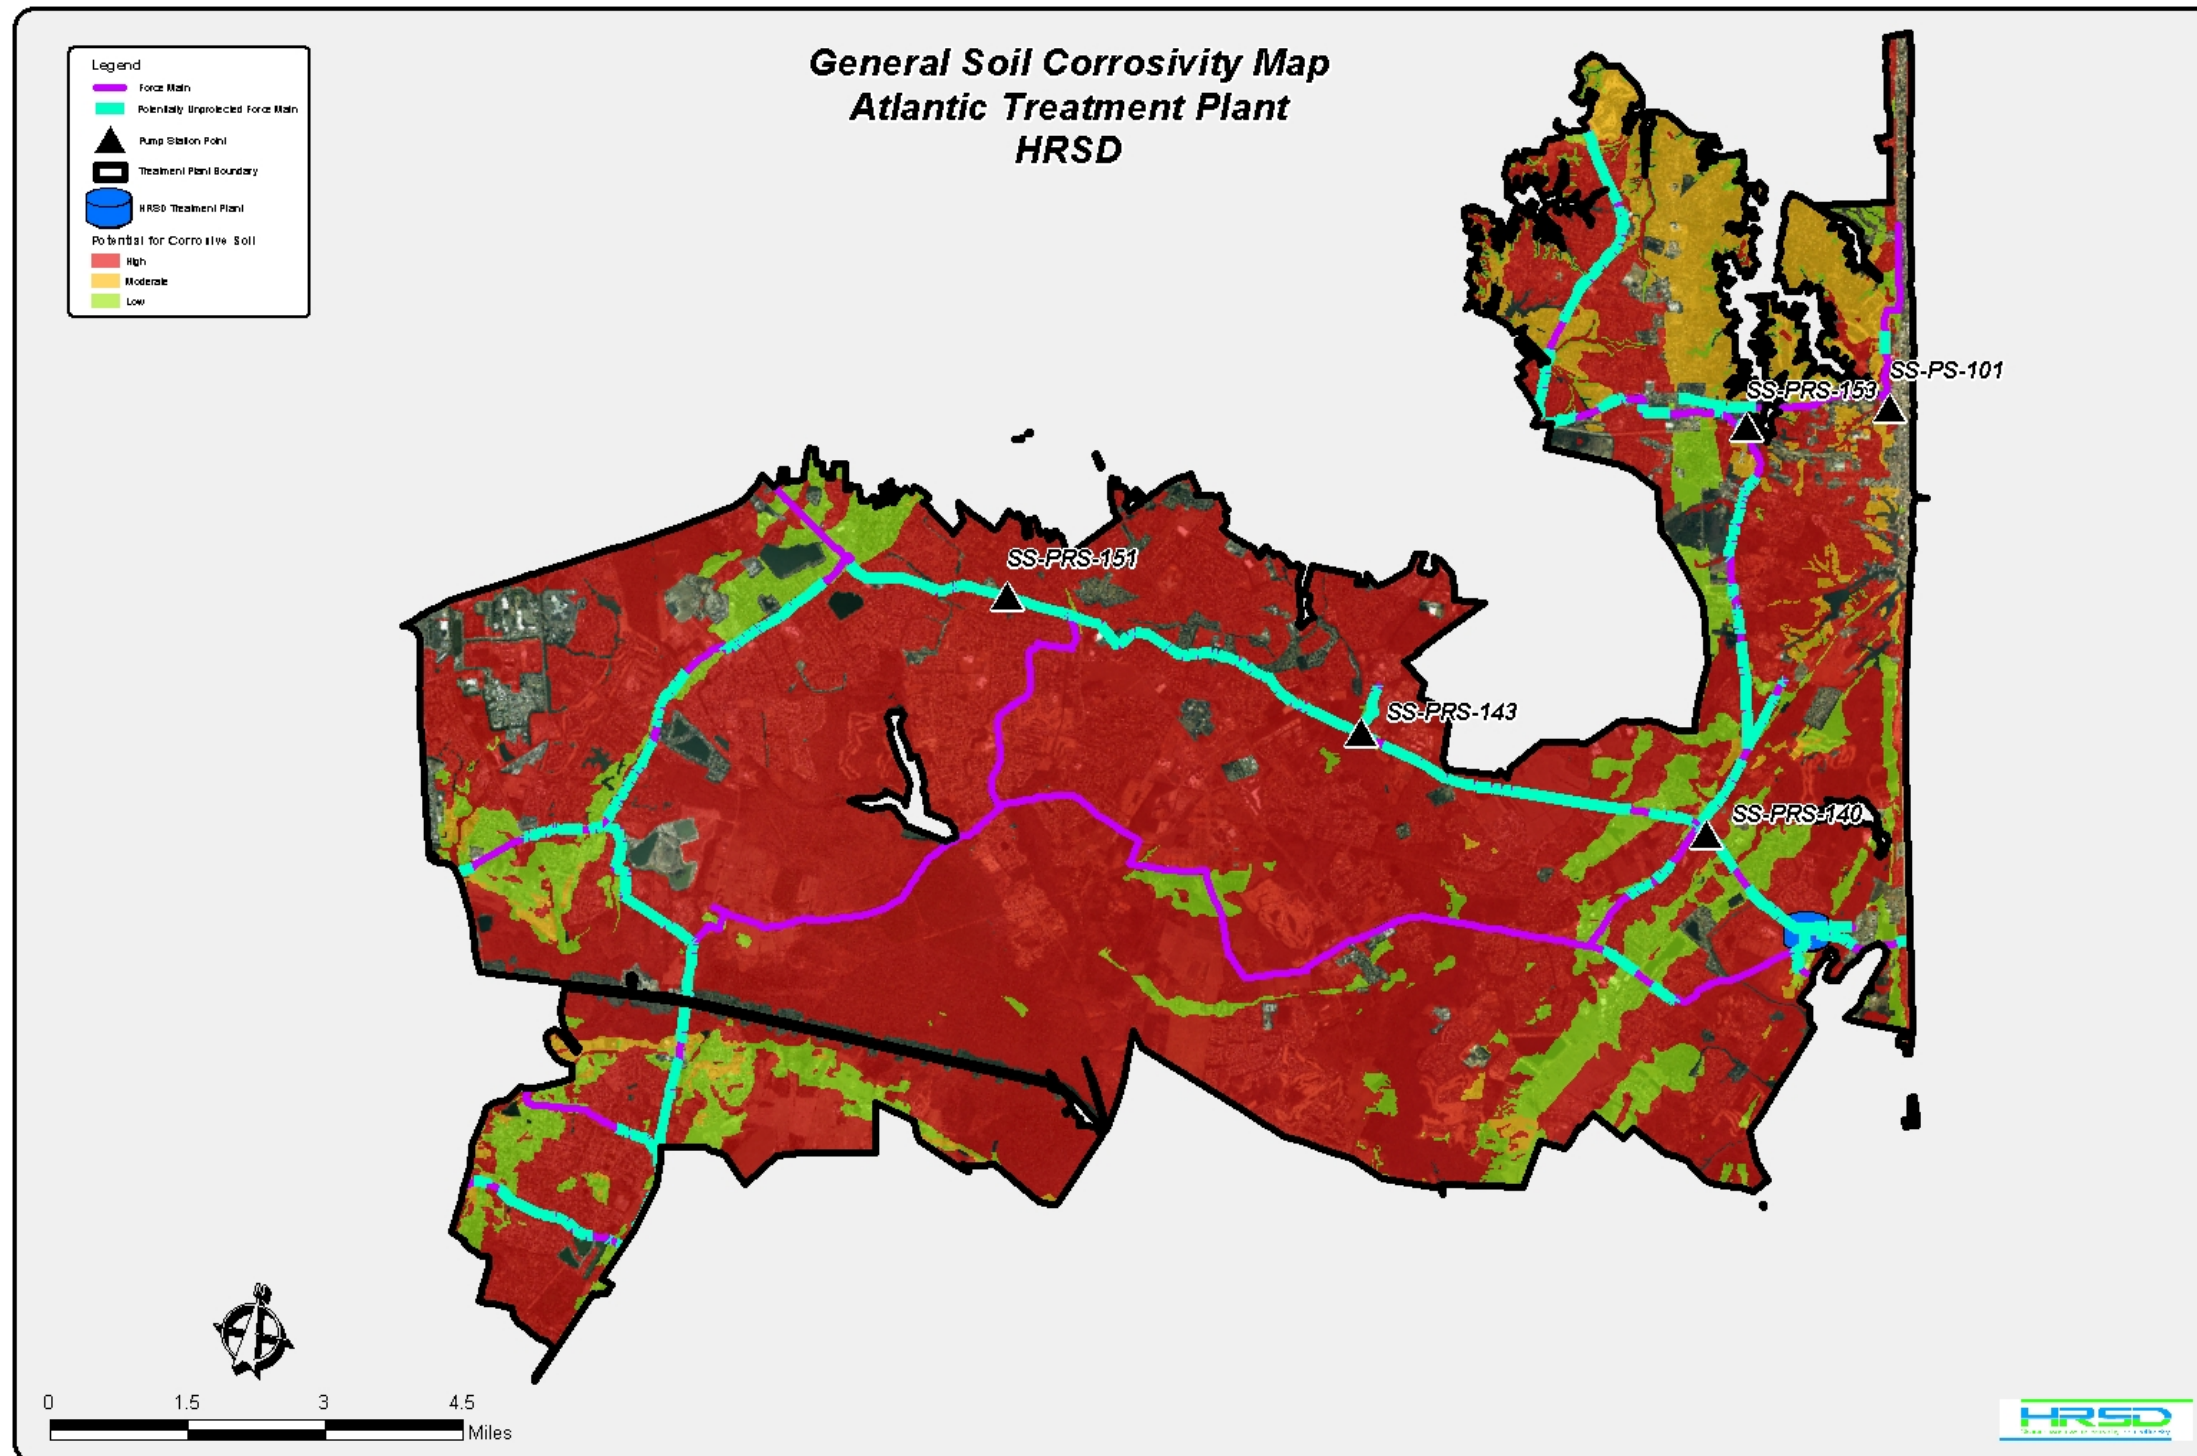
Figure D-2. General Soil Corrosivity Map for the Atlantic Treatment Plant Service Area

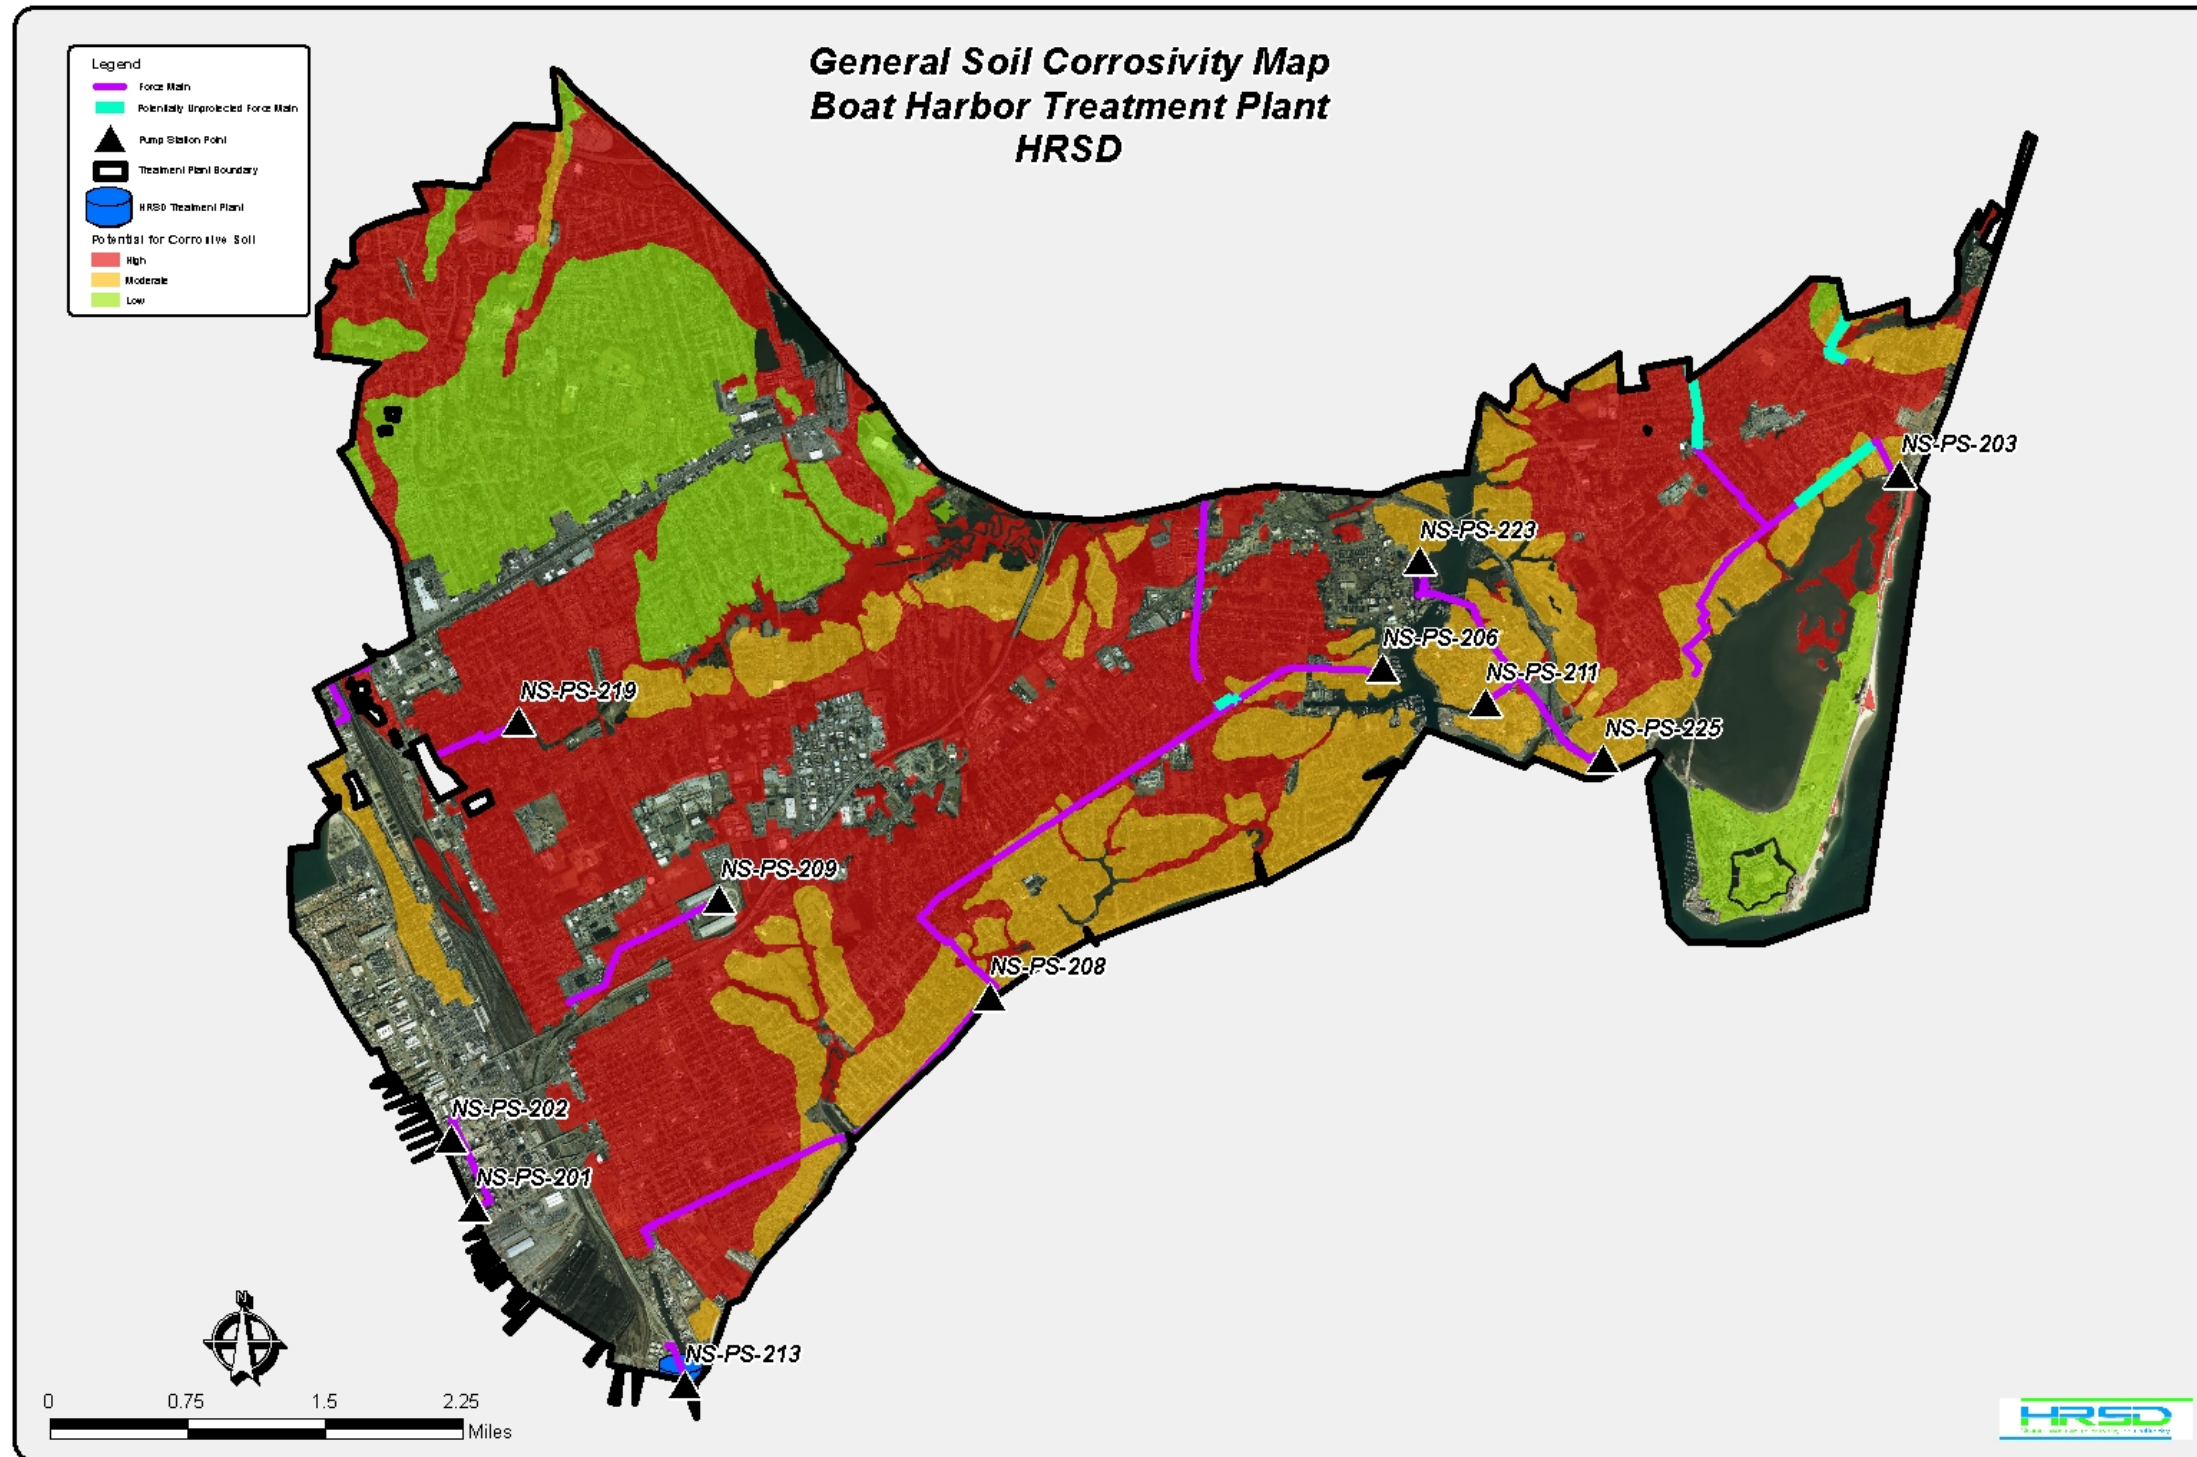
Figure D-3. General Soil Corrosivity Map for the Boat Harbor Treatment Plant Service Area

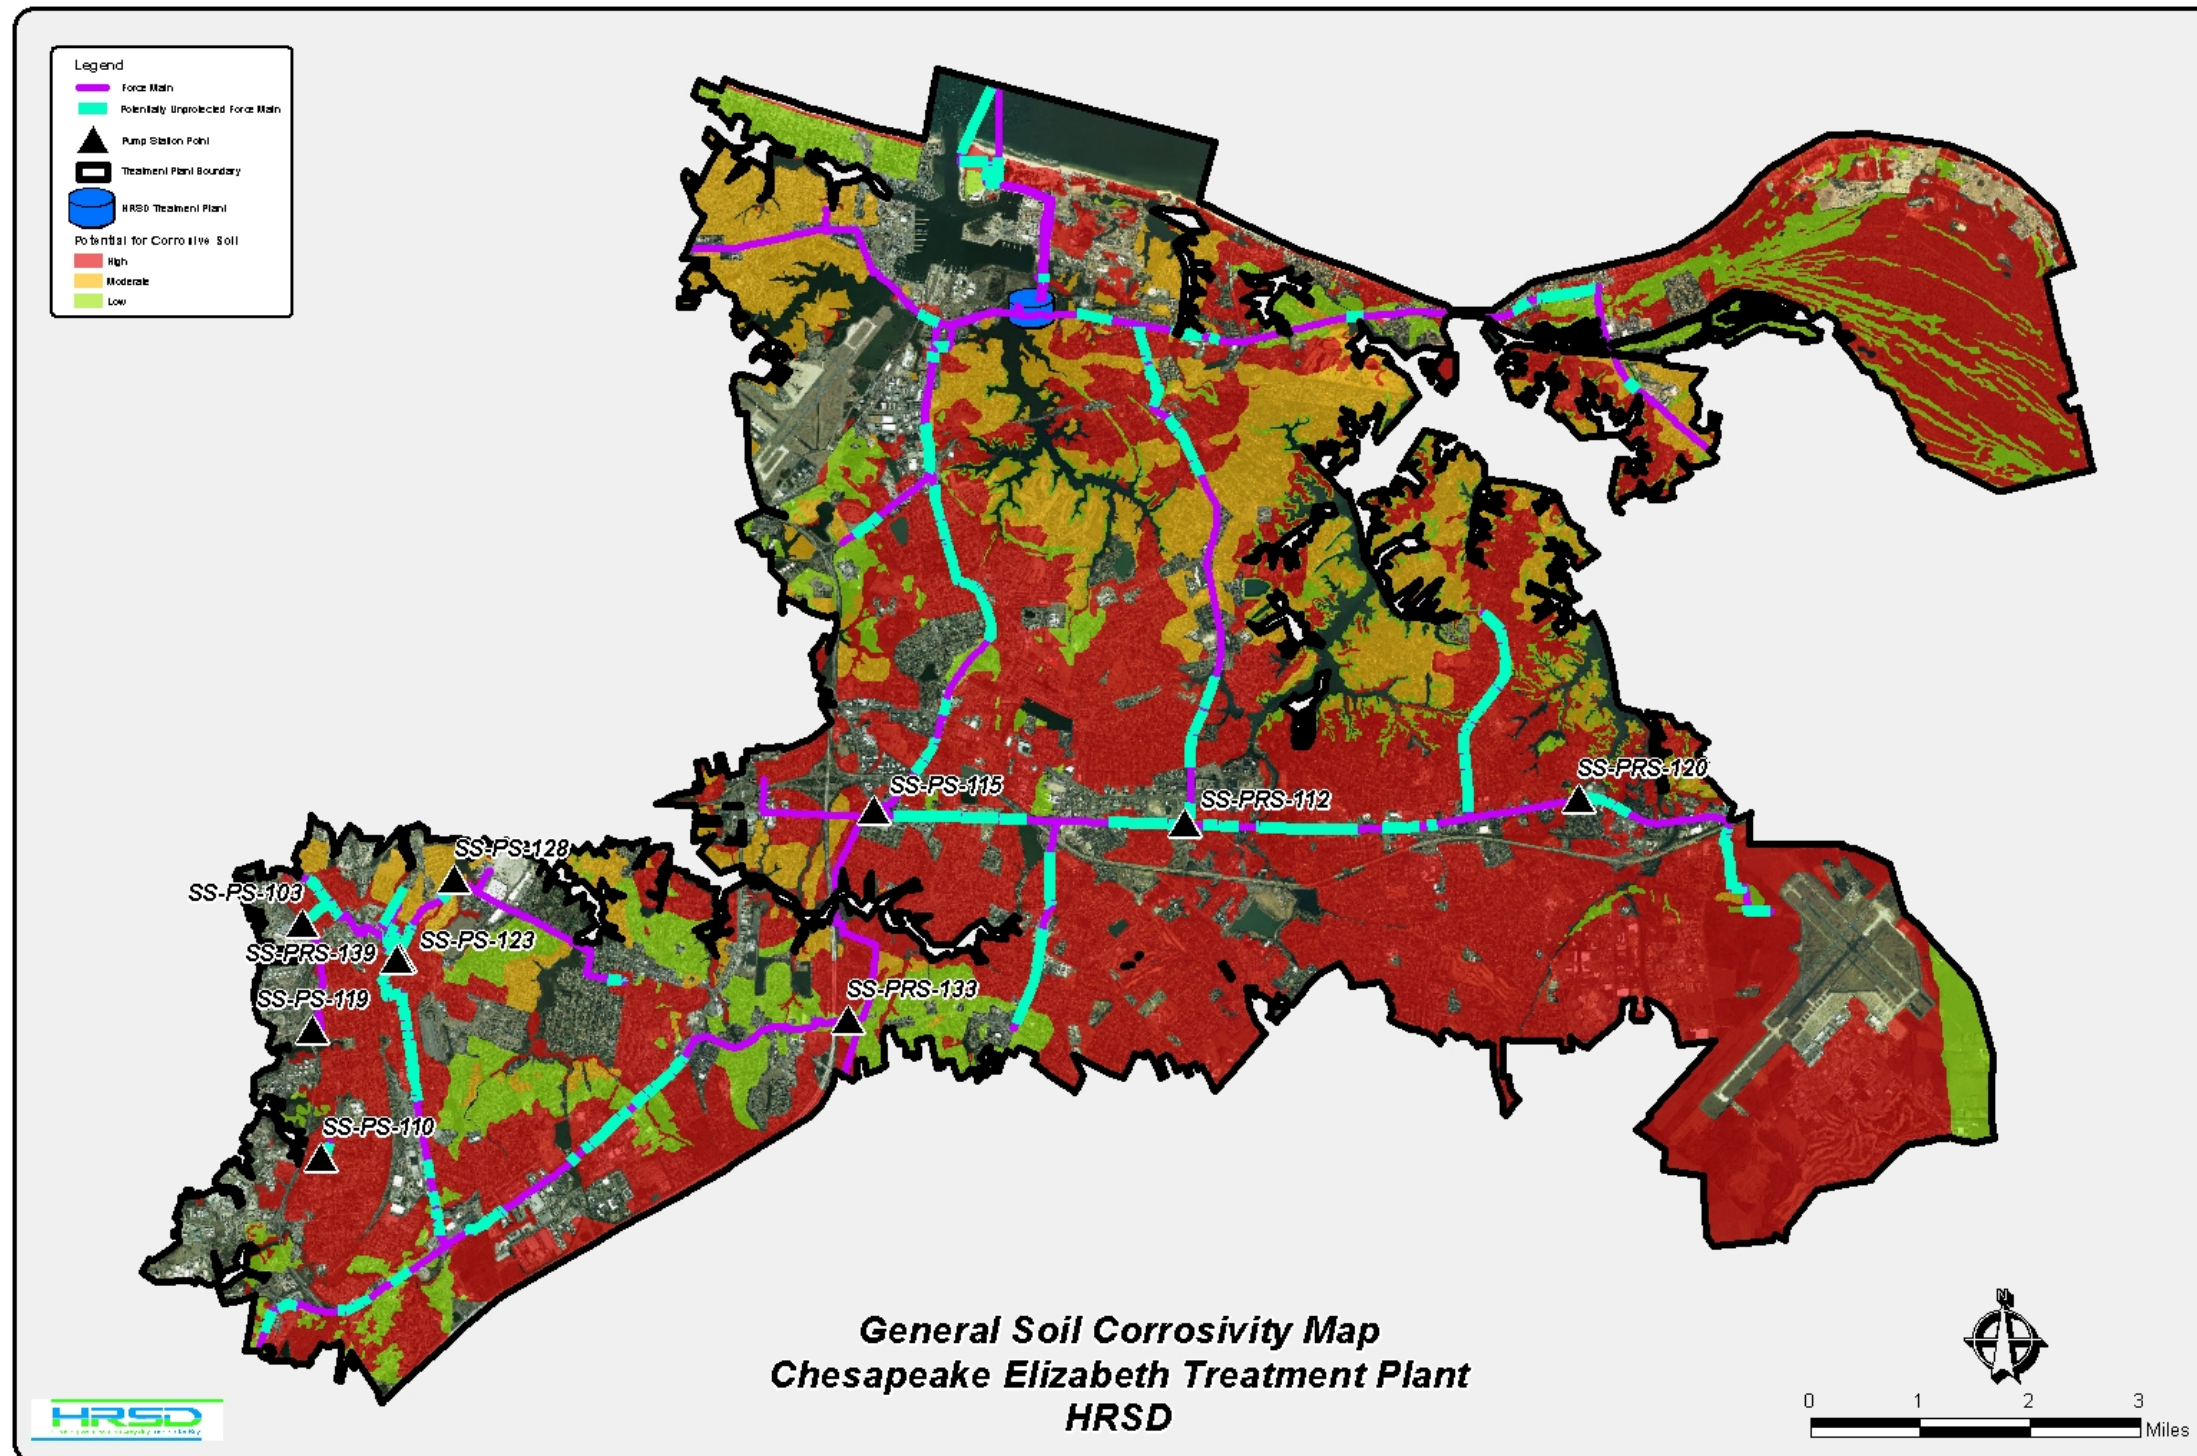
Figure D-4. General Soil Corrosivity Map for the Chesapeake Elizabeth Treatment Plant Service Area

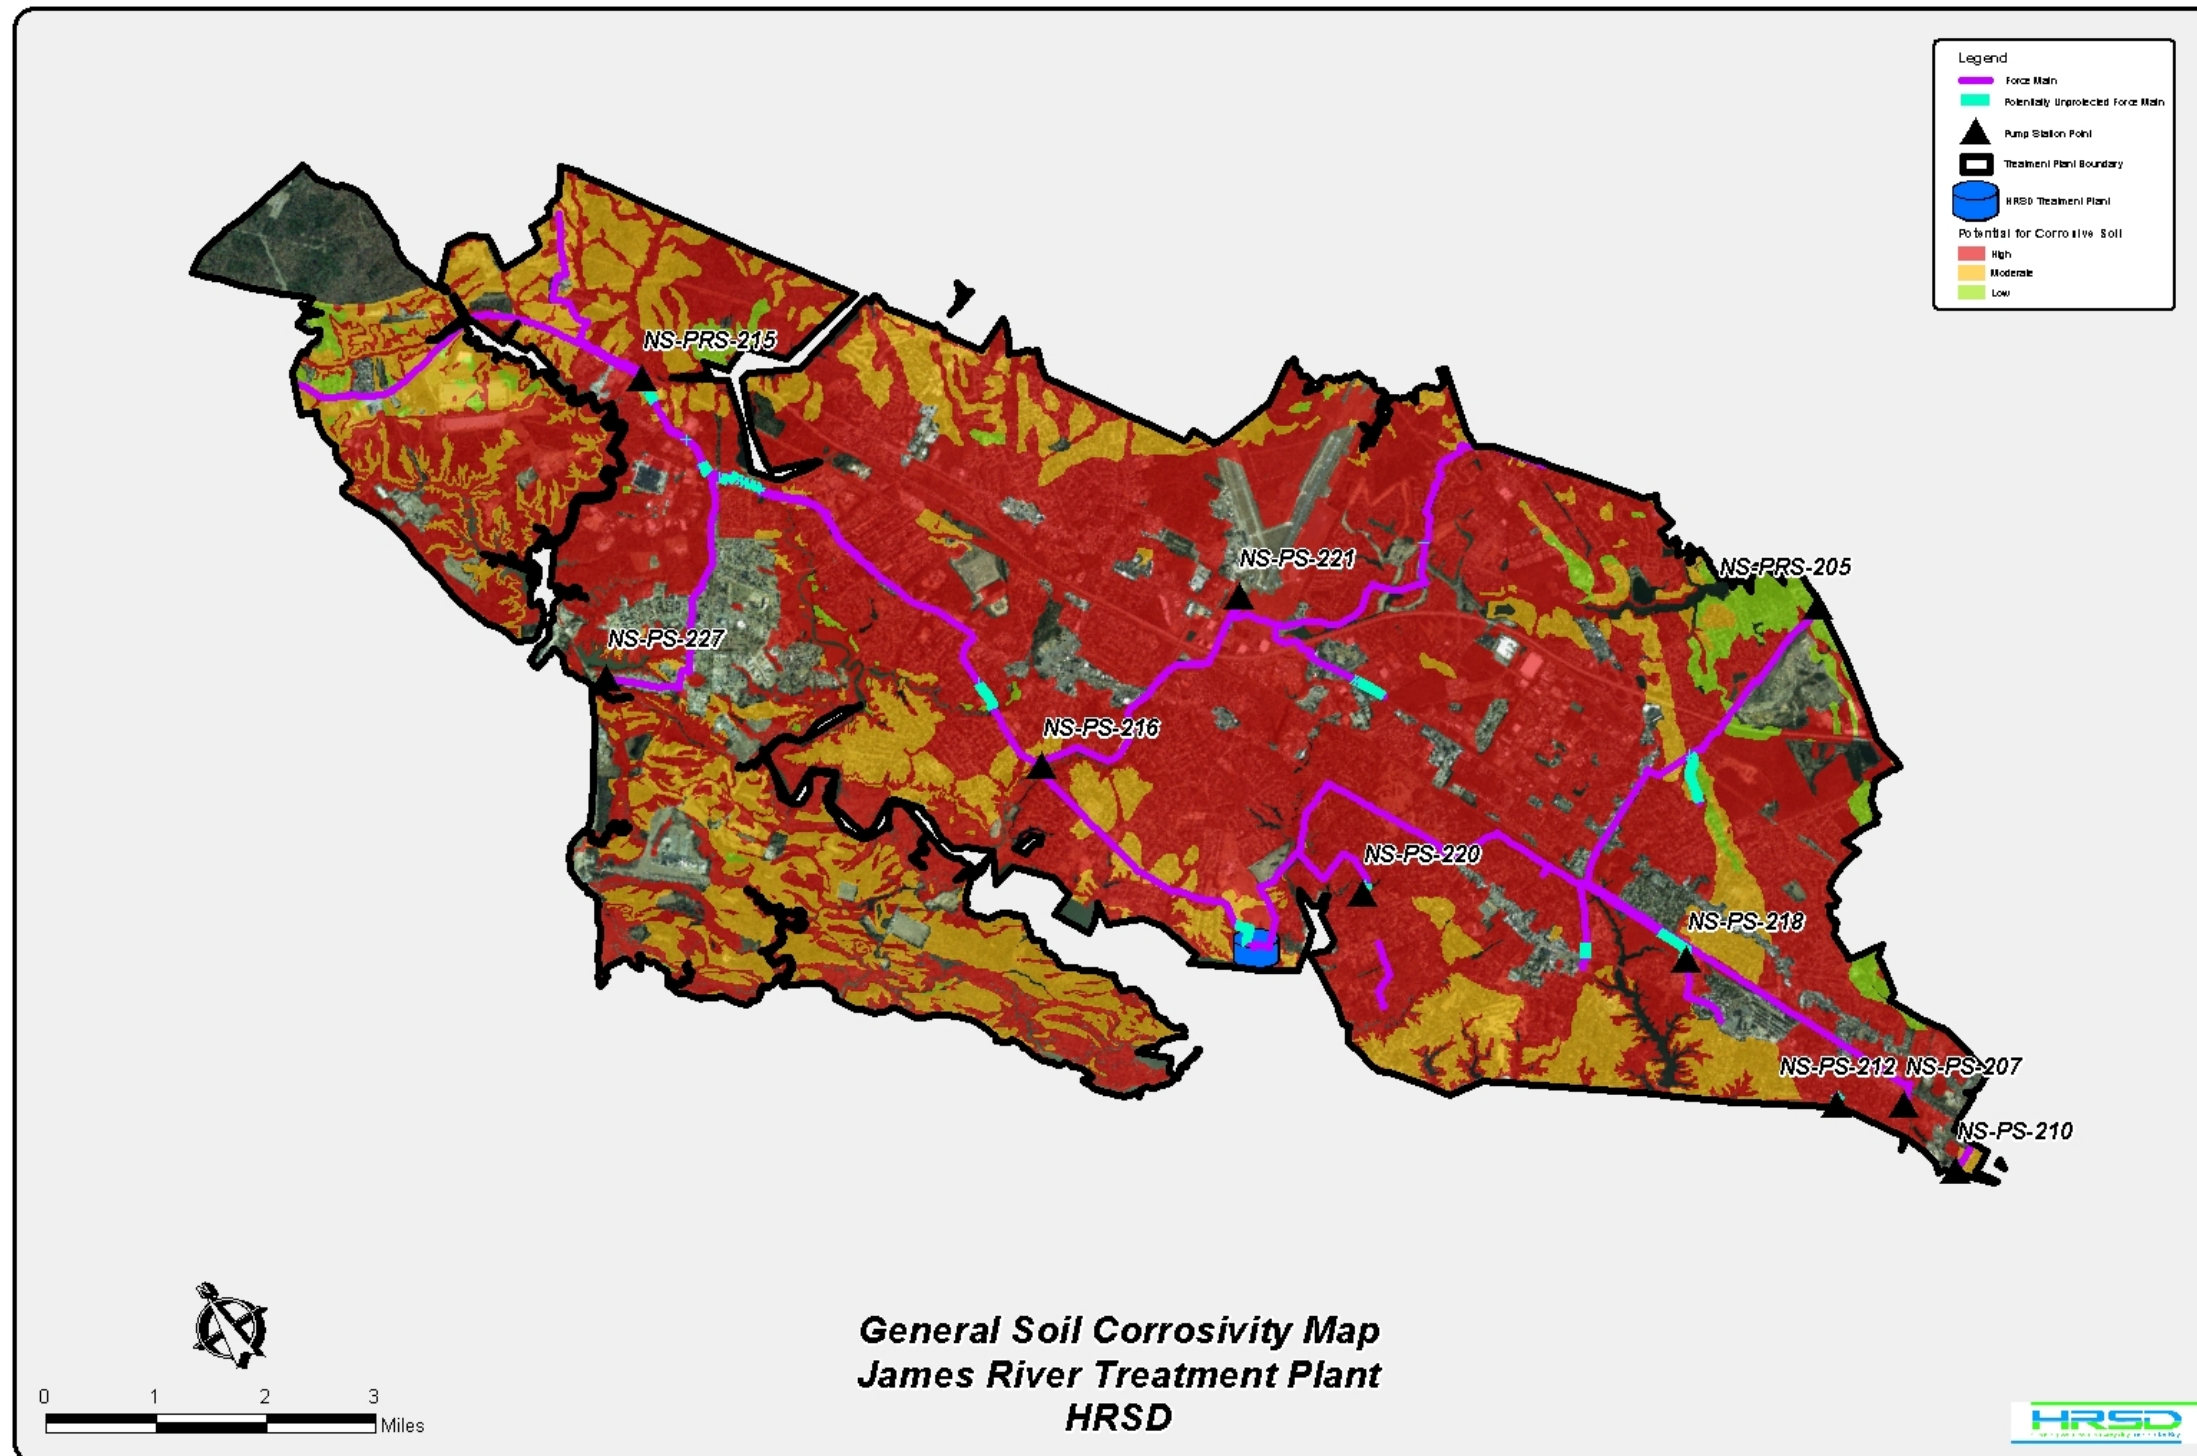
Figure D-5. General Soil Corrosivity Map for the James River Treatment Plant Service Area

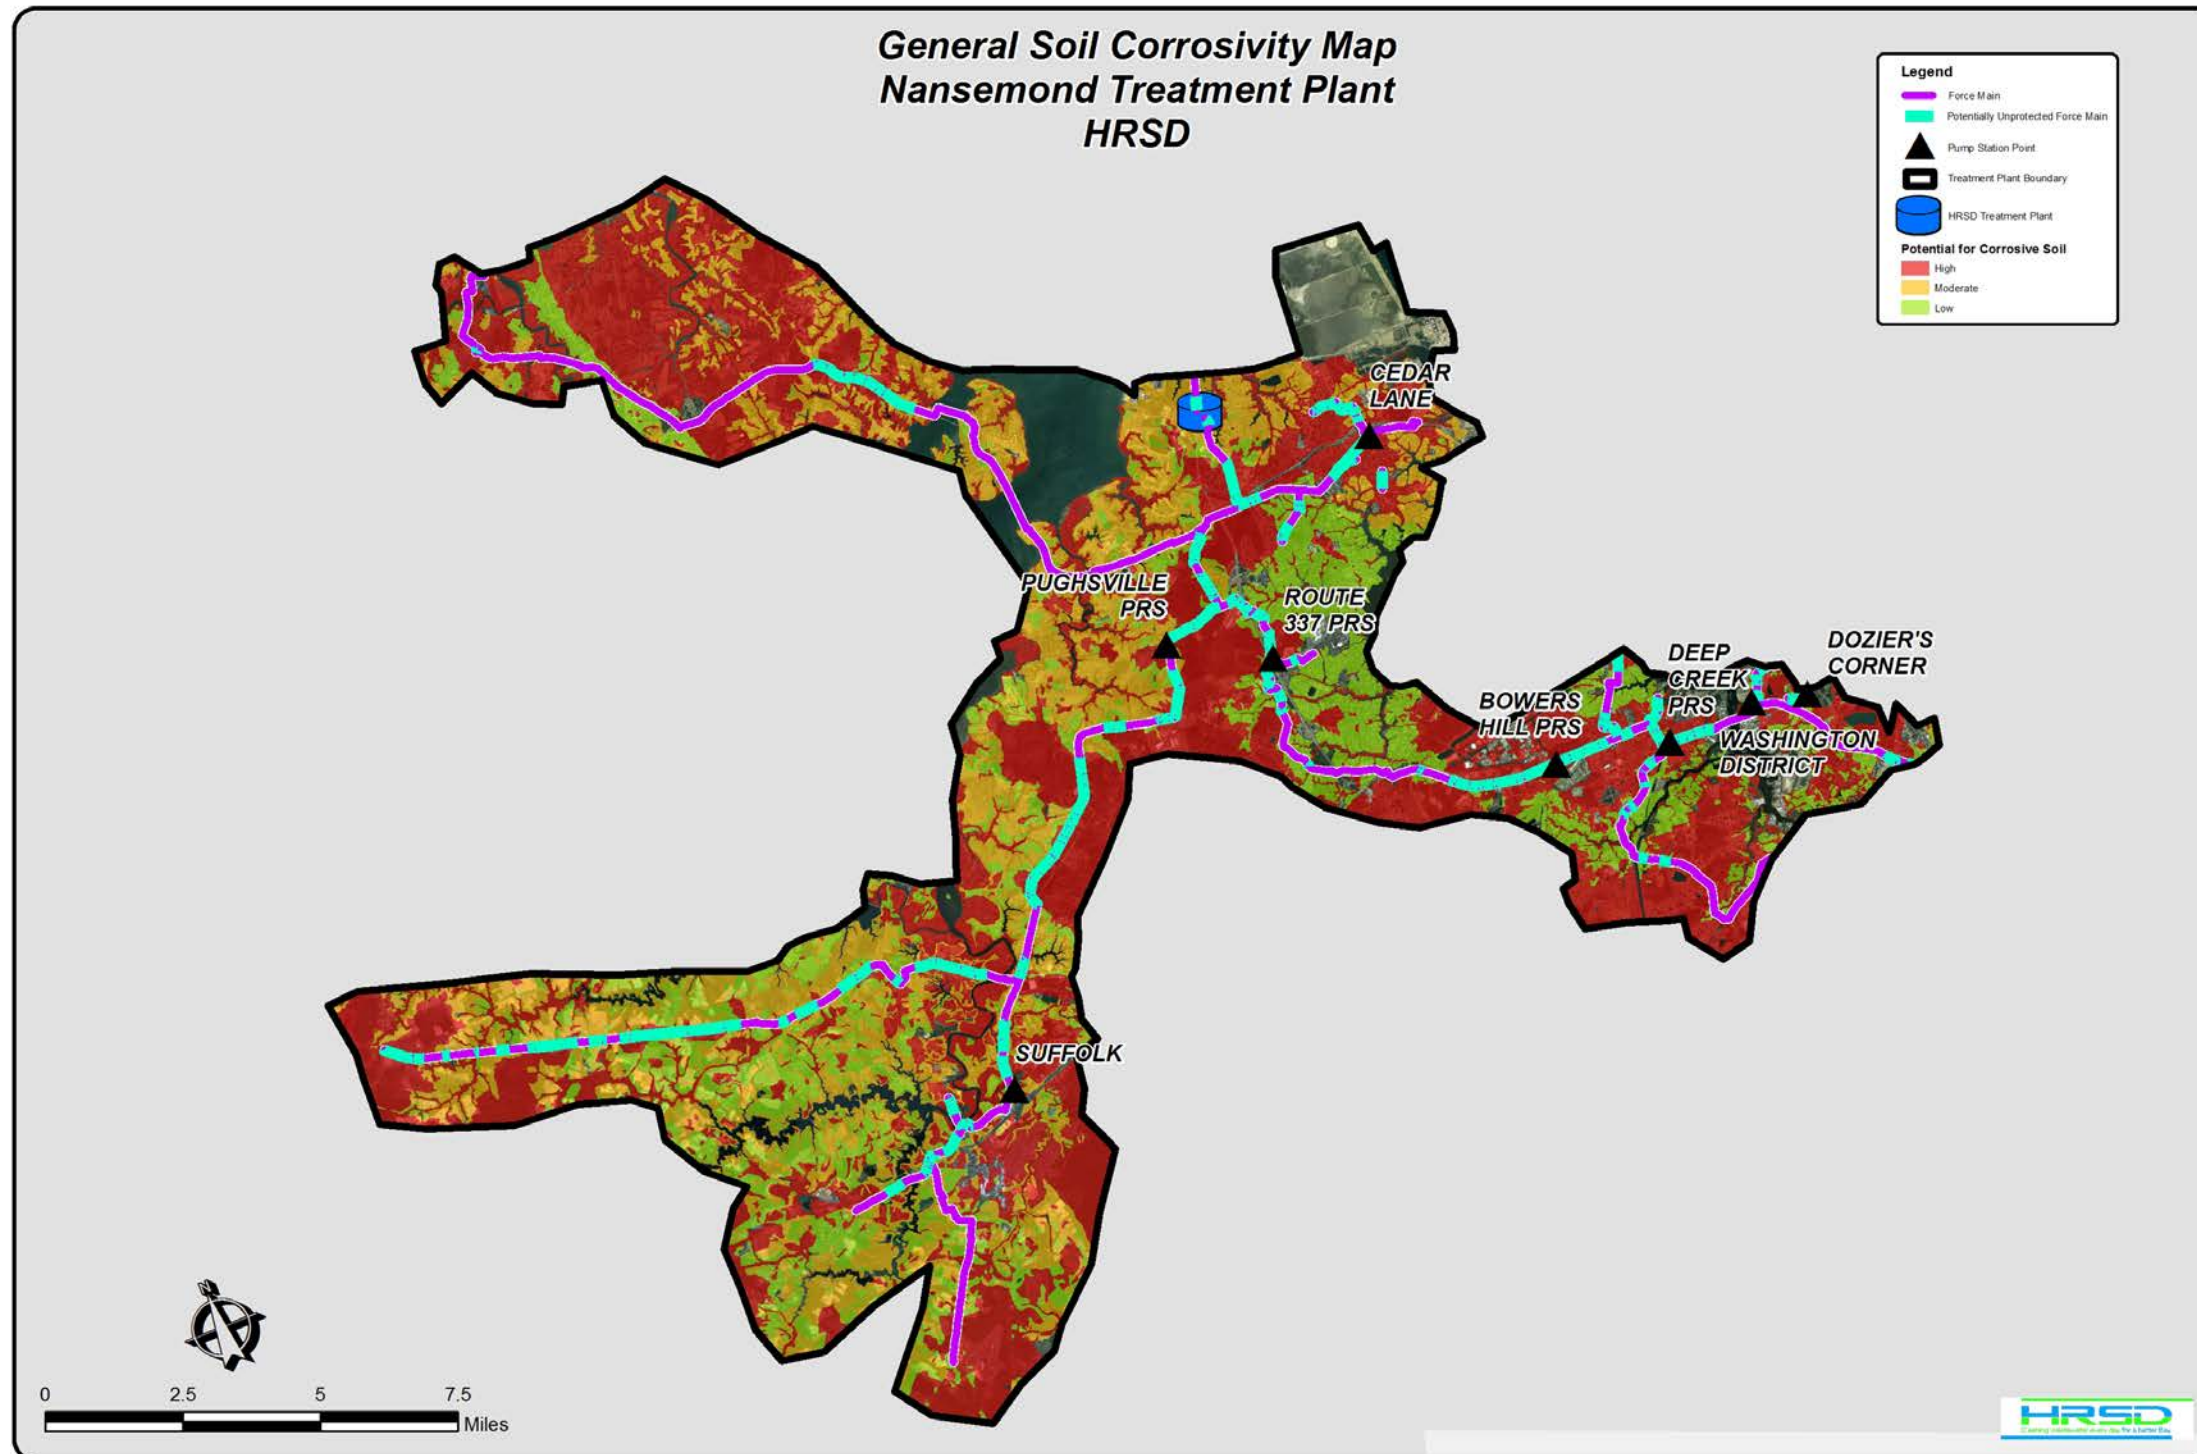
Figure D-6. General Soil Corrosivity Map for the Nansemond Treatment Plant Service Area

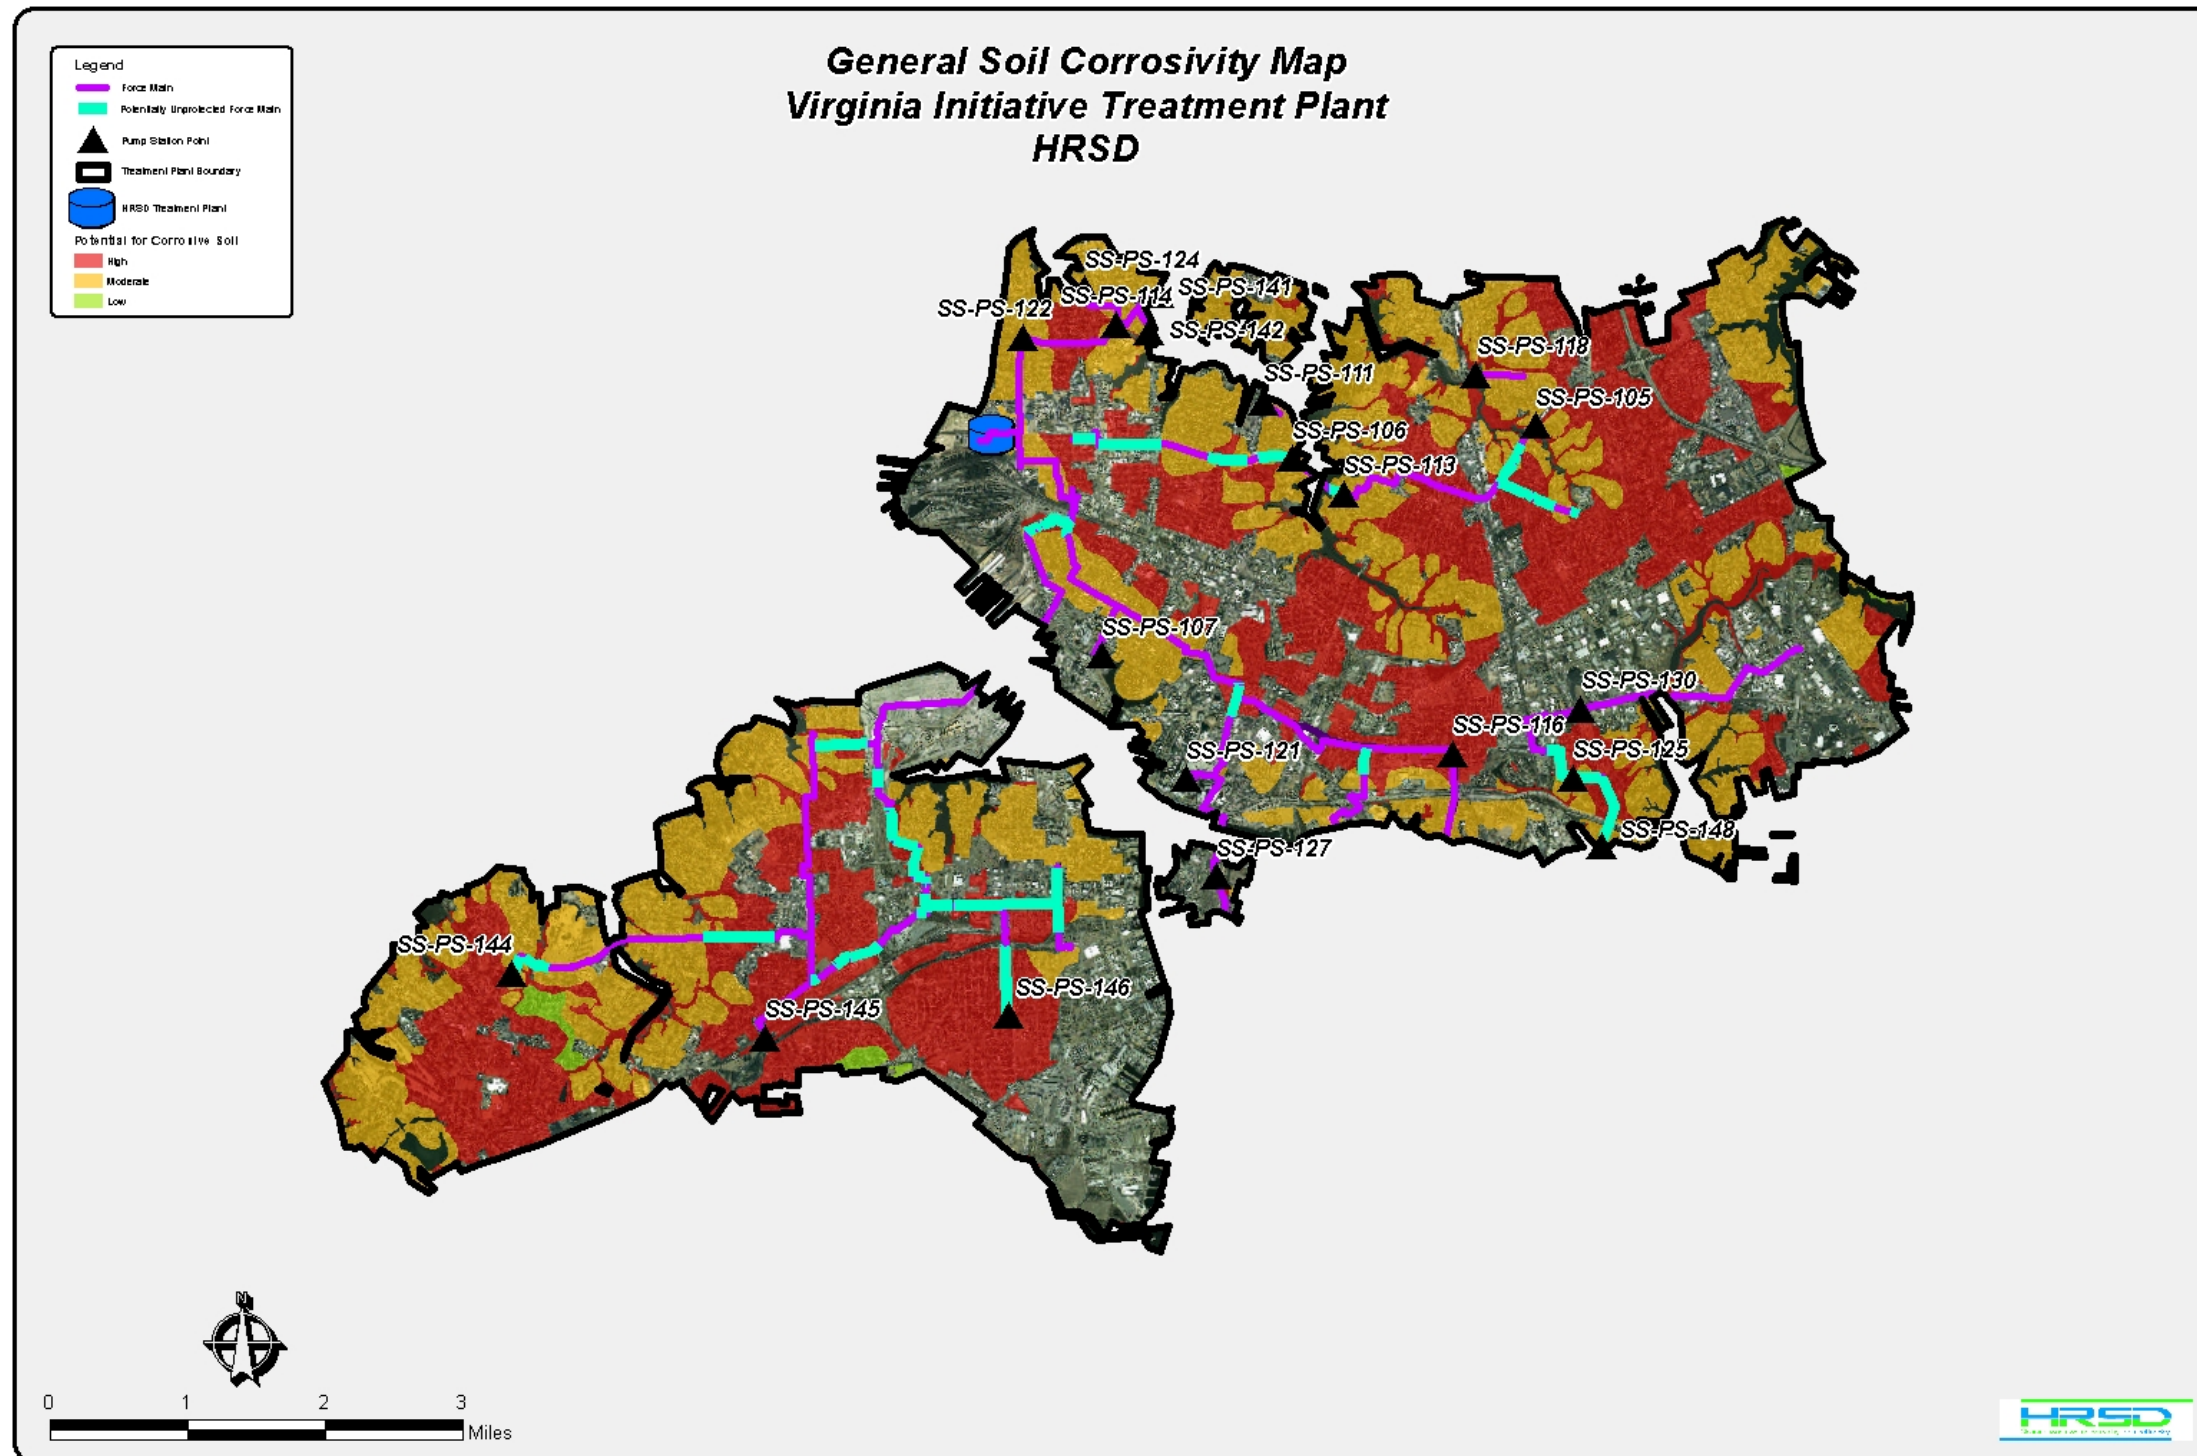
Figure D-7. General Soil Corrosivity Map for the Virginia Initiative Treatment Plant Service Area
