Appendix D: Force Main System Final Condition Assessment Report

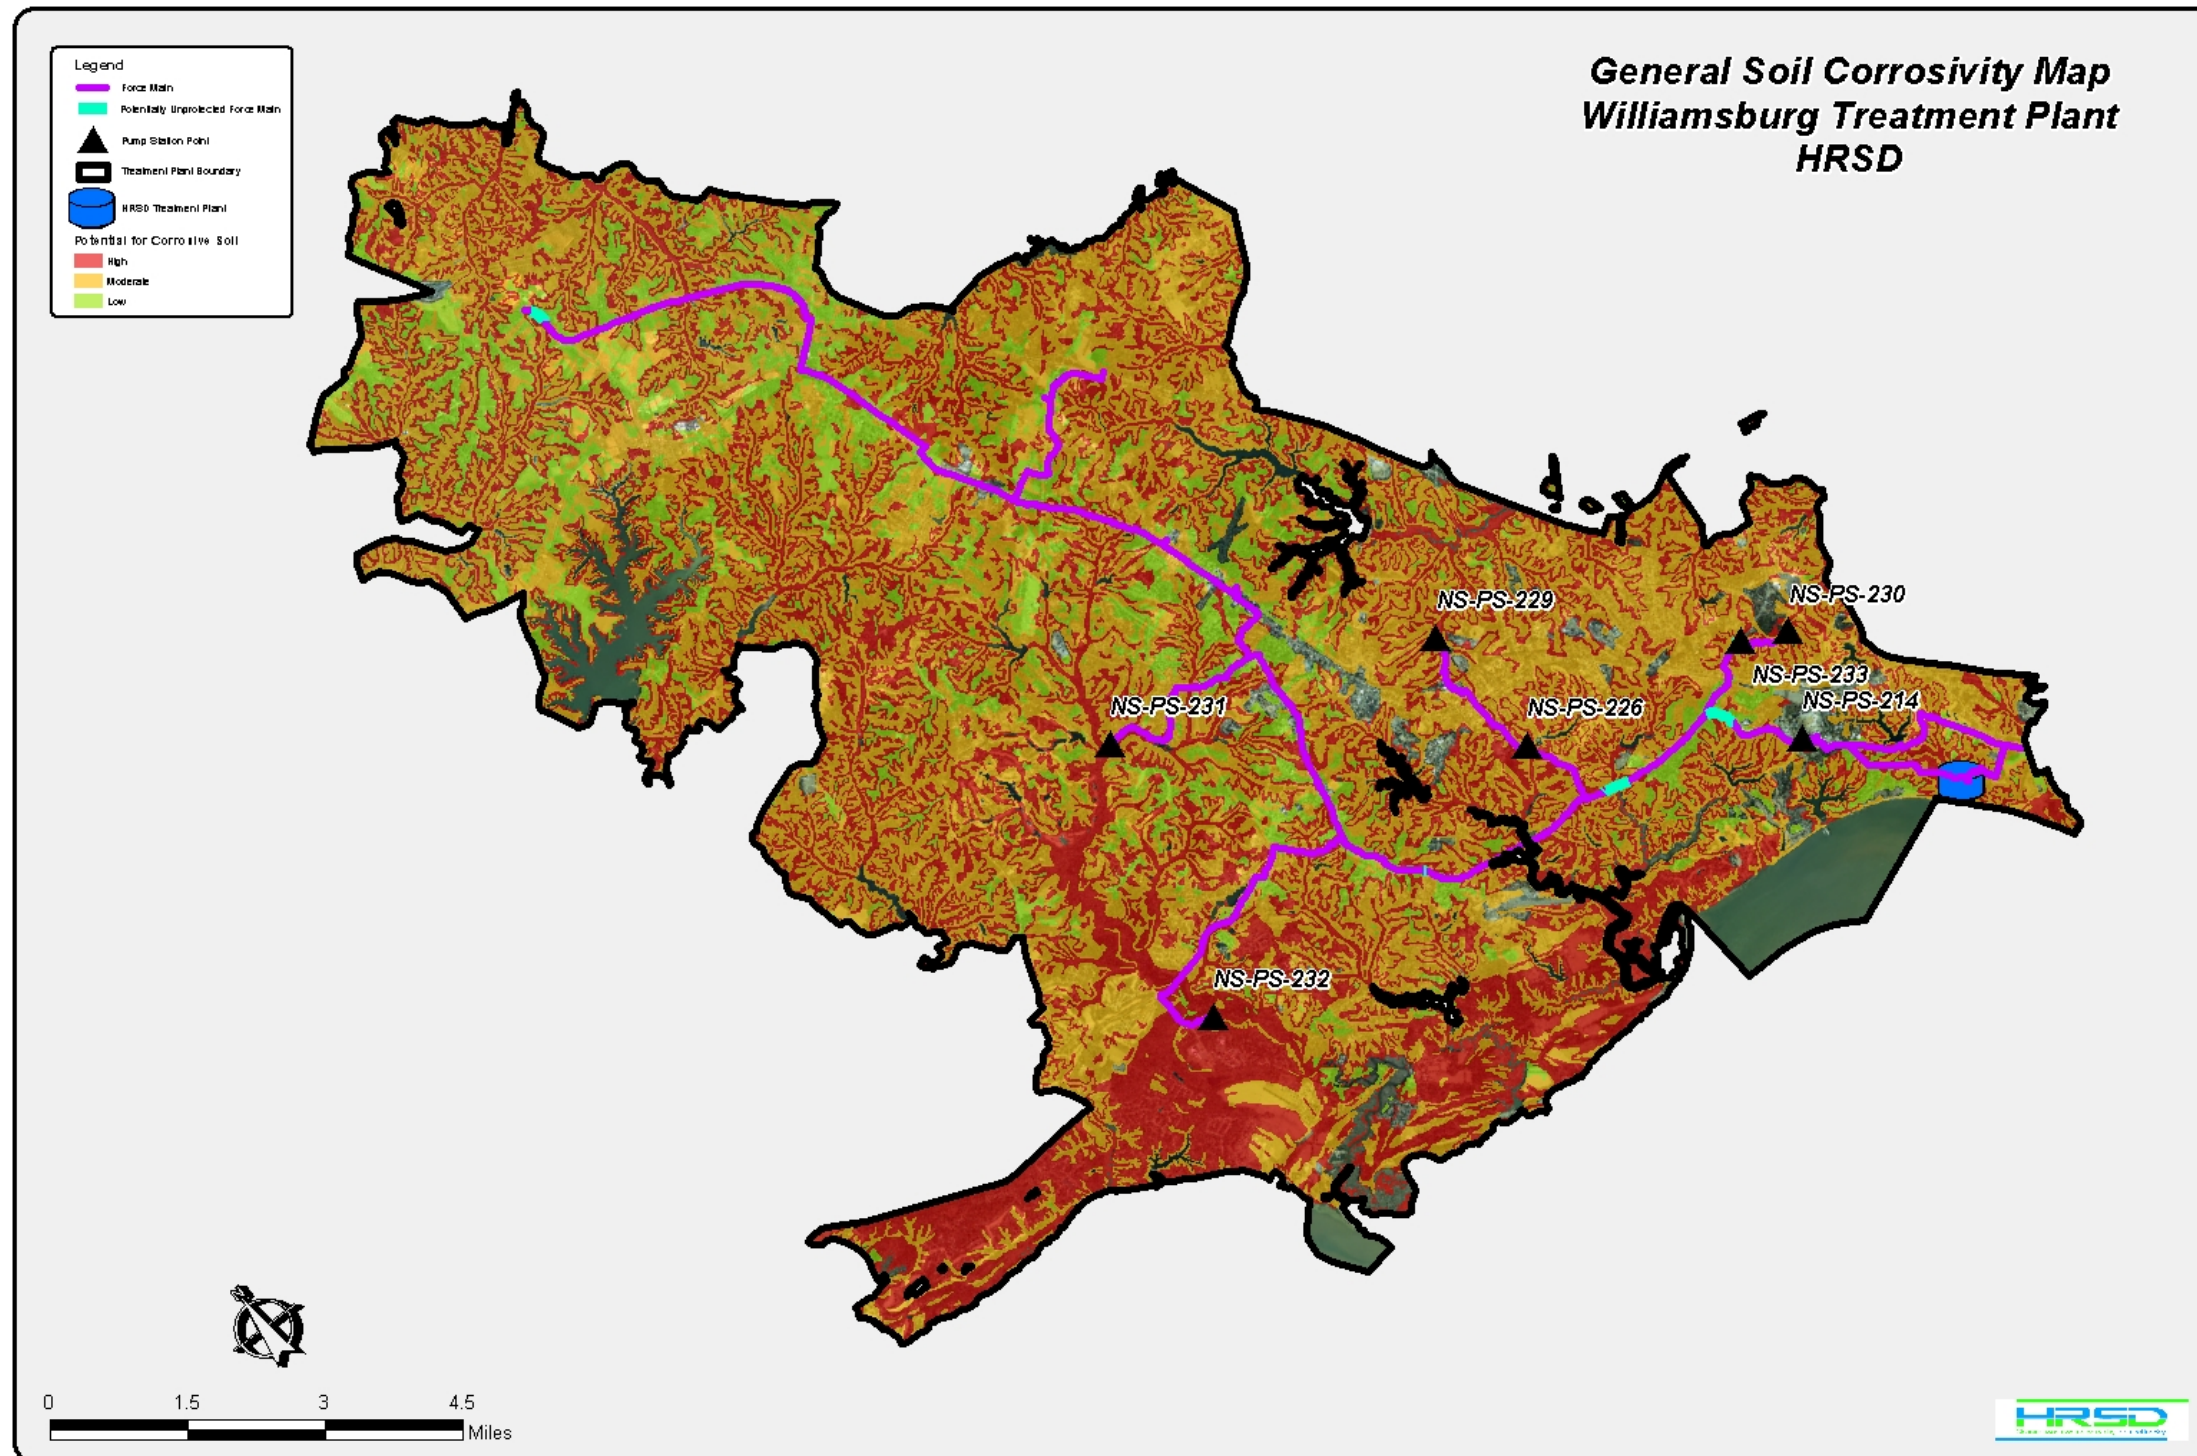
Figure D-8. General Soil Corrosivity Map for the Williamsburg Treatment Plant Service Area

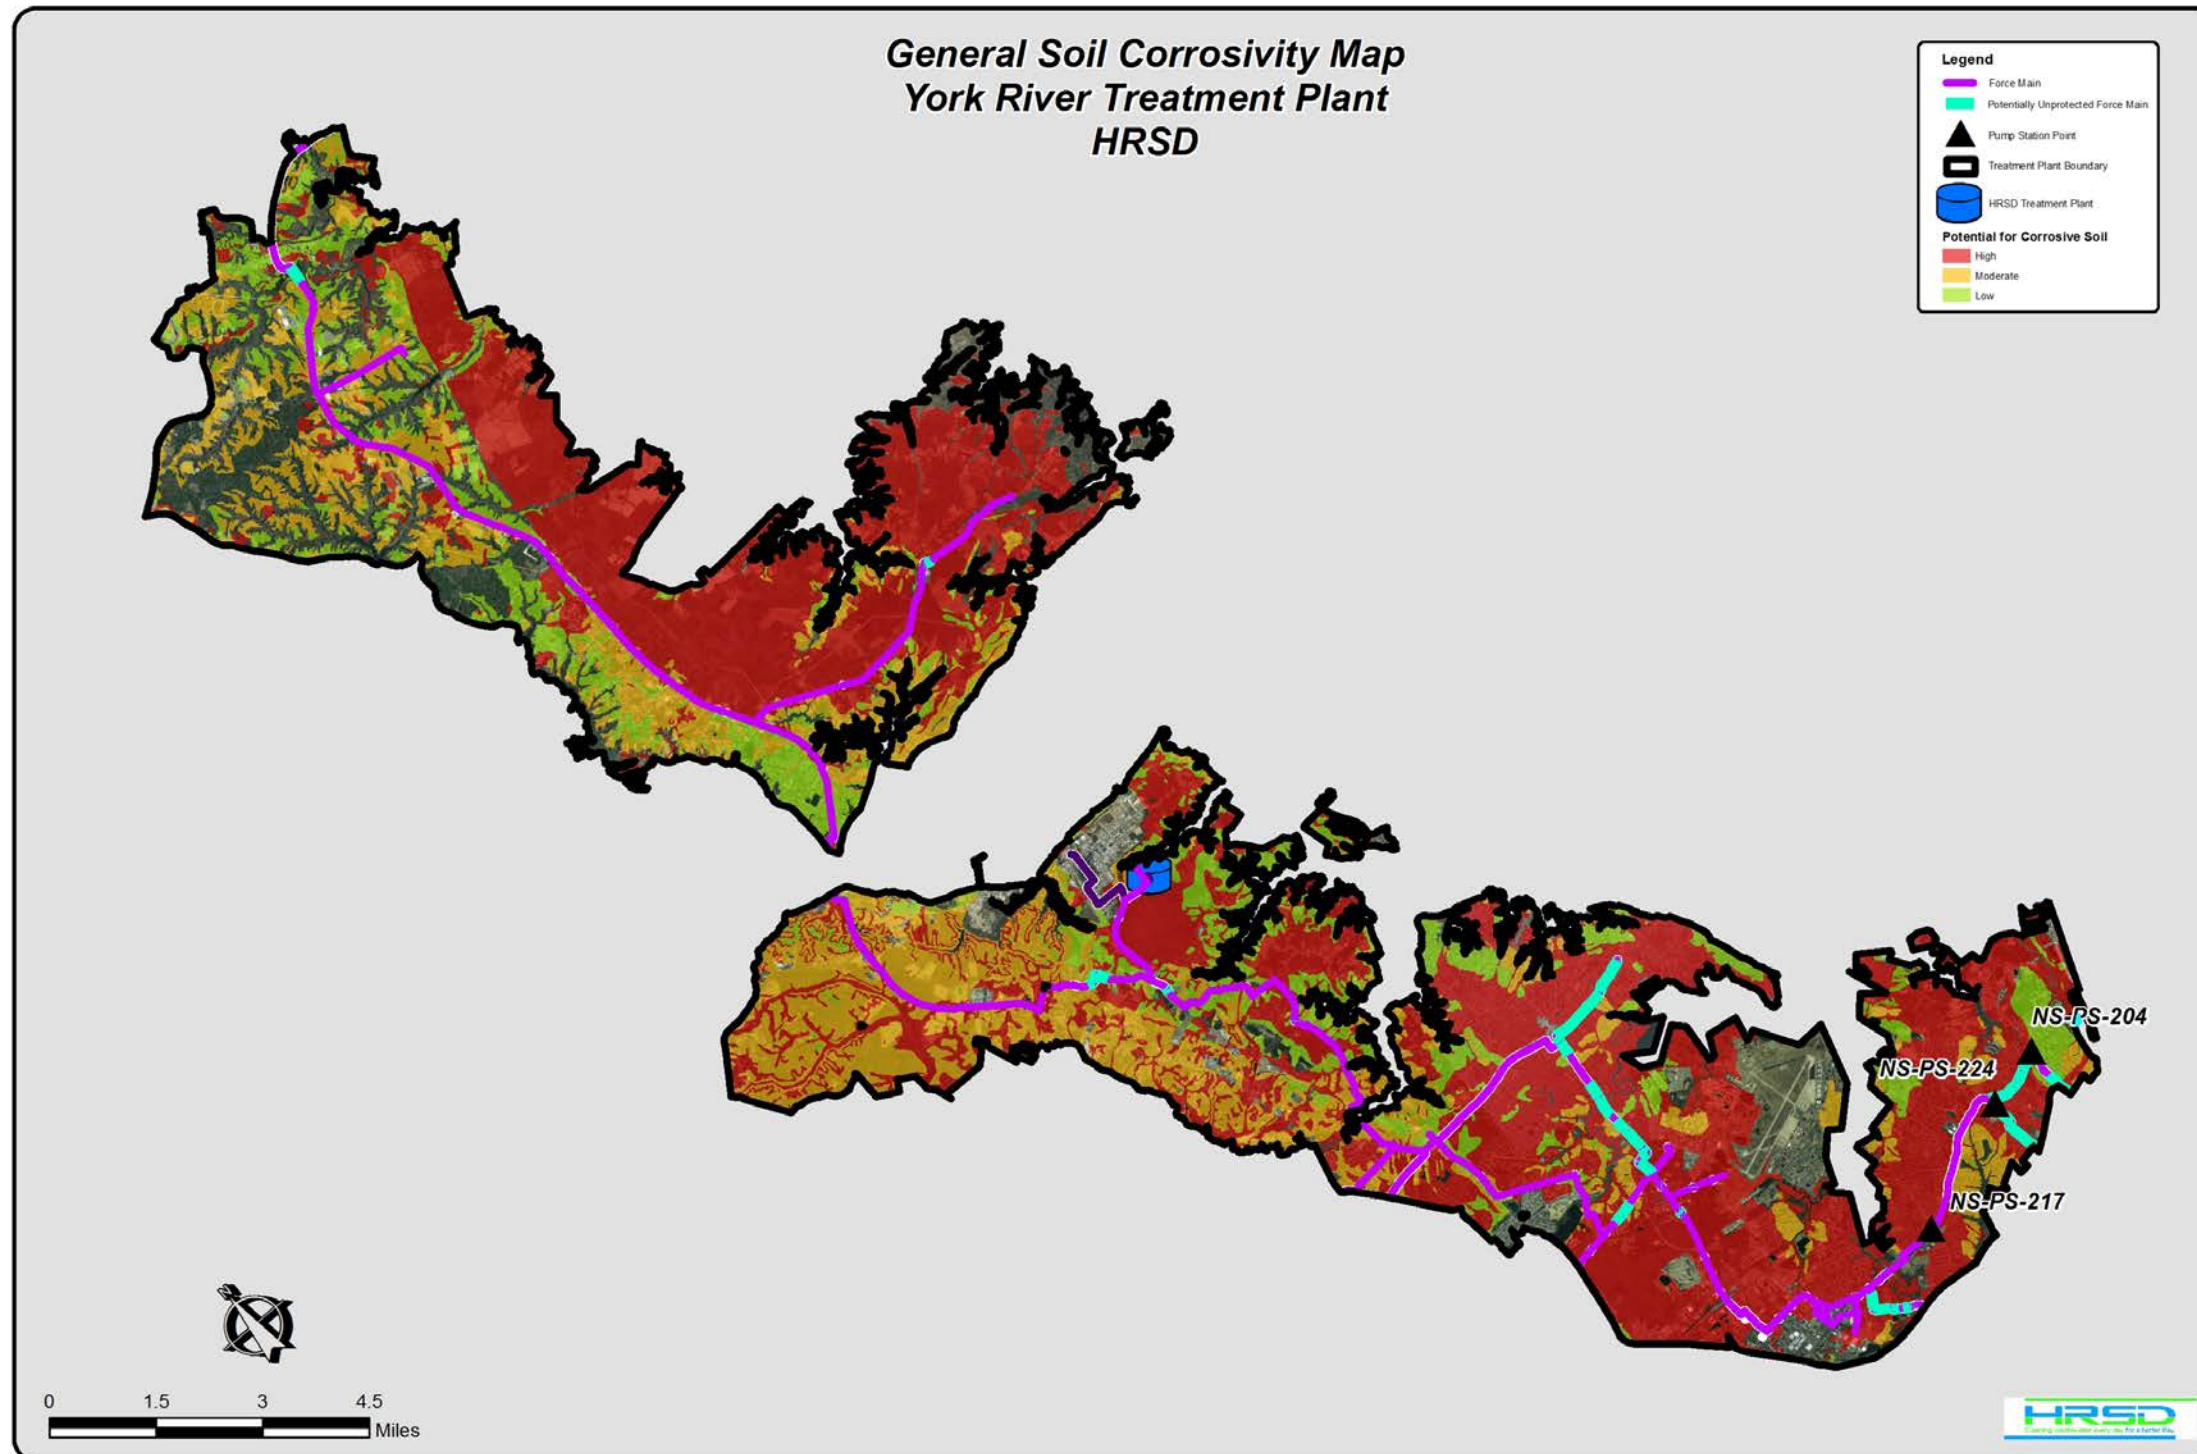
Figure D-9. General Soil Corrosivity Map for the York River Treatment Plant Service Area
